TULSA-PRO[®] Transurethral
Ultrasound Ablation System

Operator's Manual

Philips Ingenua 3T and Ingenua Elition 3T

TULSA-PRO® SYSTEM Model Number: PAD-105

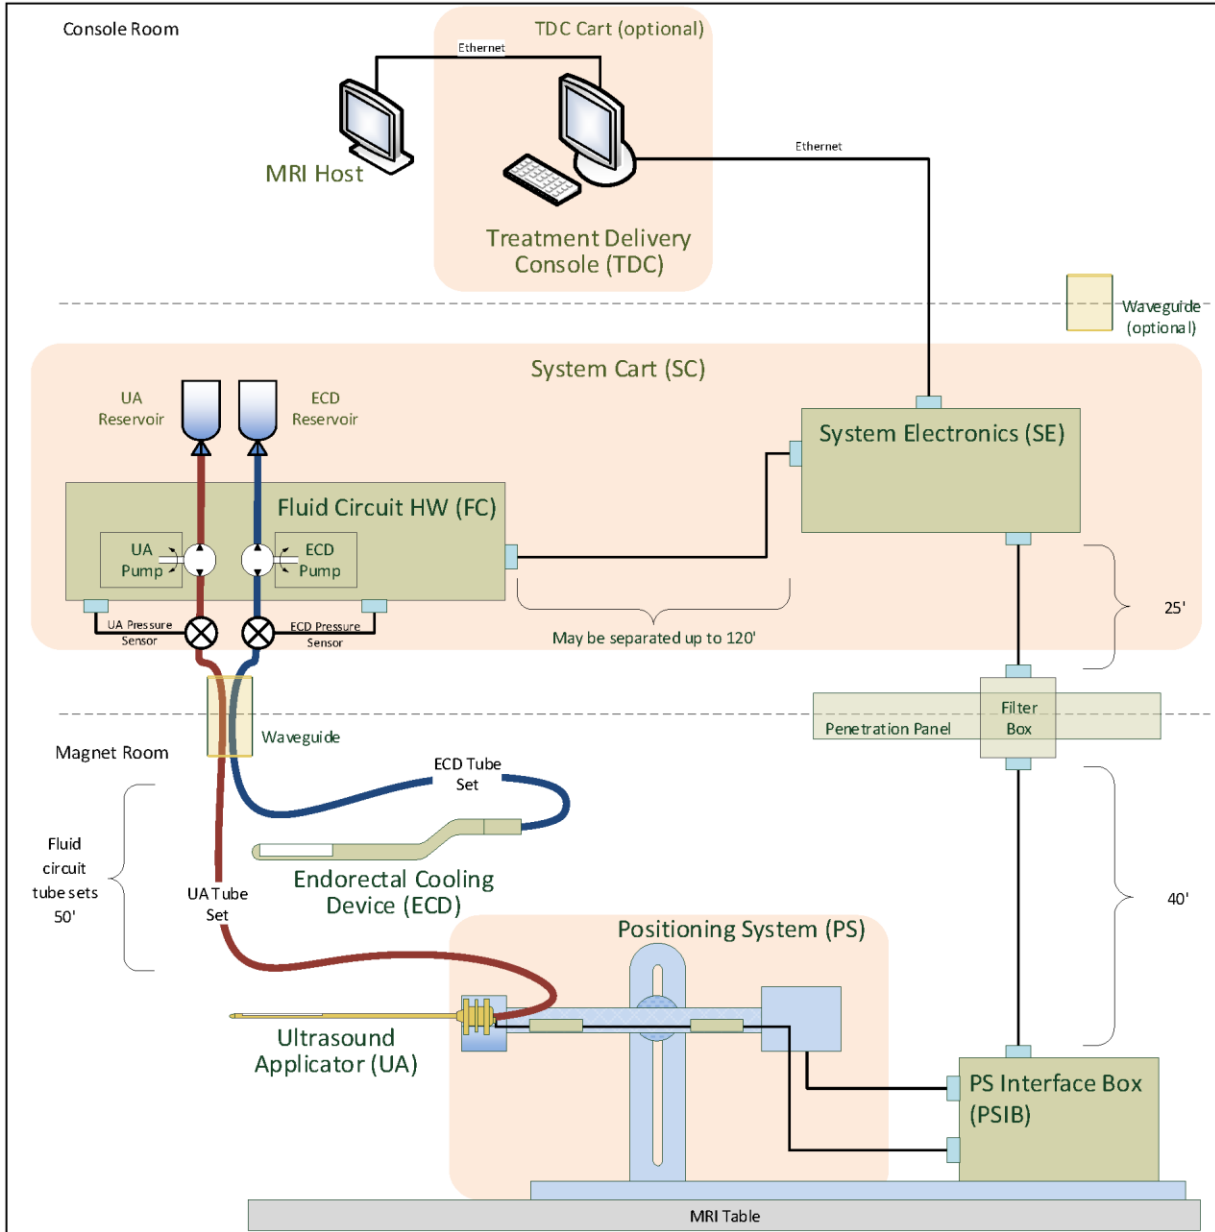
Figure 1 shows a schematic of the TULSA-PRO® equipment setup.

Figure 1: Schematic of TULSA-PRO® equipment setup

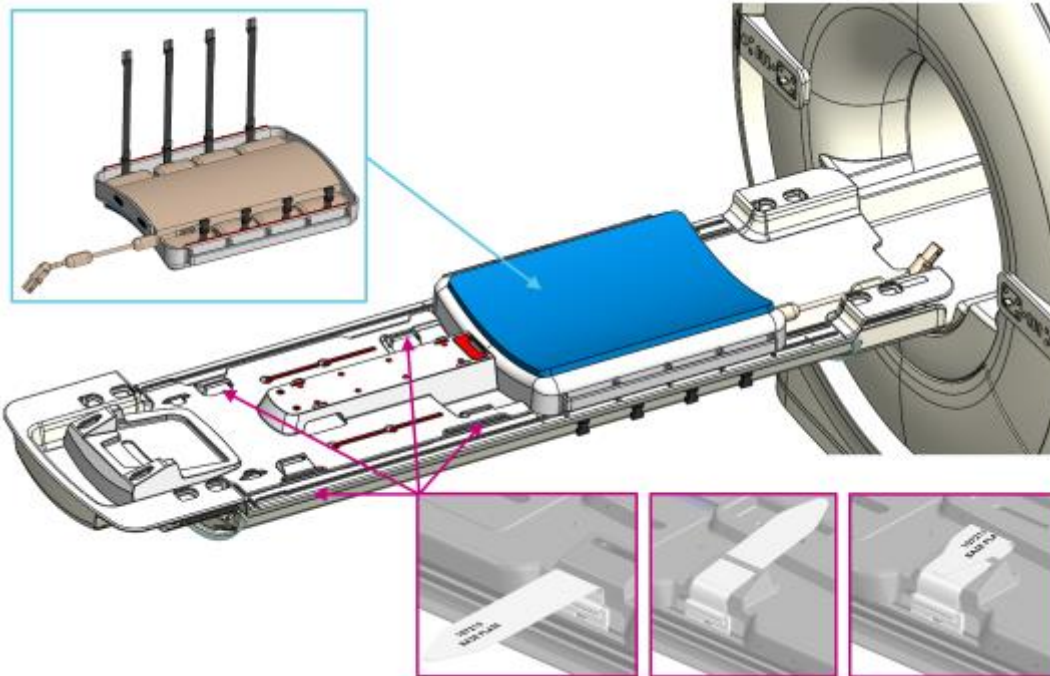
1. MRI Technologist: Attach the base plate onto the foot end of the MRI table and secure using the four base plate straps (5, your configuration might not match exactly as shown). The feet of the base plate should fit in the rails of the MRI table and not move around when in position.

Figure 2: Base plate, coil holder, and patient pad

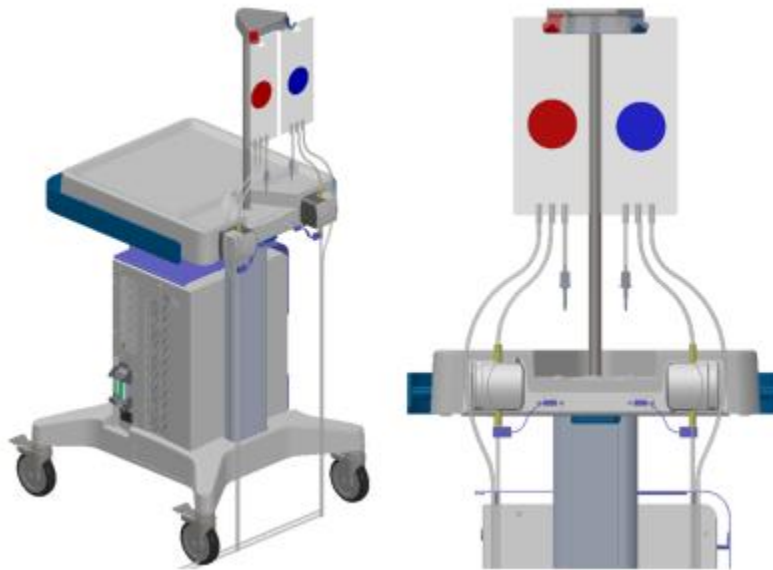
- c. Connect the ECD pressure sensor to the corresponding connection on the System Cart.
- d. Insert the spike from the empty bag into the treated ECD IV bag and then open the line clamp by the spike port to allow the contents of the ECD IV bag to be transferred to the ECD tube set.
- e. When all the contents from the ECD IV bag have been transferred to ECD reservoir bag, close the line clamp in between.
- f. Hang the ECD reservoir bag on the blue weight sensor hook on the System Cart (*Figure 4*).

Figure 4: Preparing the system cart and fluid tube sets

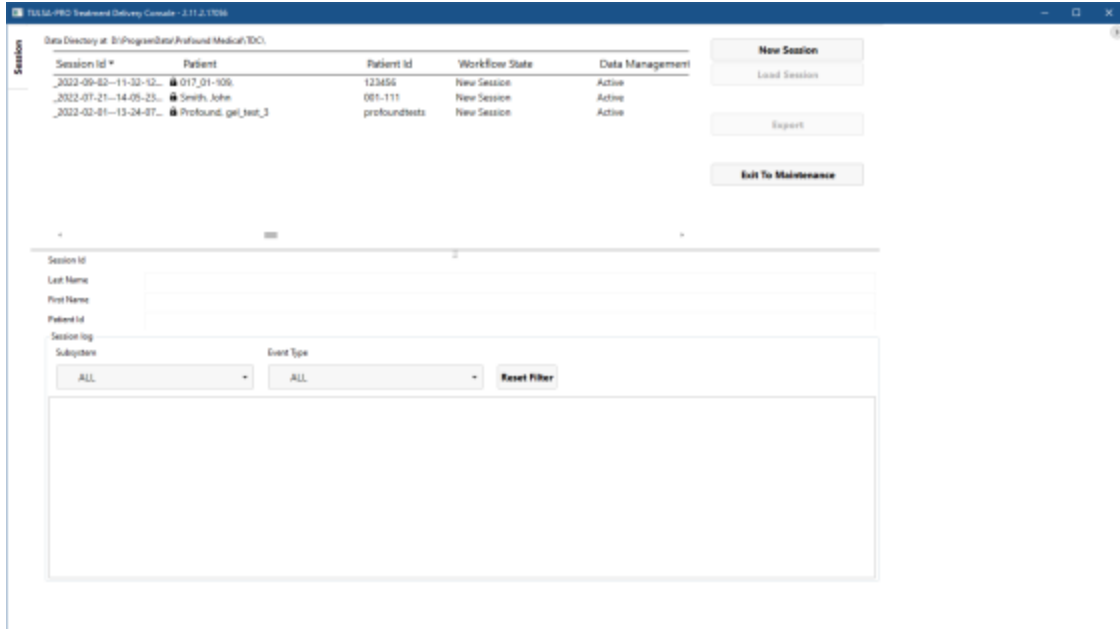
1. Launch the TDC software from the desktop. The *Session Data Management* workspace will appear. Click **New Session** (*Figure 5*).

Figure 5: Session Data Management workspace of the TDC Main Menu

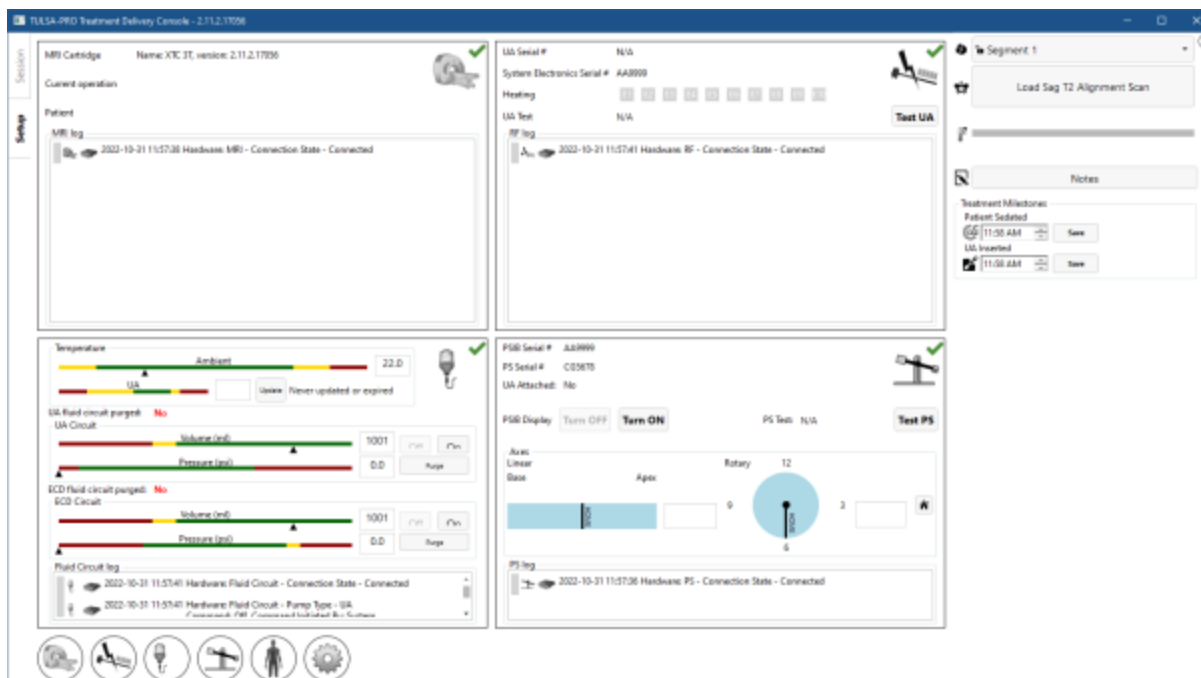
2. After selecting **New Session**, you will enter the **Setup** Workspace (*Figure 6*) where you can ensure all equipment is functioning properly before proceeding. A green checkmark will appear in the MRI quadrant of the Setup Workspace if the TDC computer and MRI host can communicate with each other, and a patient is currently open with the TULSA-PRO® MRI sequence protocol on the MRI console.

Figure 6: Setup workspace of the TDC software

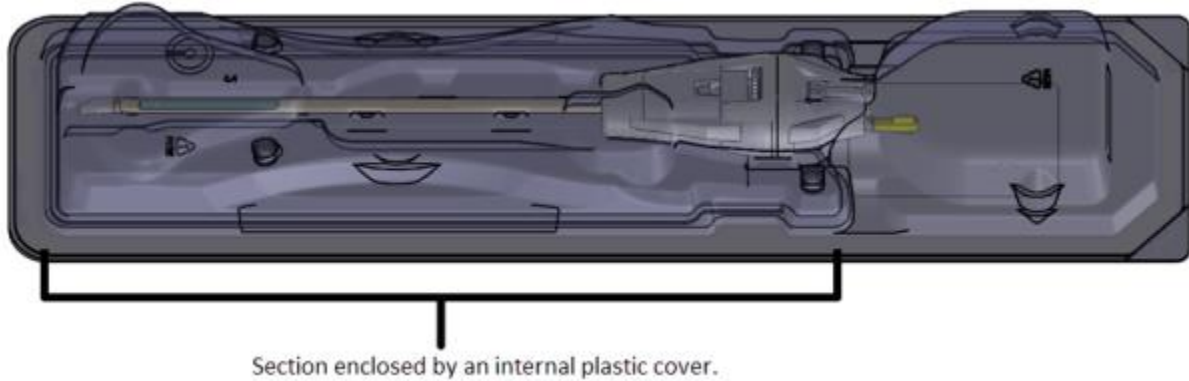
NOTE: MRI Technologist: The ECD is *not* sterile and can be handled accordingly. The UA and contents inside the UA packaging **are** sterile. *Figure 7* shows the UA inside its sealed and sterile package. There is another plastic cover that encloses the UA from its tip to the top of the handle that exposes the UA cable and guidewire inputs and fluid tubes. When you connect the fluid tubes and UA cable, the UA's sterile barrier will have to be broken. Keep the internal plastic cover over the UA during preparation to limit contamination to only the top of the UA handle.

Figure 7: UA sealed inside a sterile package

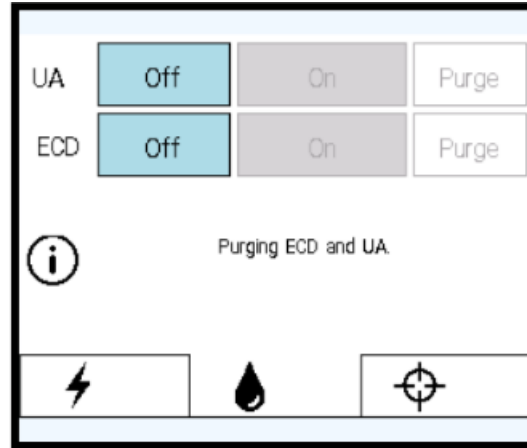
5. On the PSIB display, choose the **Fluid Circuit** tab (*Figure 8*) and **Purge** the UA and ECD fluid circuits. You can also do this from the TDC by pressing **PURGE** beside the fluid circuit (FC) quadrant (*Figure 9*).

Figure 8: PSIB Display - Fluid Circuit tab

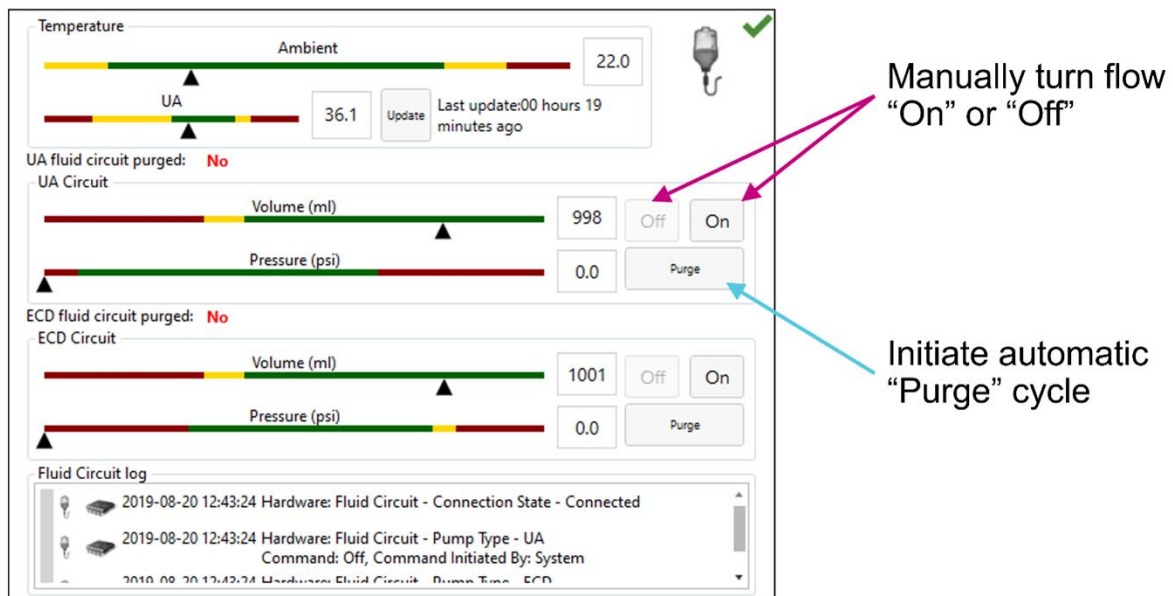
Figure 9: Fluid Circuit information box in TDC Setup workspace

7. Purge the UA of all air bubbles.
 - a. If the purging cycle ends before completing the steps in this process, return to the PSIB display (or TDC window) and manually turn the flow on by clicking **On**. The fluid pumps will remain on until you click **Off** (Figure 9).
 - b. While the purging operation is on, hold the UA in its package—be careful not to touch the UA handle to keep the UA sterile. Tip the package upwards in the 0° position, then tilt to approximately 45°, then 90°, and 135°. At each angle, slowly rotate the package approximately 360° (Figure 10).

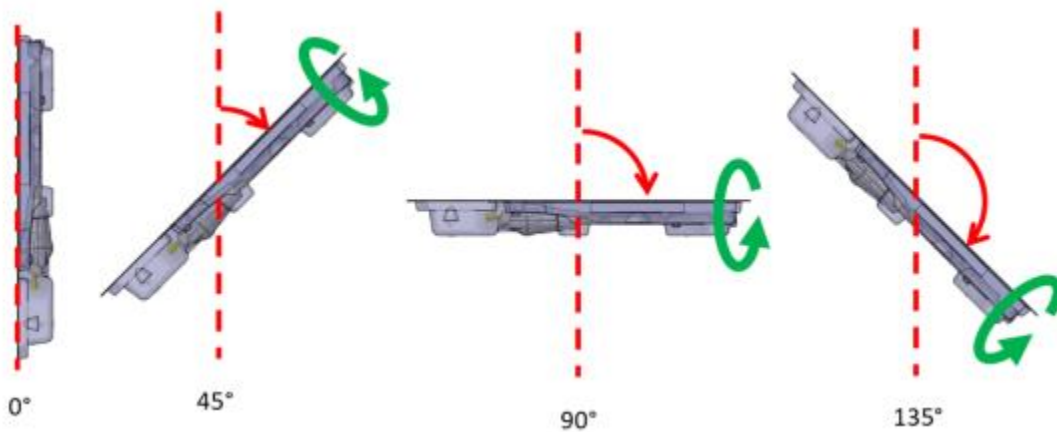
Figure 10: Recommended procedure for purging air from ultrasound applicator

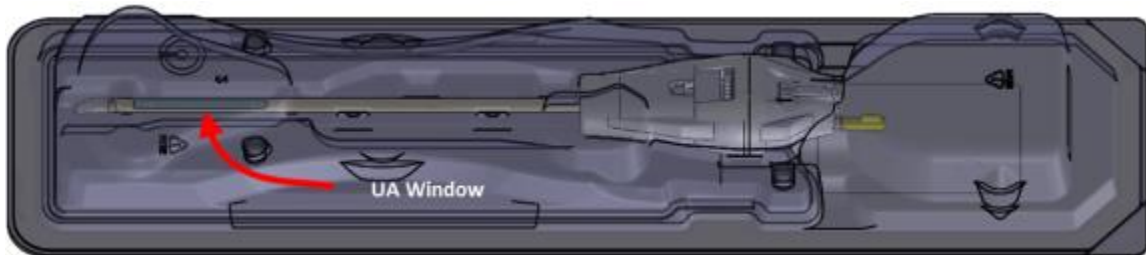
- c. Rotate the UA package so that the flat side is facing down. Inspect the UA closely through the plastic package and ensure there are no signs of water in the package, which would indicate a leak. If you see any signs of water, the UA is defective and should not be used. Use a new UA package and repeat the UA preparation procedure.
 - d. Look through the package and carefully inspect the UA window for bubbles (Figure 11). There should be **no** bubbles of **any** size. If you see bubbles, gently tap the package-end close to the UA window against the work surface to dislodge them. If you still see bubbles, repeat the procedure, starting from [step “a”](#).

Figure 11: Examine the UA window for air bubbles

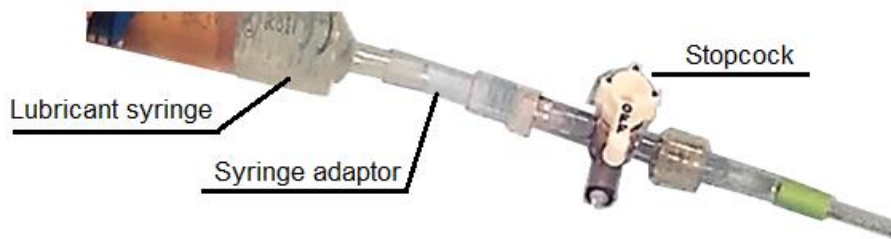
- a. Connect the provided three-way stopcock and the syringe adapter to both the green and black-labeled channels (*Figure 12*).
- b. Connect the provided low-viscosity lubricant syringes to the syringe adapters by pressing the taper on the syringe into the syringe adapter tubing (*Figure 12*).

Figure 12: Lubricant syringe with adaptor and stopcock

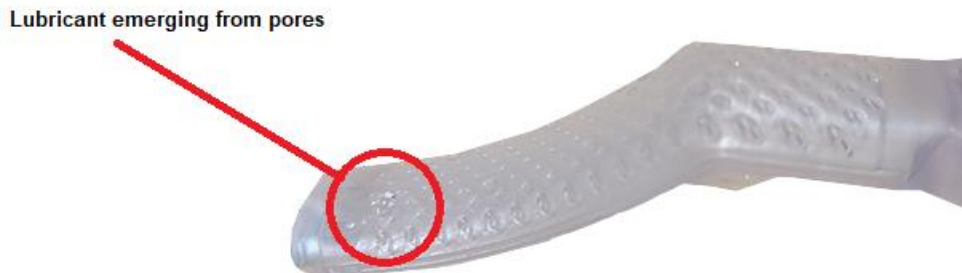
- ii. Slowly inject approximately 8-10 ml of low-viscosity lubricant into the black channel, which will add lubricant to the ECD surface. Gently press on the pores closest to the handle to allow lubricant to fill the large pores at the tip of the ECD. Ensure that some lubricant emerges from all the large pores from the handle to the tip of the ECD (*Figure 13*).

Figure 13: Lubricant emerging from ECD pores

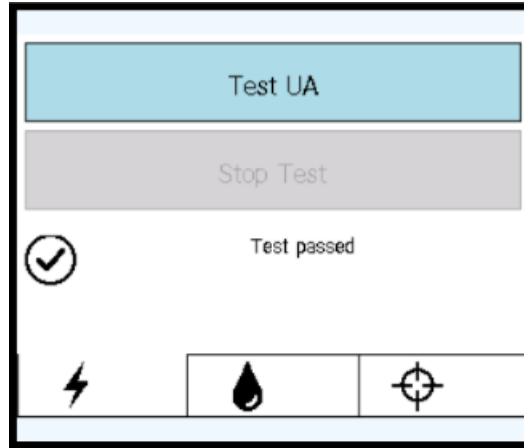
When the RF connectivity test is complete, the PSIB will display a short message (*Figure 14*). You can see detailed RF connectivity test results in the RF information box of the TDC software (*Figure 15*).

Figure 14: RF tab on PSIB display after successful RF connectivity test

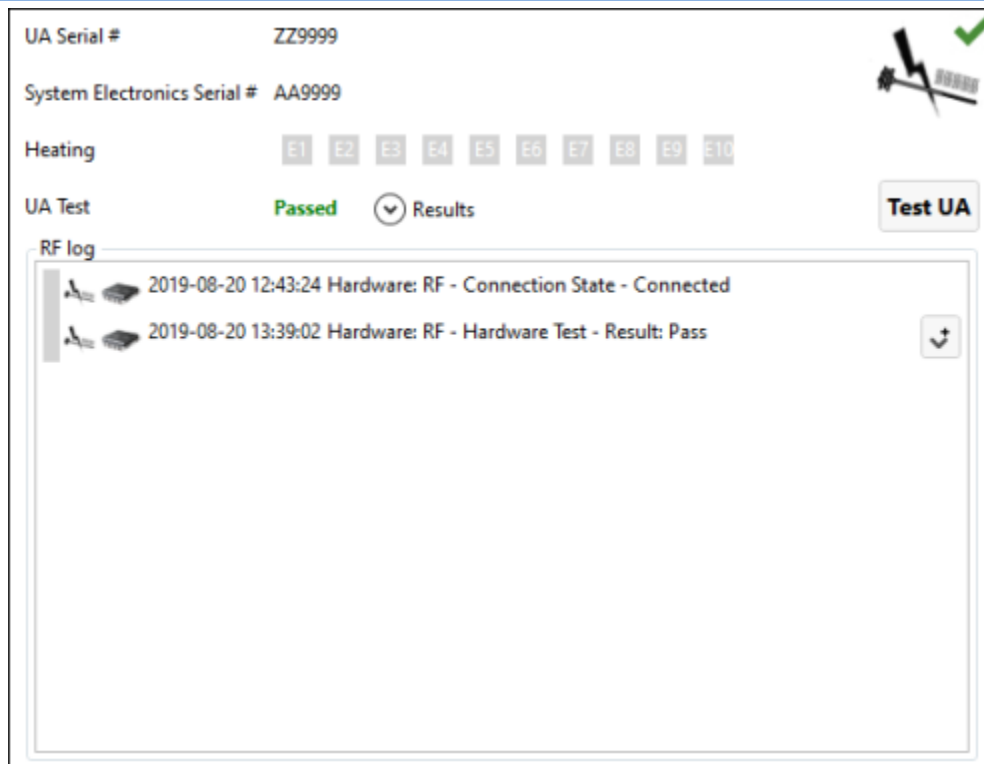
Figure 15: RF information box in Setup workspace after successful RF connectivity test

- a. Ensure the UA is connected to the UA tube set and purged of air (see *Purge the UA of all air bubbles.*).
- b. Without removing the UA from its package, ensure the UA cable is connected from the PSIB to the back of the UA. Care should be taken to avoid contaminating the UA handle.
- c. In the **RF** tab of the PSIB display (*Figure 14*), click **Test UA**.
The system will send a short burst of power to each of the ten UA elements to ensure continuity and functionality of all ten channels. This can also be done from the TDC Setup workspace from the RF information box in the top-right quadrant (*Figure 15*).

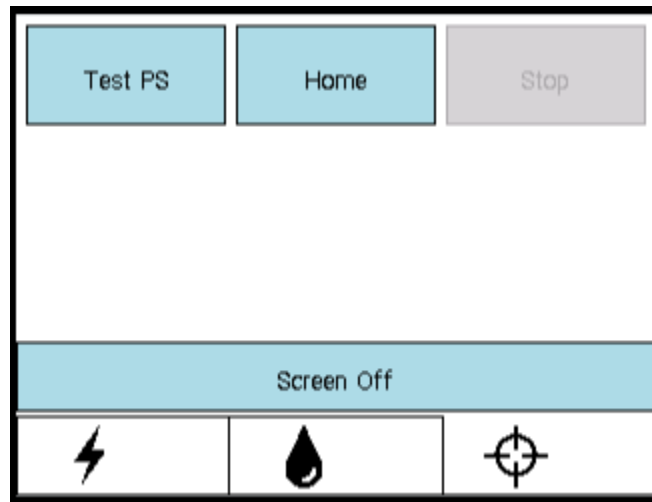
- b. On the PSIB display, select the PS tab and click **Test PS** (*Figure 16*). The system will translate the PS forward and backward to test the continuity and functionality of the translation axis as well as home the PS in the translation axis. The system will also rotate the rotational axis clockwise and counter-clockwise to test the continuity and functionality of the rotational axis. (This can also be done from the TDC *Setup* workspace in the PS information box in the bottom-right quadrant *Figure 17*.)

Figure 16: PSIB display - PS tab

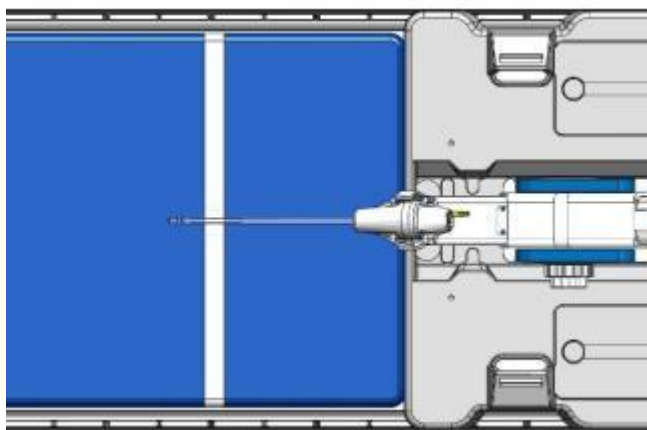
2. Position the patient on the MRI bed in a head-first supine position so that their sagittal midline is centered from left to right on the MRI table, and their prostate is centered within the treatable area (*Figure 18 [Your configuration might not match exactly as shown]*).

Figure 18: Centering and aligning the coils with the prostate

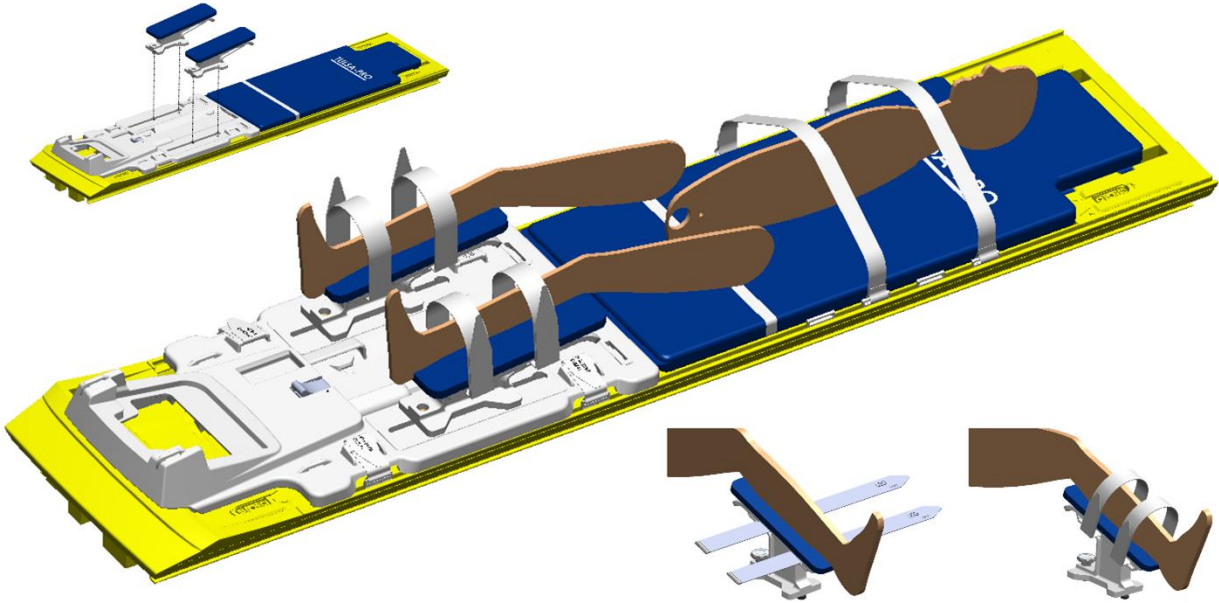
4. Have an assistant lift the patient's legs one at a time while you set up the leg supports (*Figure 19*):
 - a. Place the leg supports into the designated slots of the base plate.
 - a. Support the patient's legs and adjust the positions of the leg supports along the slots in the base plate. Insert two leg straps for each leg support by looping the straps through the leg support slots, with the label side up.
 - b. Wrap each leg support strap around the patient's leg, through the plastic ring at the end of the strap and then fasten back on itself.
5. Provide the patient with ear protection to protect against MRI-related hearing injury, even though the patient might be under general anesthetic.

Figure 19: Initial patient positioning and attachment of leg supports

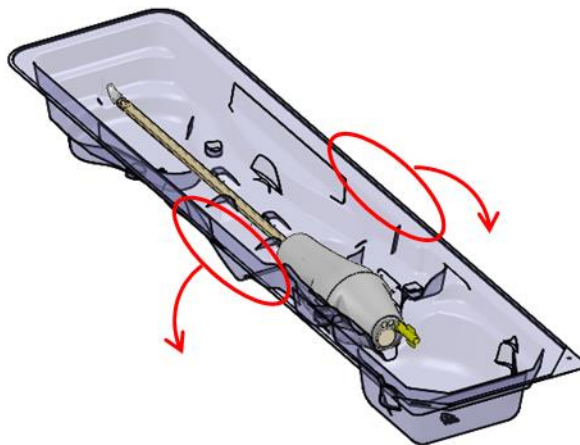
1. **MRI Technologist:** Using the fluid circuit (**FC**) tab of the PSIB display (or the FC information box of the Setup workspace in TDC), flow water into the UA by clicking **ON**.
2. **MRI Technologist:** Ensure the UA cable is connected to the UA and disconnected from the PSIB.
3. **MRI Technologist:** Without touching the UA to maintain sterility, remove the plastic cover enclosing the UA in the package.
4. **MRI Technologist:** While holding the UA packaging tray by the long edges of its perimeter, flex the tray to release the UA from its snap features (*Figure 20*).
5. **Urologist:** Using one sterile, gloved hand, remove the UA from the package by gripping the end with the white plastic handle.

Figure 20: Releasing the UA from the packaging tray

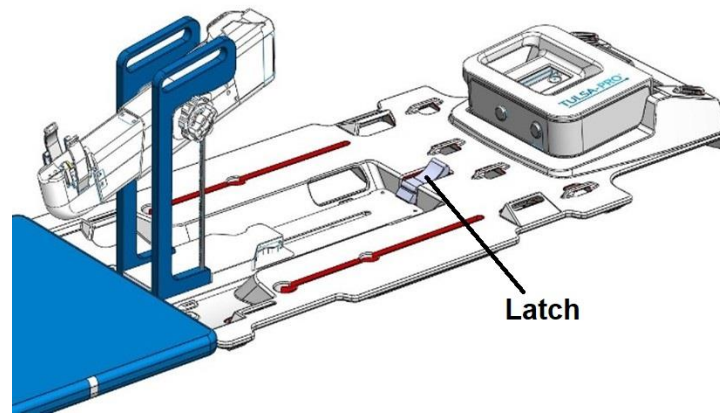
1. **Urologist:** Hold the UA handle with the UA positioned at a natural angle in the patient, while the **MRI Technologist** installs and adjusts the PS to capture the UA in the PS gripper.
2. **MRI Technologist:** Ensure that the slot for the PSIB is clear. Place the PS and PSIB in their respective slots on the base plate. Secure the Positioning System (PS) to its slot on the base plate between the patient's legs by closing the latch (*Figure 22*).

Figure 22: Secure the Positioning System using the latch on the base plate

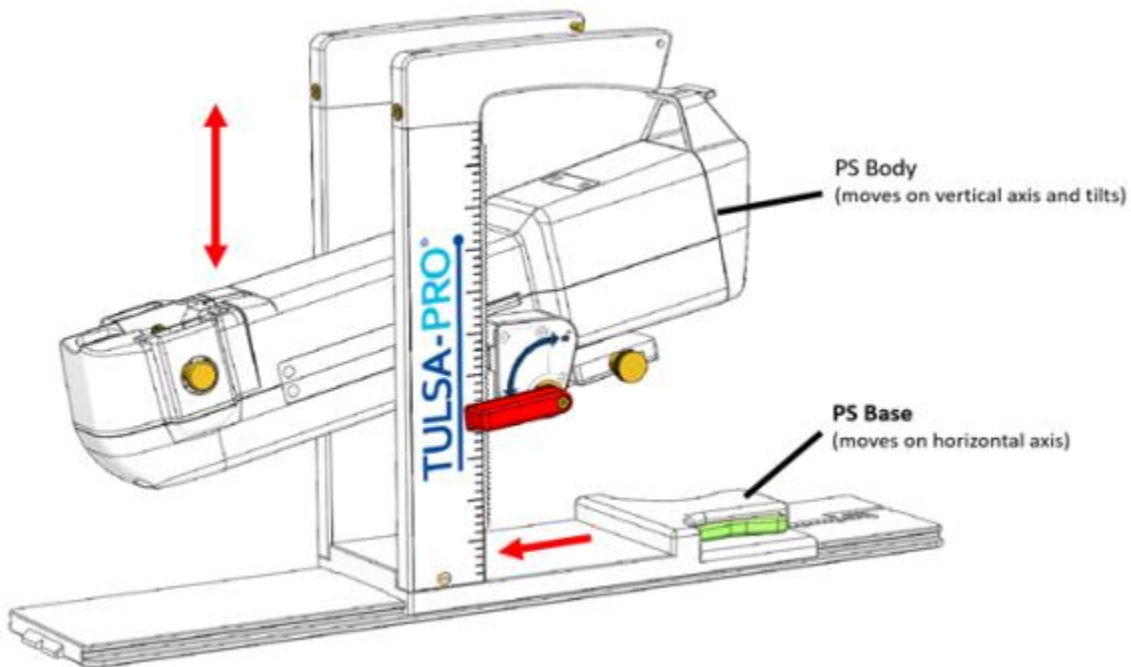
3. **MRI Technologist:** Manually move the PS into position so that the UA gripper aligns with the natural angle of the UA in the patient. Manually adjust the base of the PS forward and backward and up and down, and tilt the linear axis of the PS up and down (*Figure 23*).

Figure 23: Adjusting the Positioning System

NOTE: The PS adjustment knobs and levers are not colored as in *Figure 23*, but are colored here to help with these instructions.

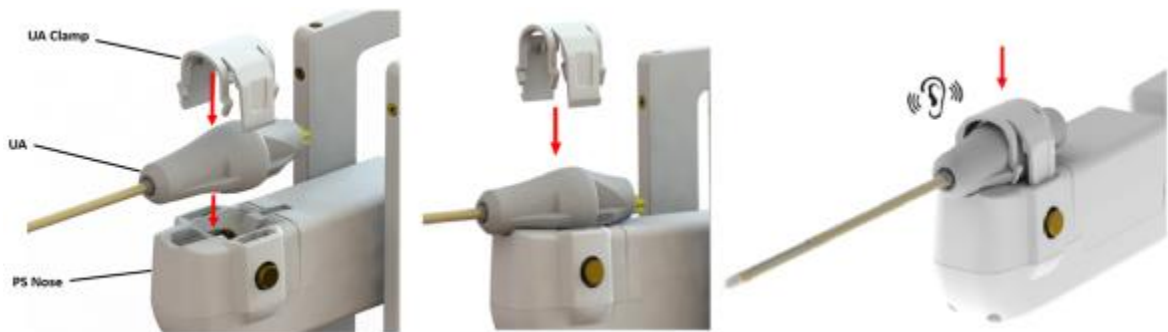
4. **MRI Technologist:** After locking the PS tilt and height, seat the UA in the PS nose and then secure it by pressing the UA clamp down over top of the UA until it is fully engaged with the PS nose. (*Figure 24*).

NOTE: You will hear an audible click when the clamp is fully inserted into the PS nose.

Figure 24: UA attachment to Positioning System

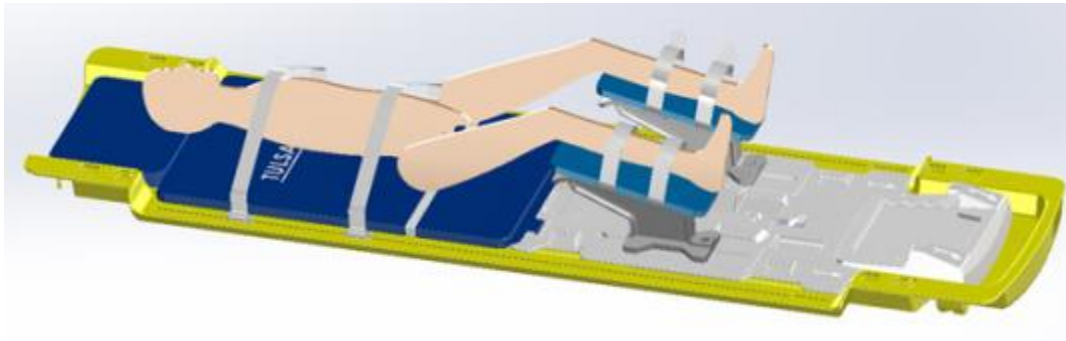
1. **MRI Technologist:** Place restraint straps around the patient to prevent motion of the pelvis during MR imaging and position the anterior coil.
2. **MRI Technologist:** Fasten one abdomen-arm strap tightly over the lower abdomen to minimize anterior-posterior breathing motion. Wrap the sheet over the abdomen and place the patient's hands on top. Fasten a second abdomen-arm strap over the arms to help fit the patient into the MRI bore (*Figure 25*, your configuration might not match exactly as shown).

Figure 25: Securing the abdomen and arm straps

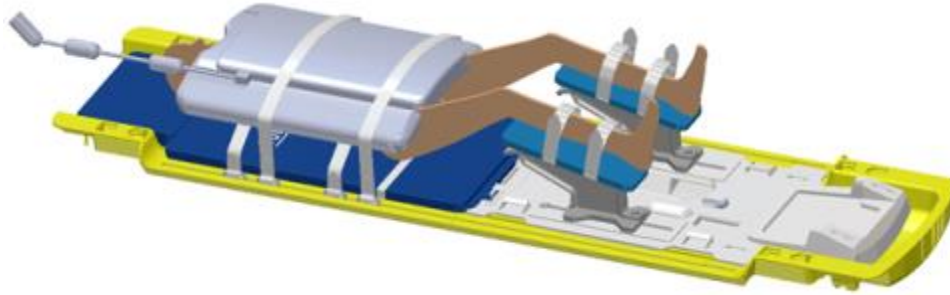
2. MRI Technologist: Strap the anterior imaging coil over the patient's pelvis and arms. The coil should cover the prostate, without interfering with the travel of the Positioning System (*Figure 26*).

Figure 26: Placement of the anterior imaging coil

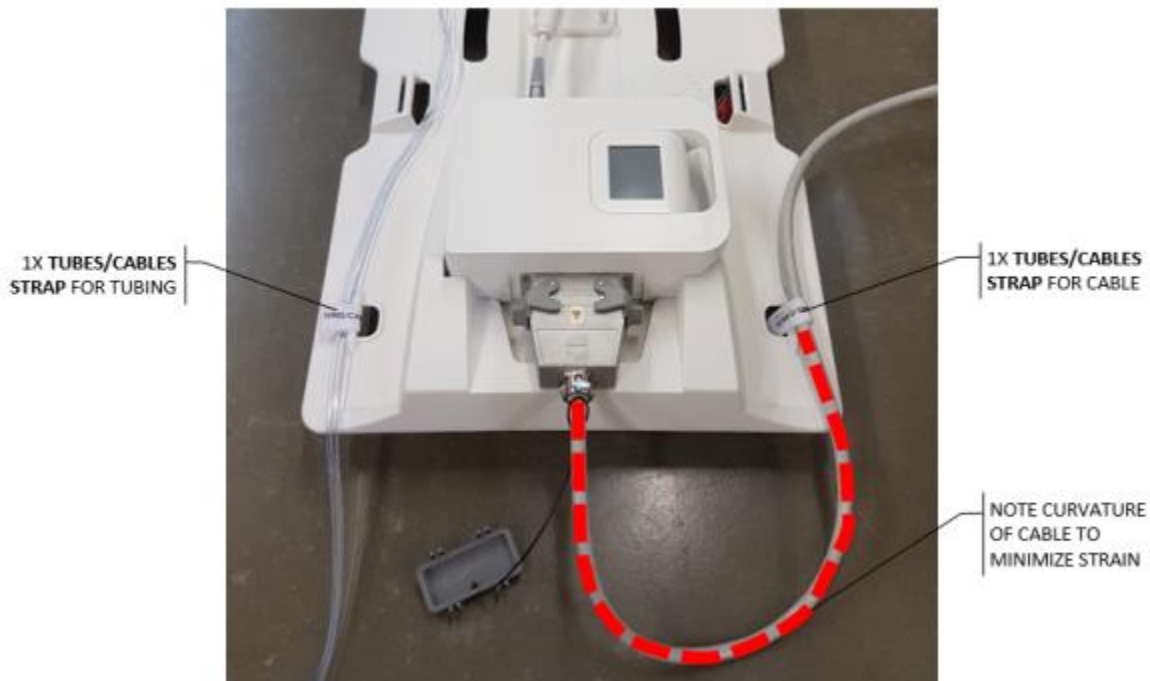
3. MRI Technologist: For the patient's comfort, use sheets to keep him warm and pads to avoid pressure points. Also, to avoid electrical burns, ensure that the patient's skin is not directly touching the coils or MRI bore.
4. MRI Technologist: Use tube-and-cable straps to manage fluid tubes and the white RF cable as shown in *Figure 27*. Leave some slack to allow the cables to slide freely and to reduce tripping hazards. Ensure no cables, tubing, or other materials can be caught while the MRI table is moving.

Figure 27: Tube-and-cable straps of base plate: one for tube sets and one for RF cable

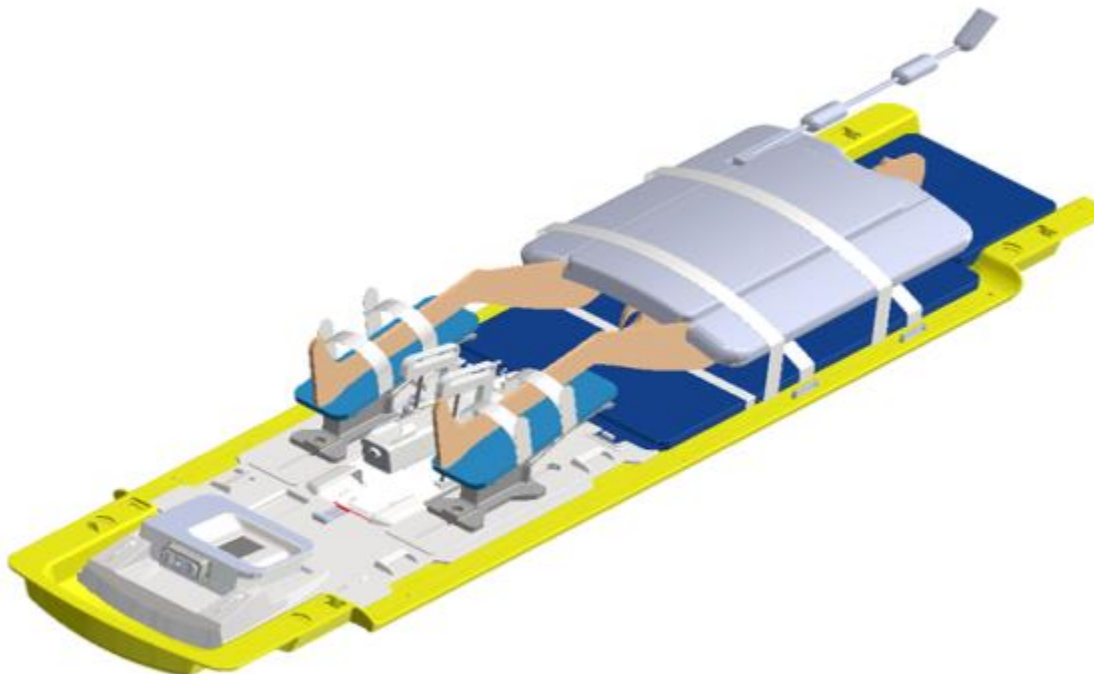
Figure 28: Patient positioning is complete

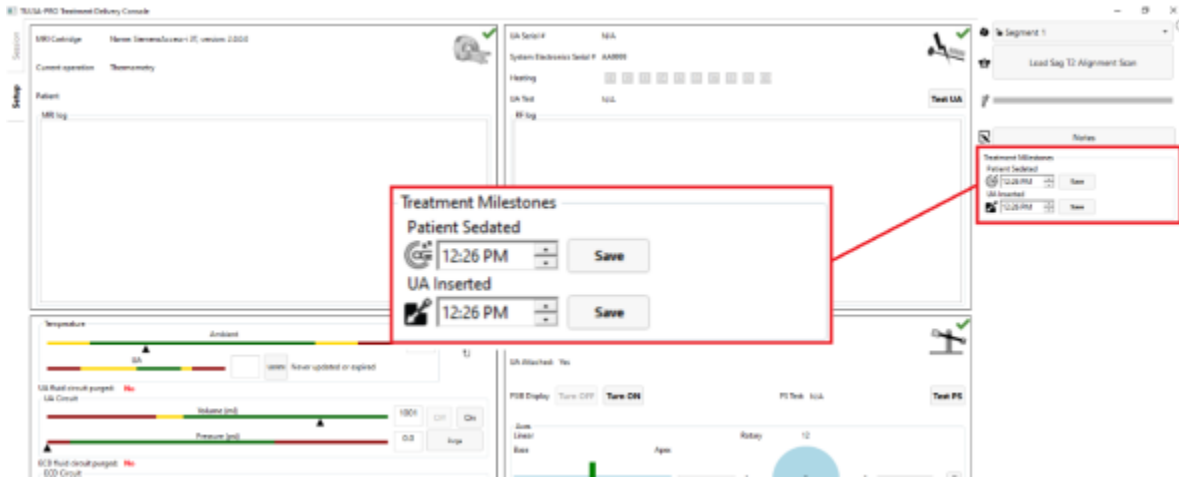
1. In the TDC *Setup* Workspace, enter the sedation and UA insertion times under **Treatment Milestones** (Figure 29).

Figure 29: Entering Treatment Milestones in the TDC Setup Workspace

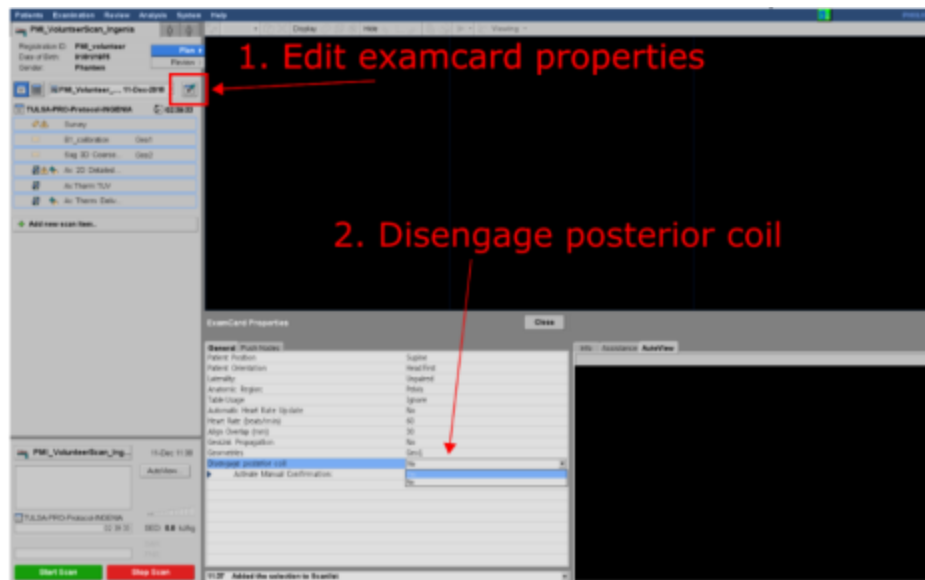
1. Align the laser scope with the prostate and anterior MR imaging coil. Set the landmark position on the MRI.
2. Slowly advance the MRI table for scanning, taking care to avoid pinching tubes and cables, pressure on the patient's skin, and direct contact of the patient's skin with the coils or MRI bore.
3. At the MRI console, check that the appropriate anterior and posterior coils are connected, and then run the **Localizer** scan.
4. Before inserting the patient into the bore, ensure the posterior coil is disengaged in the current ExamCard. It is crucial NOT to use the posterior coil. To disengage the posterior coil, edit the ExamCard properties, and change the "Disengage posterior coil" from No to Yes (9).

Figure 30: Setting 'Disengage posterior coil' to 'Yes'

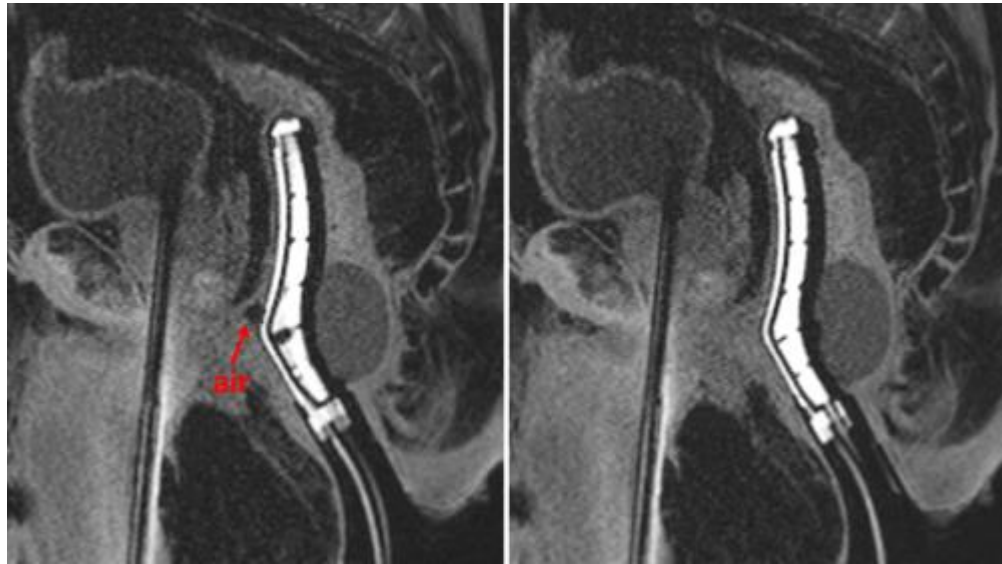
Figure 31: Sagittal images of ECD facing anteriorly towards the prostate, with air in the beam path (left) and correctly adjusted to eliminate air from the beam path (right)

- a. The cooling window should cover the prostate and expected range of ultrasound energy from the UA, as confirmed on the sagittal MRI (*Figure 31*).

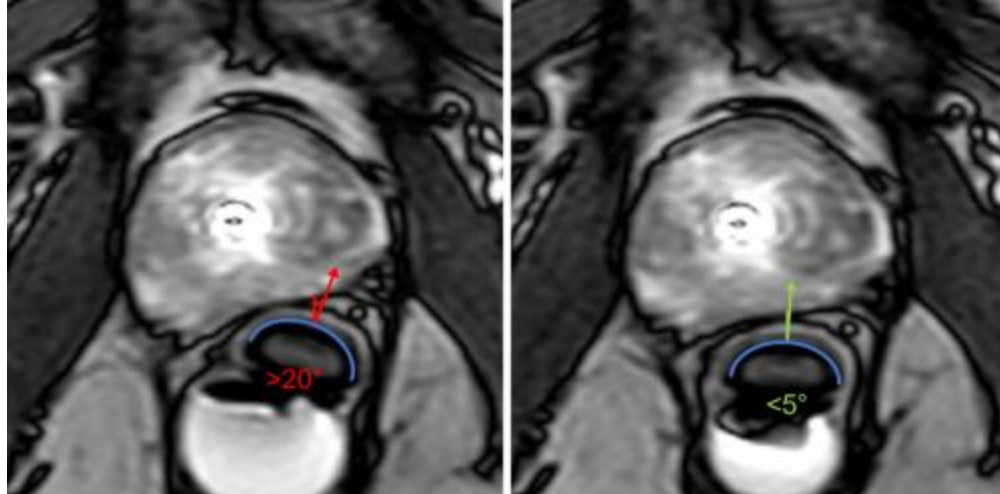
Figure 32: Axial images depicting ECD oriented incorrectly (left, rotated more than 20 degrees) and correctly (right, facing up towards the prostate)

- b. The orientation of the cooling window should face the prostate (anterior), as confirmed on the axial MRI (*Figure 32*).

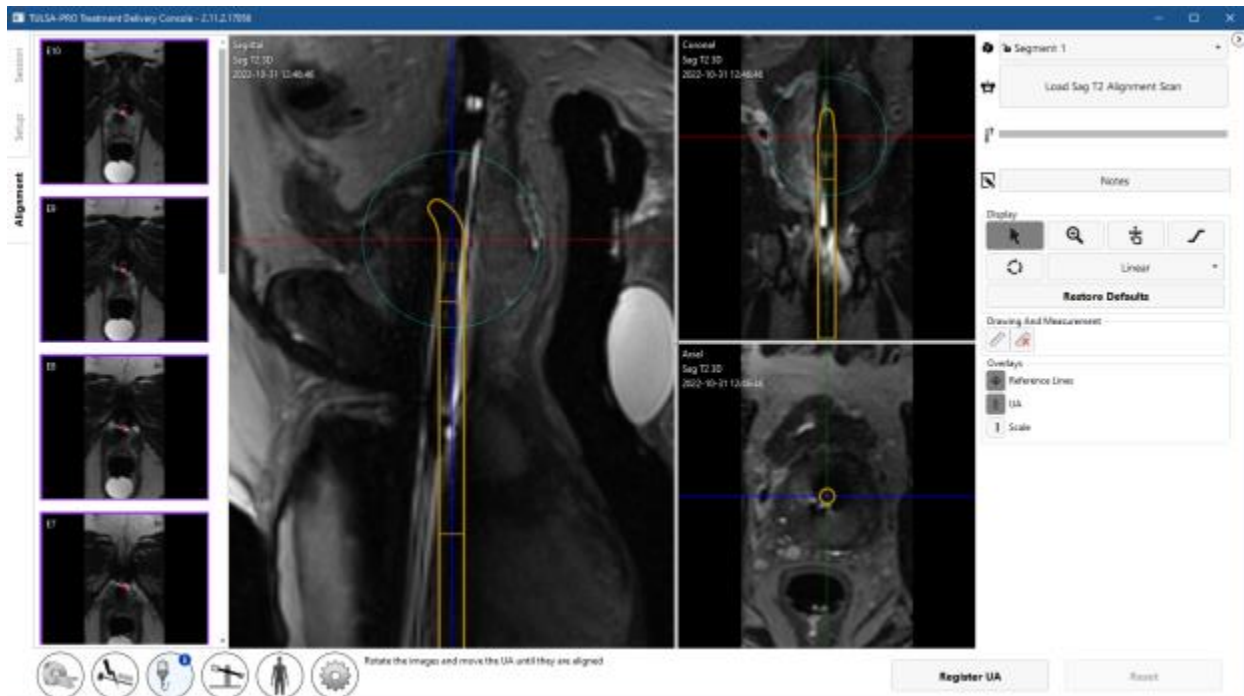
Figure 33: UA before alignment

Radiologist: Use the Alignment workspace to define the location and angulation of the UA in the TDC software by aligning a graphical representation of the UA with the actual UA on the MRI image in three dimensions. Accurate alignment will be critical to safe and effective heat delivery within the intended tissue volume. See example below of the UA in MR images before (*Figure 33*) and after (*Figure 34*) Alignment.

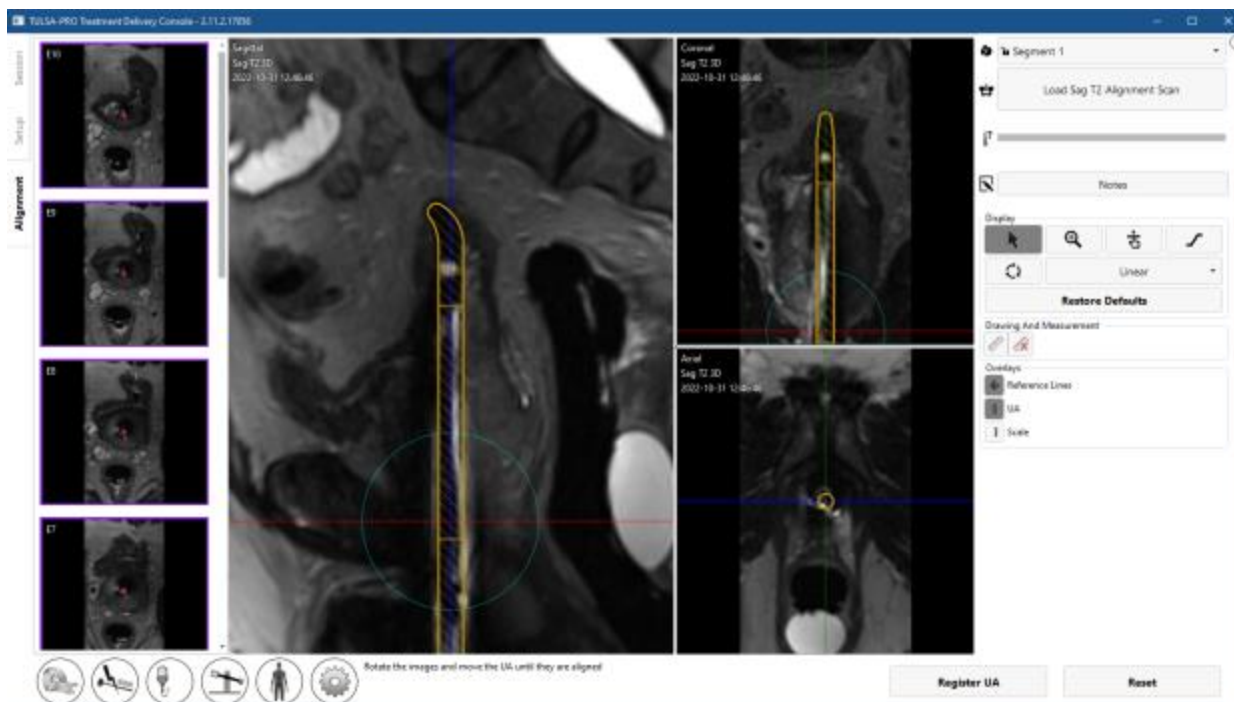
Figure 34: UA after alignment

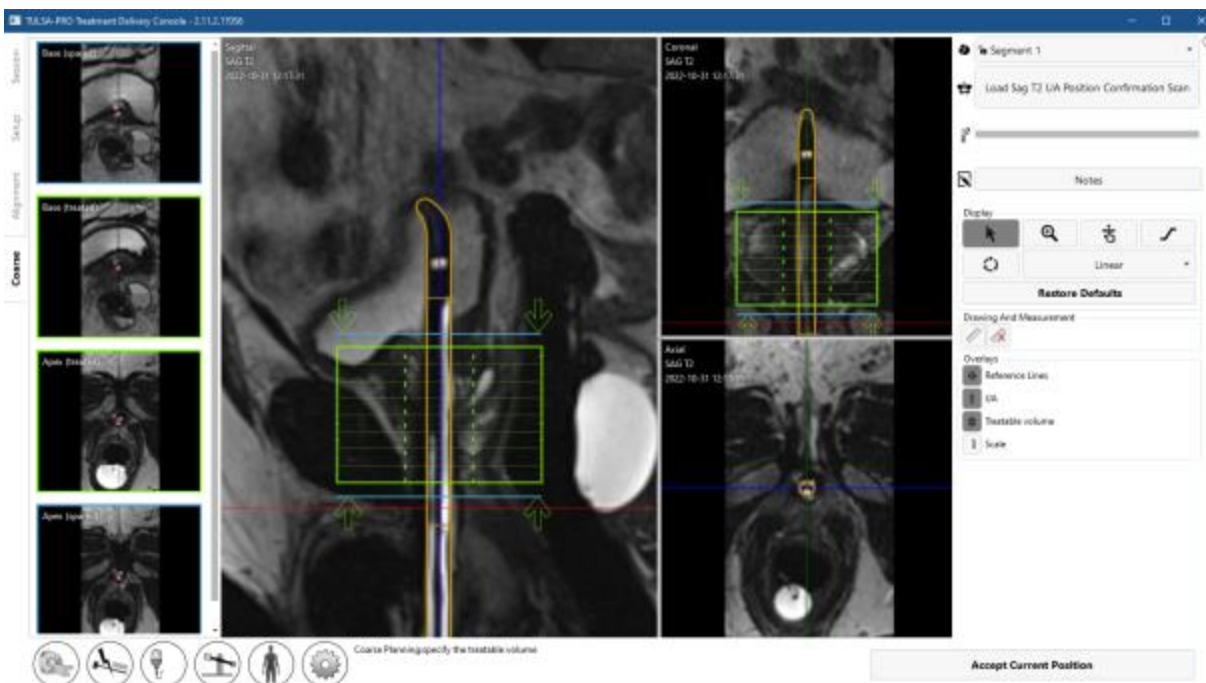
Figure 35: Coarse Planning workspace in TDC software

The treatment volume is displayed as a green rectangle on the sagittal and coronal views. Regions beyond a light blue line displayed 4 mm from the bottom and top edges of the green rectangle on the sagittal and coronal views are anatomical regions expected to be spared fully from thermal coagulation (*Figure 35*).

NOTE: When determining where to position the UA, identify the external urinary sphincter. If the external urinary sphincter cannot be identified, it should be considered immediately adjacent to the prostate apex. Place the light blue line below the first element on the external urinary sphincter (*Figure 35*).

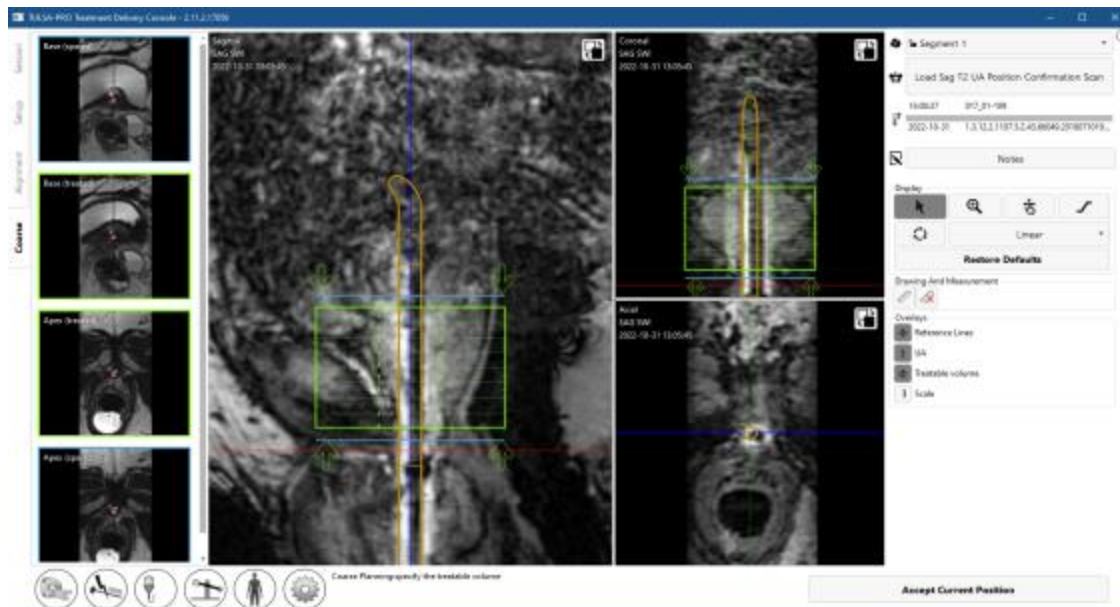
Figure 36: Using mpMRI Vision in Coarse Planning to visualize calcification on a SAG SWI scan and adjust the UA position to reduce the shadowing effect of the calcification on treatment

2. Radiologist: When adjusting the UA position, the presence of any small calcifications in the beam path should also be considered. Use the mpMRI Vision feature in Coarse Planning to load a set of sagittal susceptibility-weighted images (SWI), which highlight the magnetic field disturbances caused by intraprostatic calcifications. To reduce the shadowing effect of calcifications on ultrasound propagation and tissue heating, place the midline of the calcification between two adjacent ultrasound elements (instead of directly in front of an element) (Figure 36).
