TULSA-PRO[®] Transurethral
Ultrasound Ablation System

Operator's Manual

Philips Ingenua 3T and Ingenua Elition 3T

TULSA-PRO® SYSTEM Model Number: PAD-105

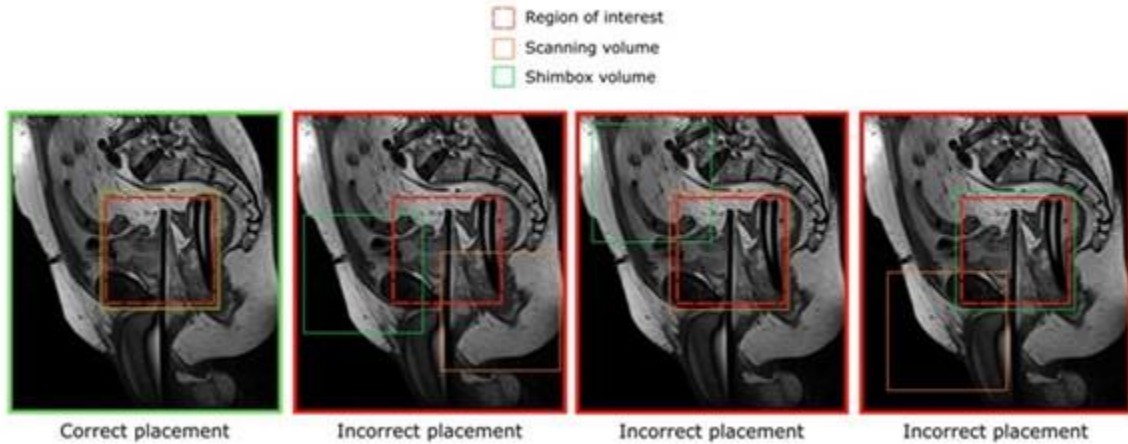
Figure 37: Examples of correct and incorrect placements of the shim box

1. MRI Technologist: Open AX THERM for editing in the Offc/Ang tab, change the AP, RL, and FH values for both Stack Offc. and Ang (*Figure 38*). to match those in TDC. Do the same for the shim volume. If the shim volume includes more than just the patient anatomy (e.g. air), reduce the size of the shim box (*Figure 37*).

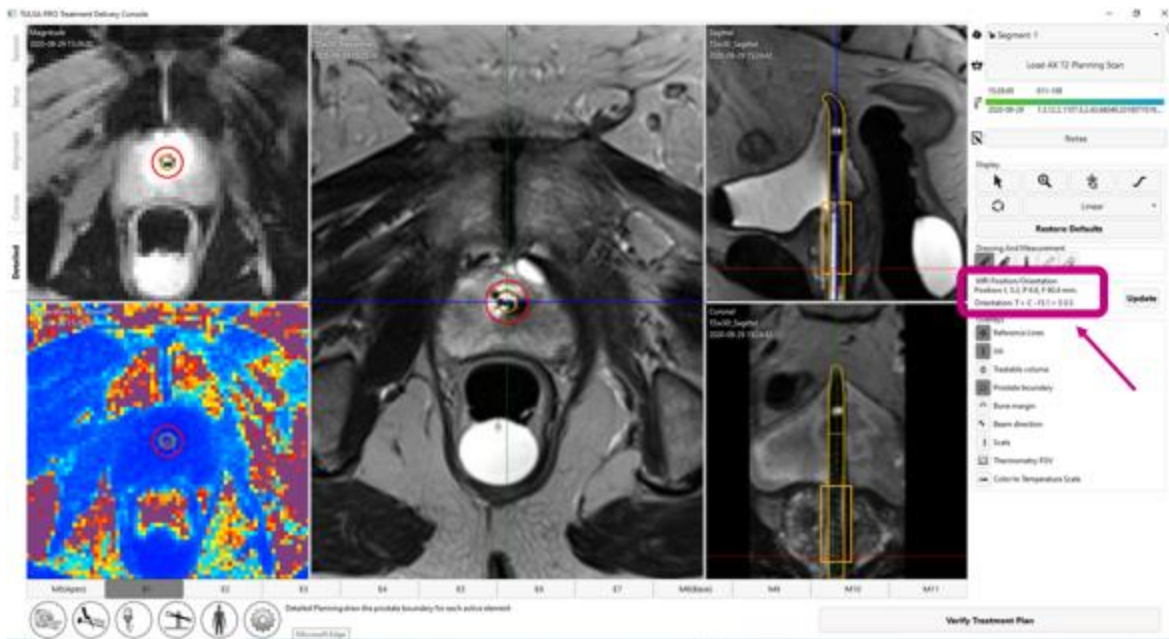
Figure 38: Detailed Planning workspace with Thermometry Magnitude and Temperature Uncertainty (MRI Position/Orientation coordinates used to prescribe treatment planning images are highlighted)

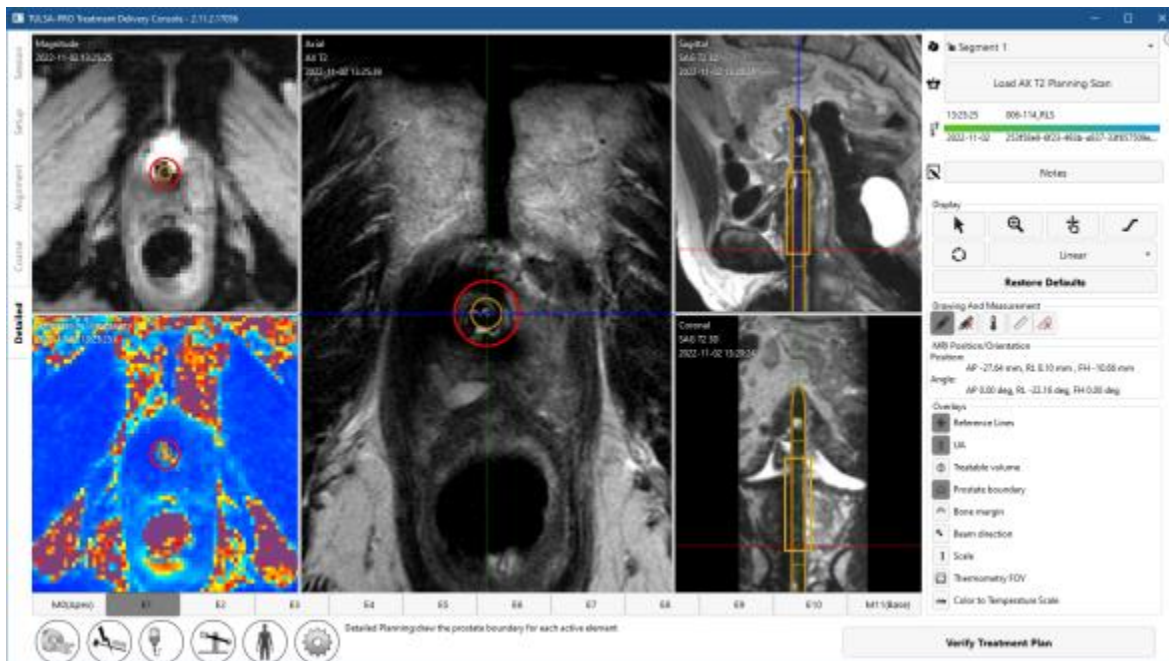
Figure 39: Detailed Planning workspace with Thermometry Magnitude and Temperature Uncertainty

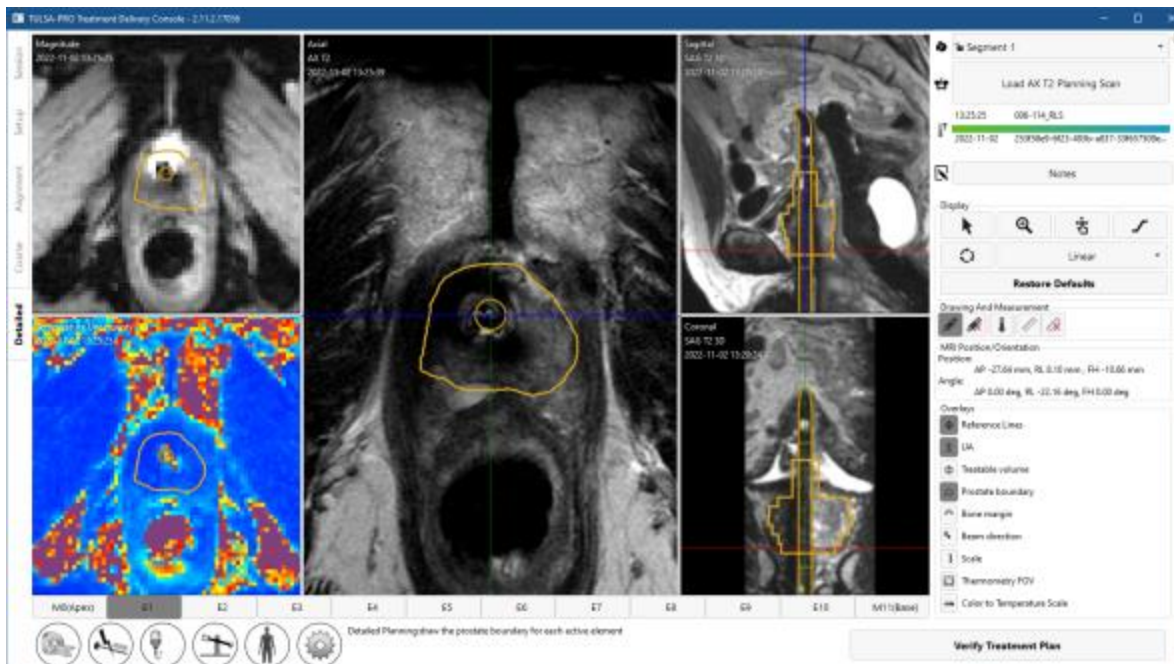
Figure 40: Detailed Planning after drawing boundaries

- To draw the prostate boundary, select the drawing tool and outline the tissue to be ablated on each slice based on the corresponding AX T2 and THERM magnitude images (Figure 40). You can select individual slices by clicking on the numbered tab at the bottom of the screen or by pressing the left and right arrow keys on the keyboard. Use the sagittal and coronal views of the SAG T2 images to verify the intended ablation zone in three dimensions.

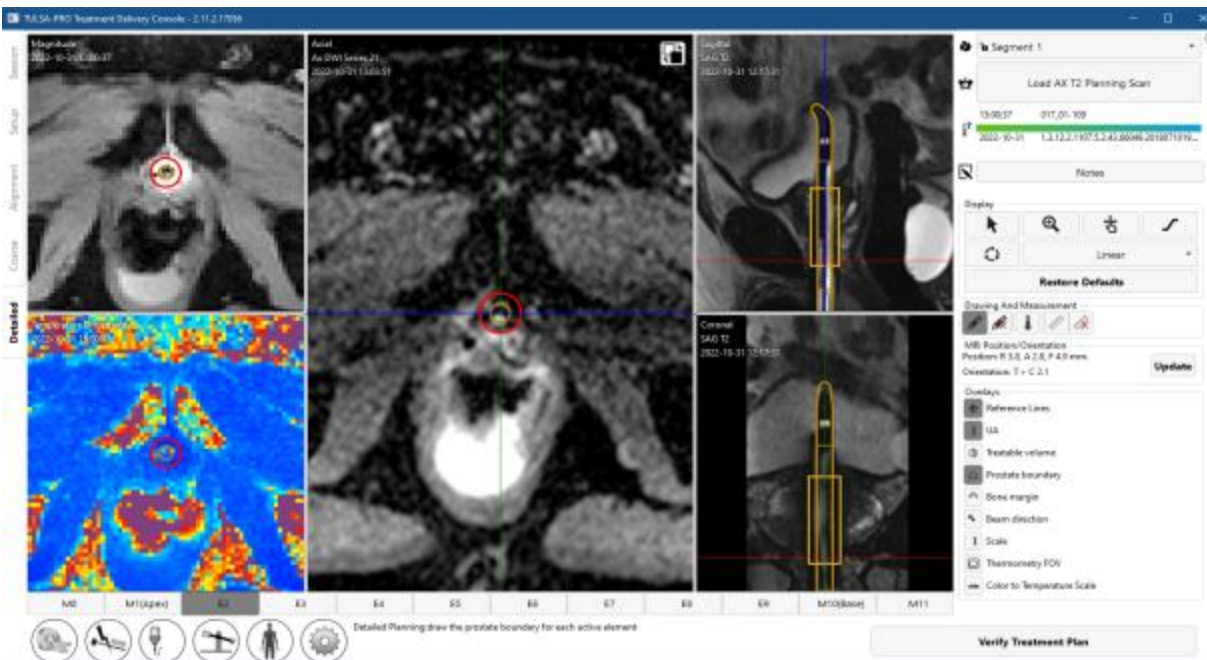
Figure 41: Using mpMRI vision in Detailed Planning to visualize intraprostatic differences in tissue properties on an AX DWI scan and select tissue intended for ablation

Radiologist: When prescribing the treatment volume, use the mpMRI Vision feature in *Detailed Planning* to load a set of axial diffusion weighted images (DWI), which can be used to visualize intraprostatic differences in prostate tissue to help select tissue intended for ablation (*Figure 41*).

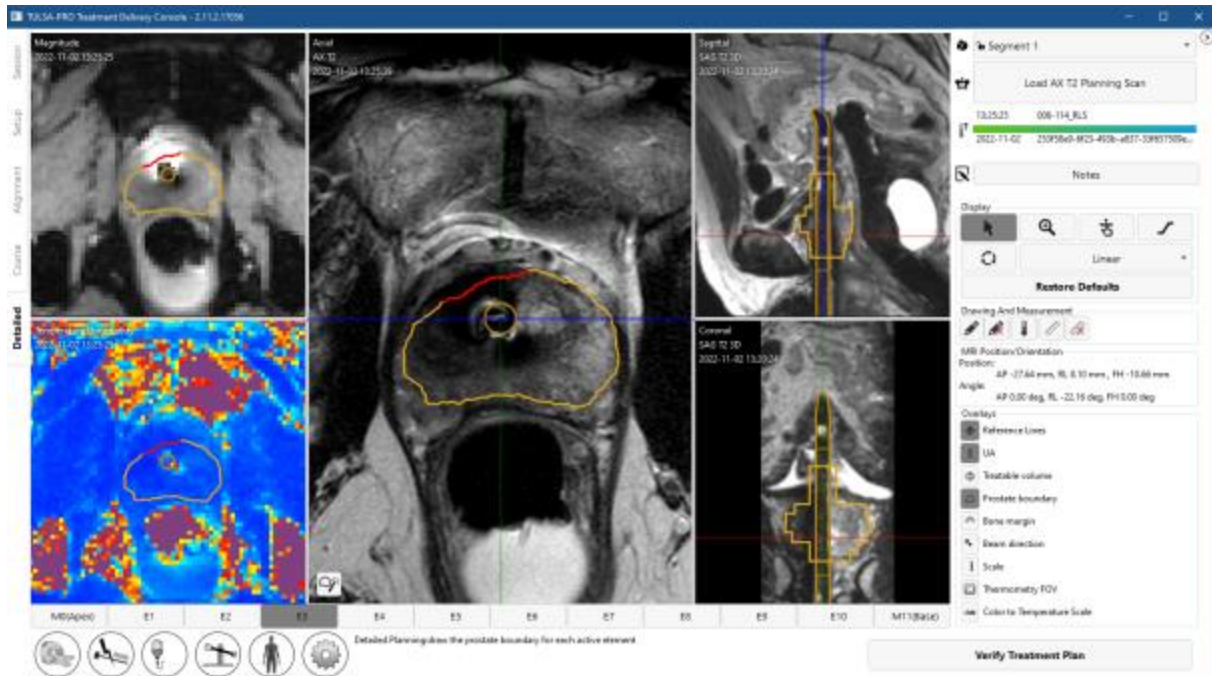
Figure 42: Using the Contouring Assistant feature in Detailed Planning to apply a software-assisted prostate boundary as a starting point for treatment planning on a selected slice

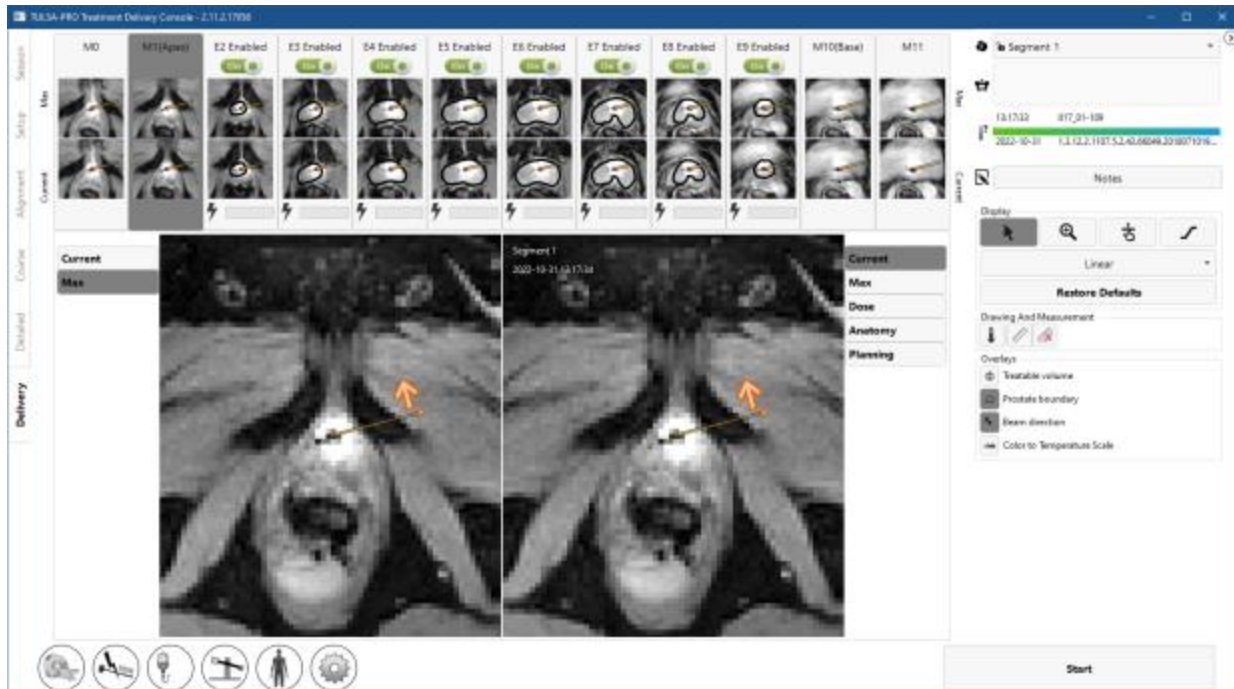
Figure 43: Delivery workspace of TDC software - Drag the orange dot to define the starting UA angle, and click the orange arrow to define the direction of rotation

The *Delivery* workspace displays information from 12 axial slices in real time: 10 slices corresponding to the elements (E1-E10) that can deliver heating, and two additional slices corresponding to the Monitoring Elements, M0 and M11 (*Figure 43*). Images are updated every 5 to 7 seconds during treatment as new images from the MR scanner are processed into temperature information.

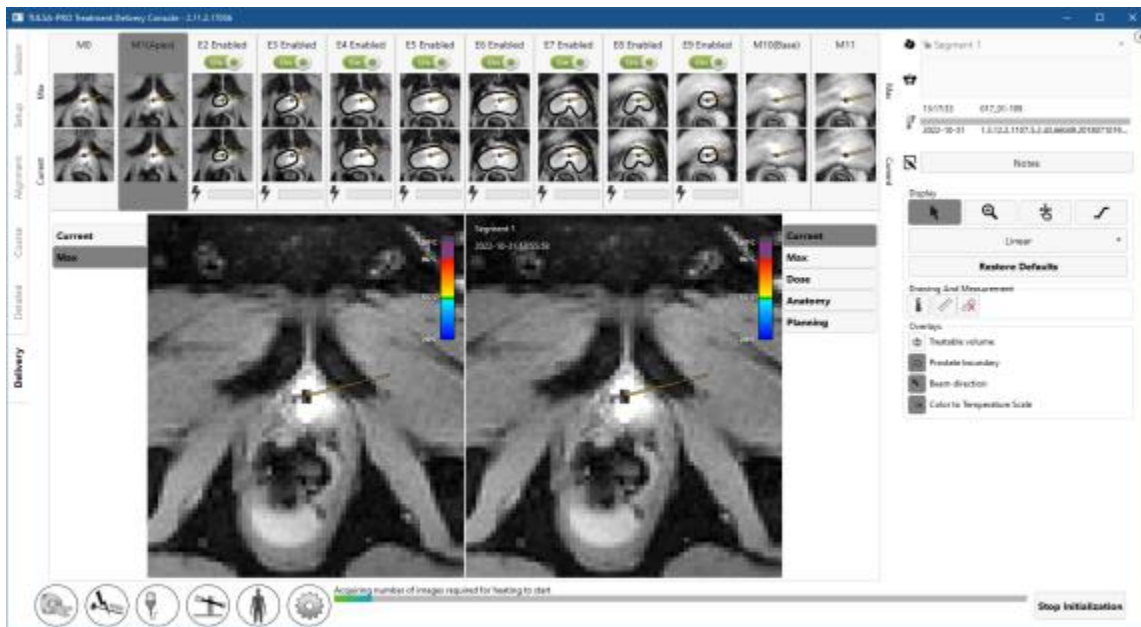
Figure 44: Treatment Initialization state

- c. In the top menu on the MRI console, select **Examinations > Repeat Prescans**.
 - d. **Do not run the scan until instructed by the physician.**
 2. Radiologist: Click **Start treatment** on TDC. It will prompt you to verify the core body temperature using an external temperature measurement device before proceeding (10). Enter the temperature in degrees Celsius and click **Confirm**. The TDC will go into **Treatment Initialization** state and is now ready to receive thermometry images (Figure 44).

The first 25 imaging dynamics are received during the **Treatment Initialization** state, where all hardware is configured to prepare for heat delivery. During this step, the Radiologist should closely monitor the magnitude and thermometry images and click the **Stop Initialization** button if there is evidence of severe thermometry artifacts or patient motion that could affect treatment.

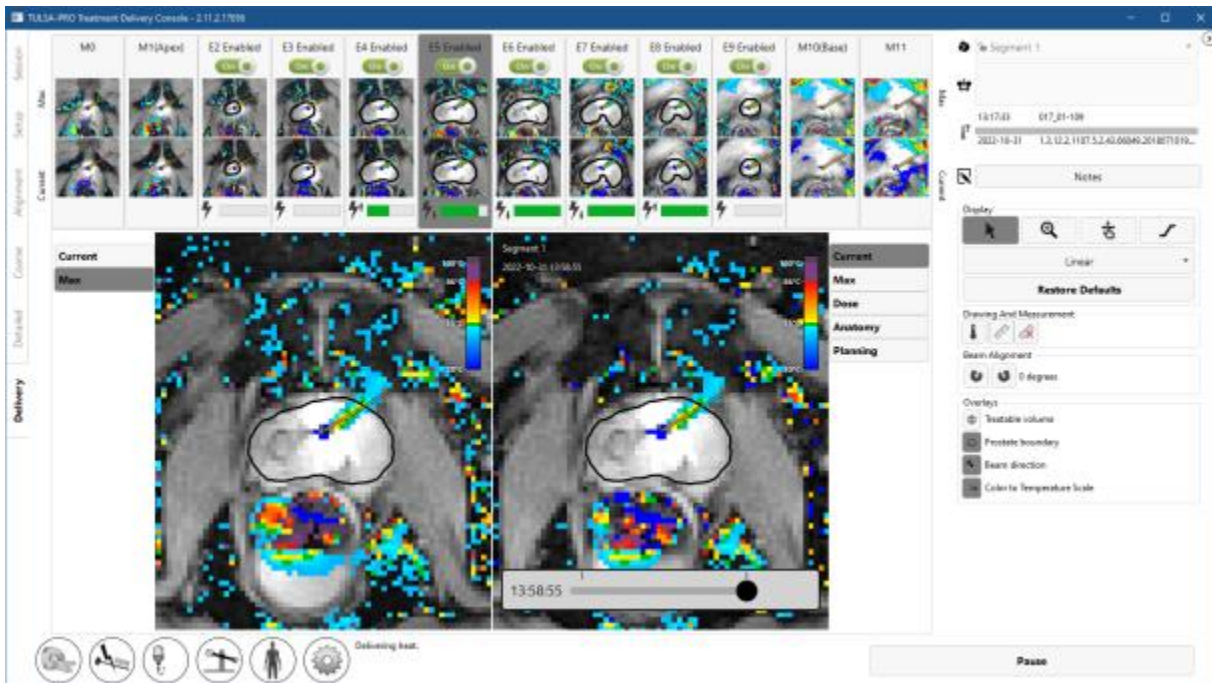
Figure 45: Ultrasound heating has begun

Radiologist: After receiving 25 thermometry dynamics, heating begins (Figure 45). Throughout the ablation, actively monitor real-time treatment images on all slices, ensuring that:

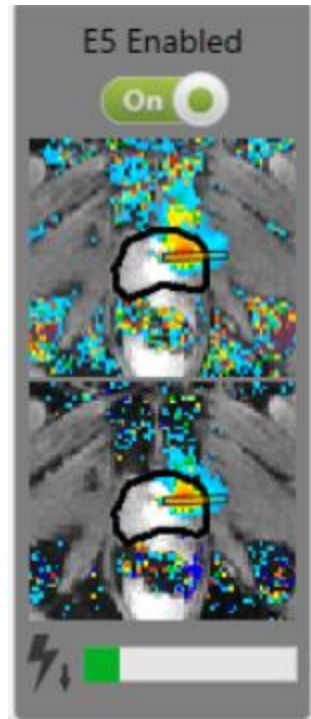
Figure 46: Active element in the Delivery workspace
(Green bar shows power is being delivered from this element.
Down-arrow indicates element is operating at low frequency.)

If unintended heating of important structures outside the prostate is observed at any time, unselect the switch to disable power to that element (*Figure 46*).

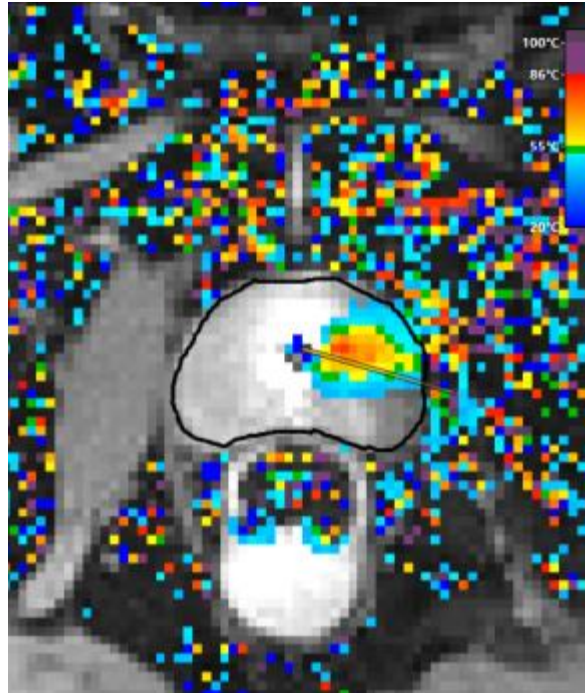
Figure 47: UA beam orientation overlay

The expected heating direction in the TDC software is represented by a feature called the **UA Beam Angle** (*Figure 47*), which is a visual overlay over the MRI Thermometry image and represented as a line extending radially outwards from the UA center.

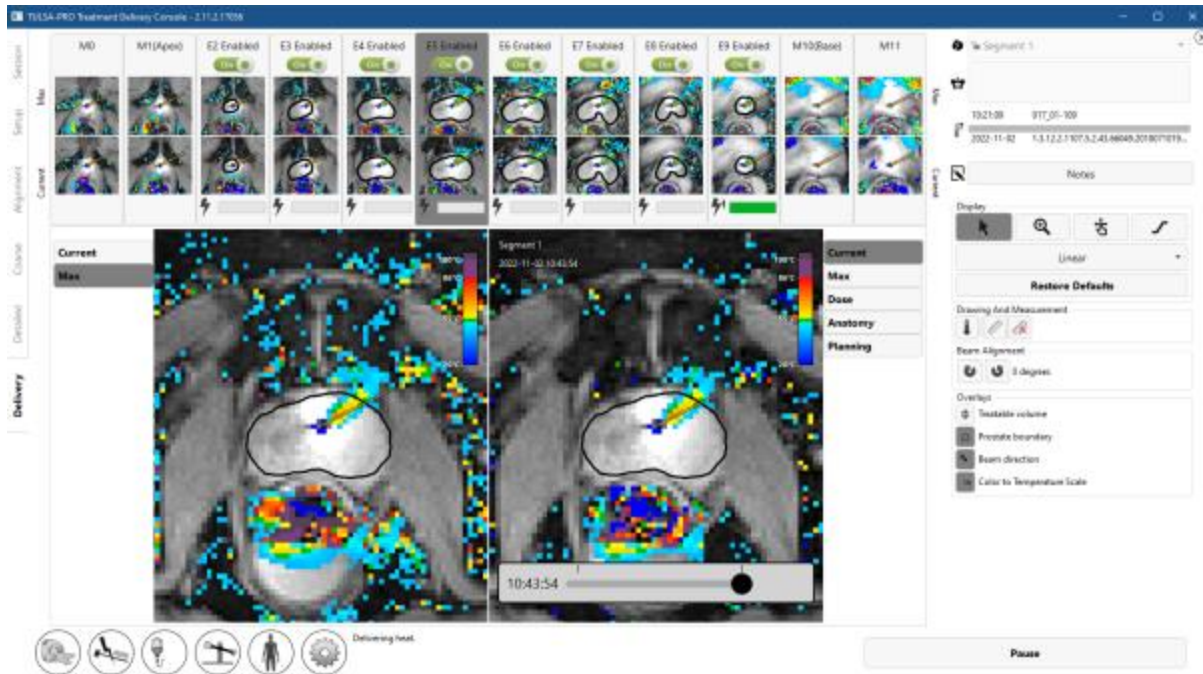
Figure 48: Misaligned ultrasound heating and UA beam angle

During treatment delivery, if it is observed that the direction of ultrasound heating and the UA beam angle do not correspond or align with each other on the Current Temperature view (Figure 48), adjust the beam angle. If the adjustment does not resolve the problem, click Pause and create a new treatment segment (see *Creating a new Treatment Segment*) to suspend ultrasound delivery and thermometry acquisition. Enter the MRI magnet room to ensure the UA is properly mated to the PS. If the problem persists, contact a Profound Medical authorized service representative.

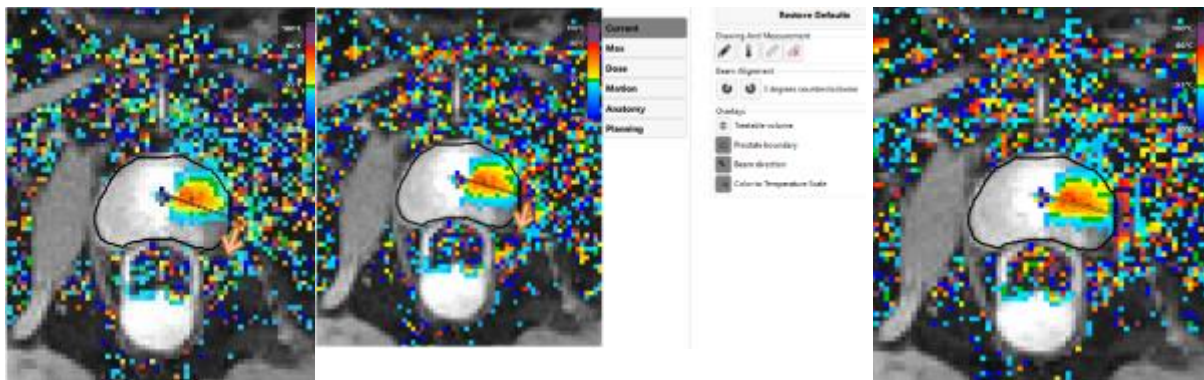
The UA is treating in the clockwise direction and the UA beam angle leads

The **Beam Alignment** buttons are used to adjust the beam angle in increments of 1 degree each time it is clicked. In this image

directions, up to a maximum of 5 degrees in either direction. It is recommended to perform beam alignment near the start of treatment when the heating pattern from the UA is a developing narrow beam. As treatment progresses, since the UA rotates while delivering heat, previously heated tissue can still appear hot and make it difficult to identify where the heat is currently being delivered. As an example, *Figure 49* shows a UA beam angle that is offset from the heating pattern of the temperature map. Next, the beam angle adjustment buttons are used to rotate the UA beam angle back toward the center of the heating pattern. After the adjustment is complete, the UA beam angle is positioned more centrally within the heating pattern.

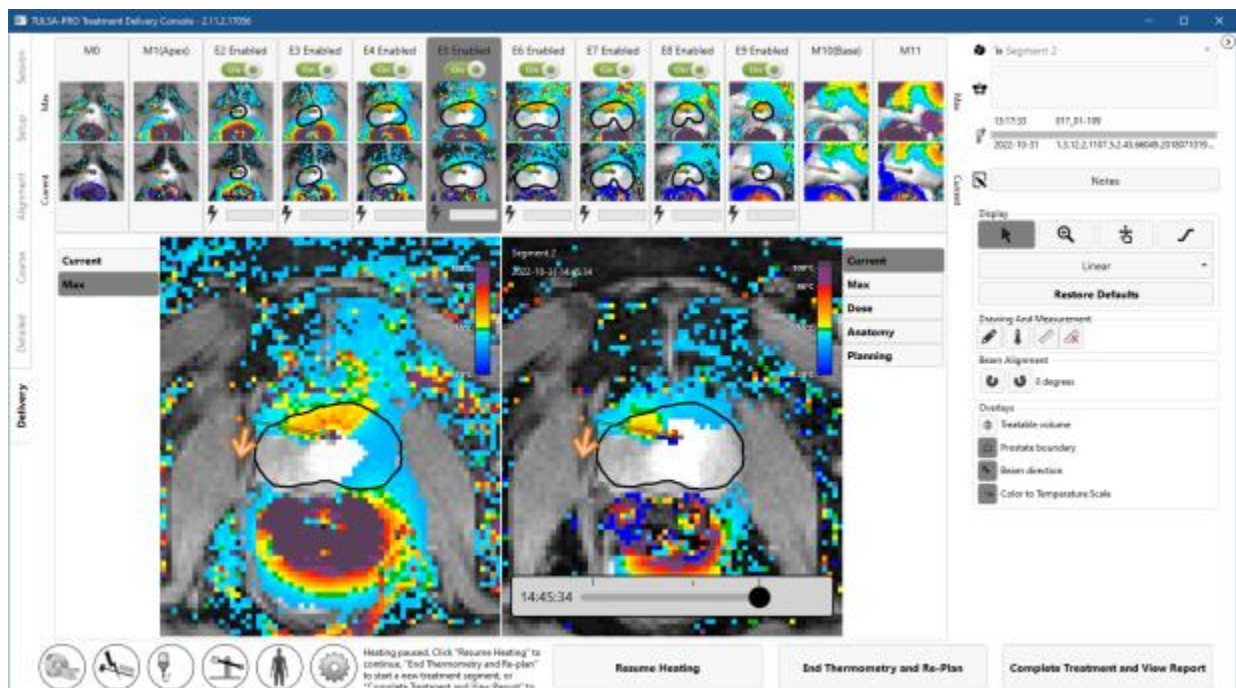
Figure 50: Delivery workspace with treatment and heating paused

Radiologist: At any time during Delivery, click **Pause** in the bottom-right corner of the screen (see *Figure 45*). While in the paused state, all heating from the UA is suspended while thermometry acquisition continues (*Figure 50*).

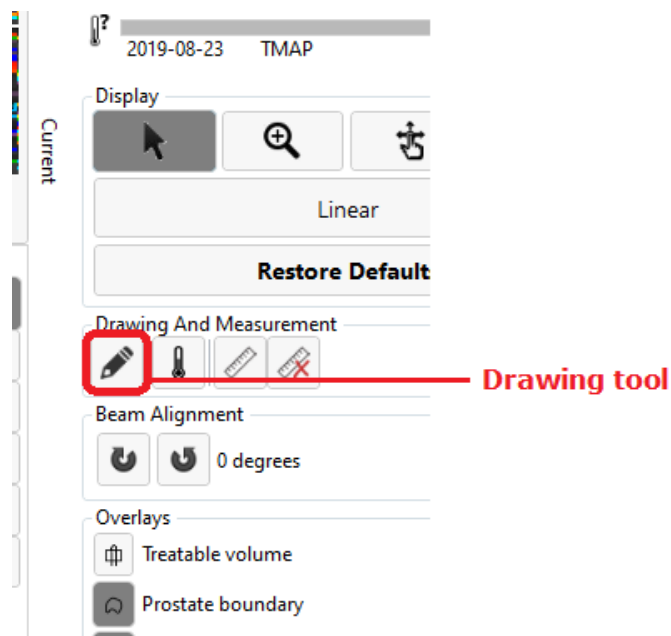
Figure 51: Prostate-boundary 'Drawing' tool on Delivery screen

1. Pause the treatment delivery.
2. Once delivery is paused, expand the right panel in the Delivery workspace to select the prostate boundary drawing tool (*Figure 51*).

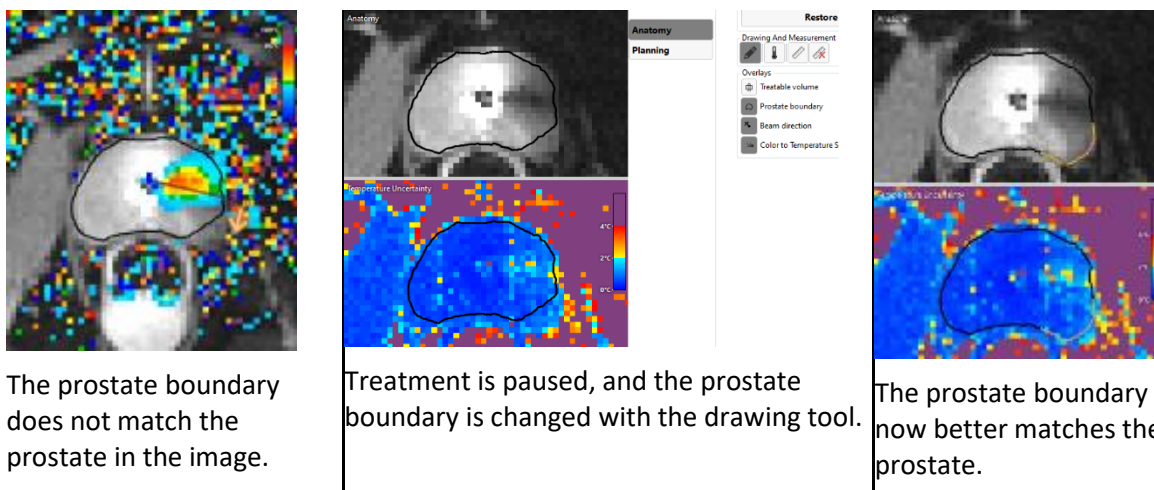
The prostate boundary does not match the prostate in the image.

Treatment is paused, and the prostate boundary is changed with the drawing tool.

The prostate boundary now better matches the prostate.

Figure 52: Editing the prostate boundary

3. Click the drawing tool. The TDC displays a new pane showing the prostate boundary contour and the temperature uncertainty for the selected slice (*Figure 52*).
4. Modify the boundary as needed on each slice. As with the thermometry uncertainty images in Detailed Planning, avoid drawing the boundary through high-temperature uncertainty regions.
5. If satisfied with the modified boundaries on all slices, click **Apply**. The TDC will validate the changes to the boundary and then you can click **Resume Heating** to resume treatment delivery. Otherwise, click **Discard Changes** to start editing from the current boundaries again. If none of the changes are acceptable, then create a new treatment segment by clicking **End Thermometry and Re-plan**.

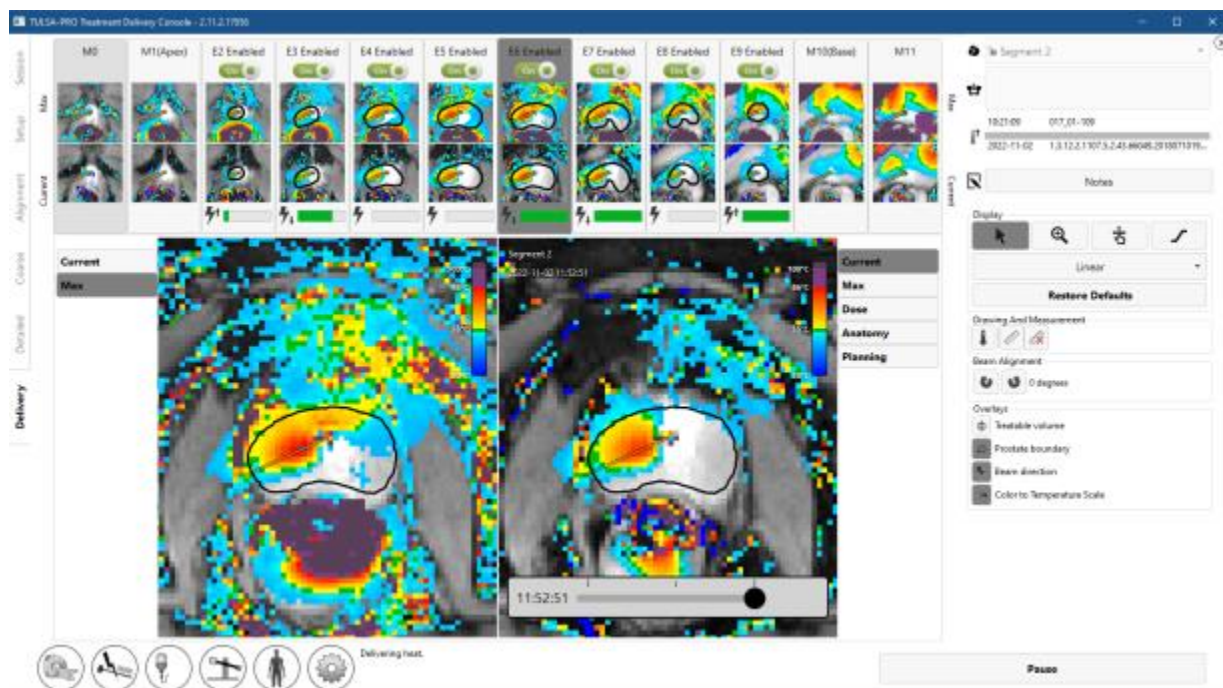
Figure 53: History slider in Delivery workspace

The History Slider appears at the bottom of the right viewport in the Delivery workspace (*Figure 53*), and is accessible during live treatment delivery, when treatment is paused, and after treatment is completed.

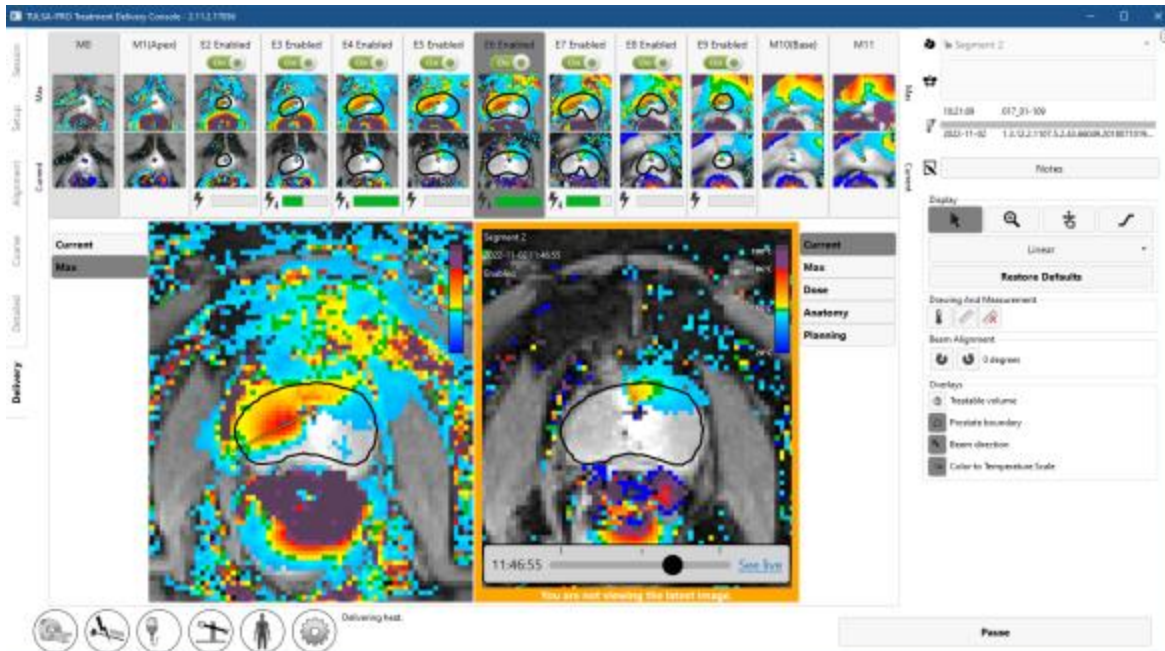
Figure 54: “You are not viewing the latest image” message below history slider

NOTE: When viewing images from previous timepoints, a frame around the right viewport shows that the latest images are not being viewed (*Figure 54*). A dashed line shows where the beam angle was at the previous timepoint. To return to the current timepoint, click **See live** or drag the History Slider until the framed message disappears.

5. To return to the current dynamic, click **See Live** or drag the history slider until the message that reads “You are not viewing the latest image” disappears.

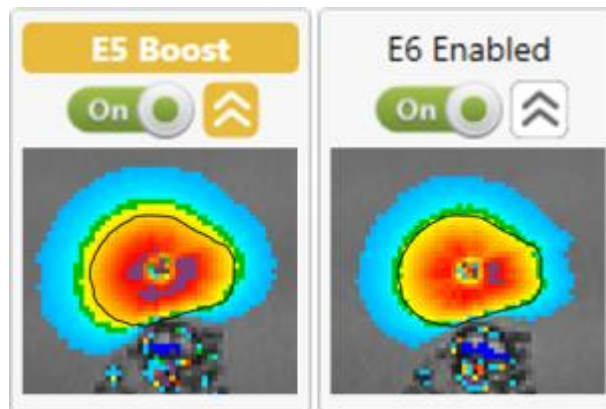
Figure 55: Max temperature maps of the same target boundary treated with boost (left) and without (right).

Figure 1 shows the maximum temperature view in a case where Thermal Boost was applied on one slice and not on the other.

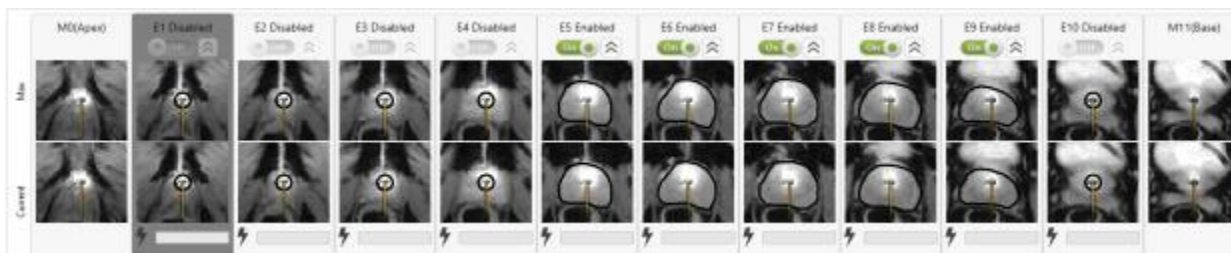
Figure 56: Enabled elements

1. Make sure the individual element is Enabled (switch is set to **On**). For example, in Figure 2, elements 5 to 9 are enabled.

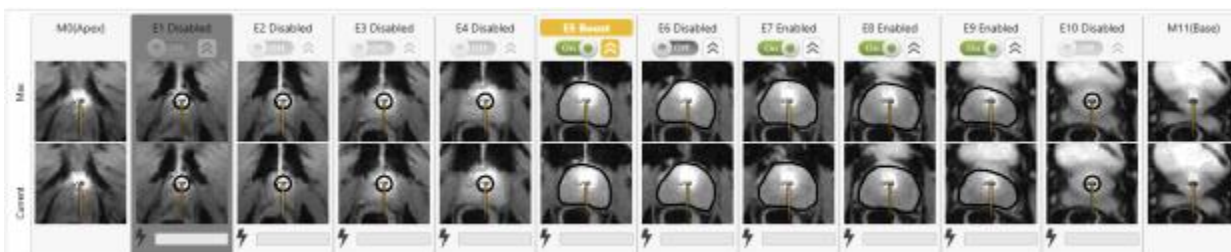
Figure 57: Thermal Boost enabled

2. Click on the double-chevron to activate the **boost**. When Boost is activated, the element's label will change from **Enabled** to **Boost**, its Boost icon will turn yellow, and the Thermal Boost control parameters will remain in effect for that element until deactivated. For example, in Figure 3, heating is Enabled on elements 5, 7, 8, 9, and Boost is activated on Element 5.

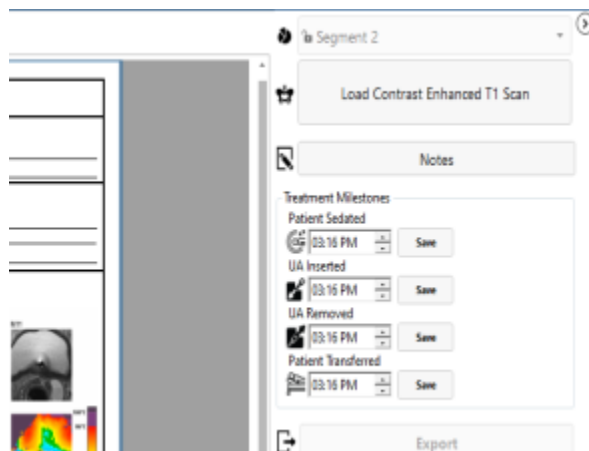
Figure 58: Treatment Milestones panel in Reports workspace

MRI Technologist: Use the Treatment Milestones panel in the *Reports* workspace (*Figure 58*) to record:

After saving each Treatment Milestone, the area will turn gray and the **Save** button will be replaced by **Edit**.

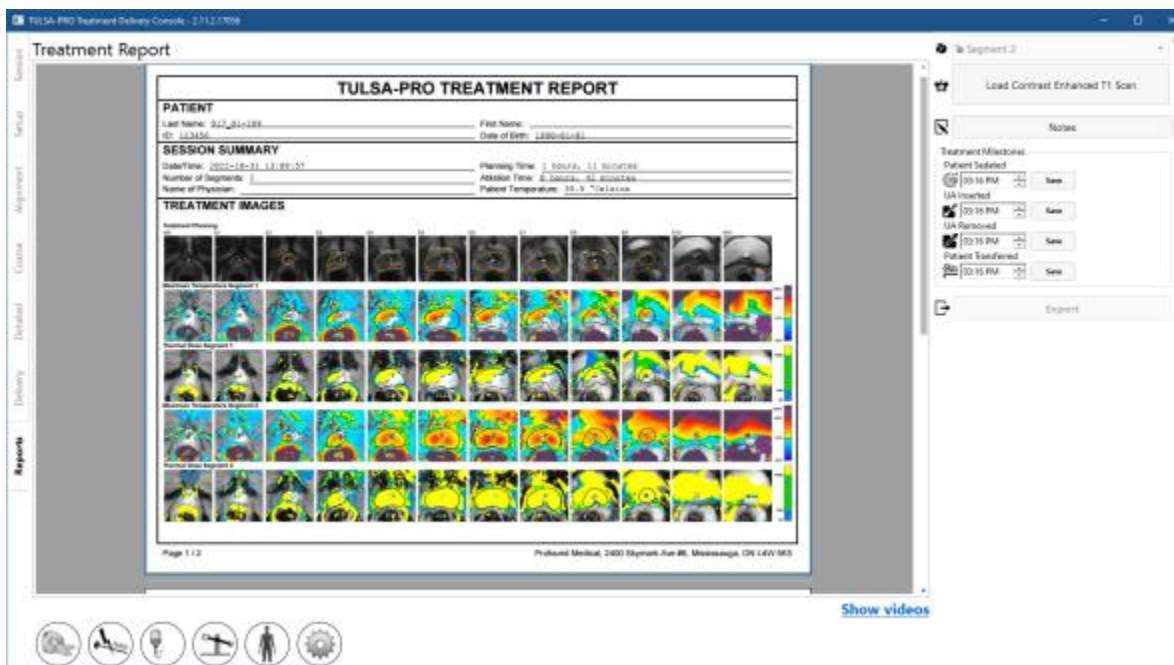
Figure 59: TDC Reports tab

When the Treatment Delivery Console (TDC) enters the *Reports* workspace, users see a brief summary of the treatment session (Figure 59). At the same time, the TDC starts to generate videos of the treatment, which might take several minutes.

The **TREATMENT IMAGES** section shows the AX T2 scan for each slice, as used for planning, followed by the maximum temperature observed in each treatment segment and the estimated thermal dose. If there was more than one treatment segment, there will be one series of maximum temperature images and thermal dose images for each segment.

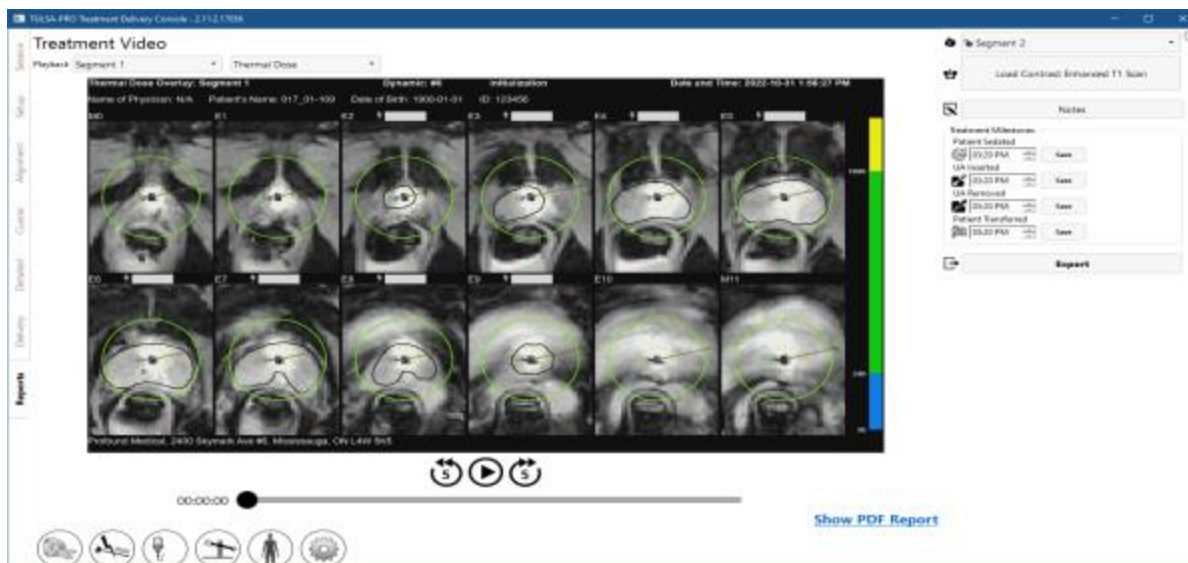
Figure 60: Treatment video displayed in Reports workspace

When TDC has finished generating the treatment videos, the [Show videos](#) link will be available at the bottom of the *Reports* workspace. Click [Show videos](#) and the report region of the display will show the treatment videos (*Figure 60*).

You can play (▶) the video for the treatment segment (or if the session had multiple segments, use the segment selector (Figure 60) to choose an individual segment) and choose to see the anatomy with an overlay of the current temperature, maximum temperature, or thermal dose. Each video also shows the prostate boundary, the direction of the beam at each moment, and the intensity of heating.

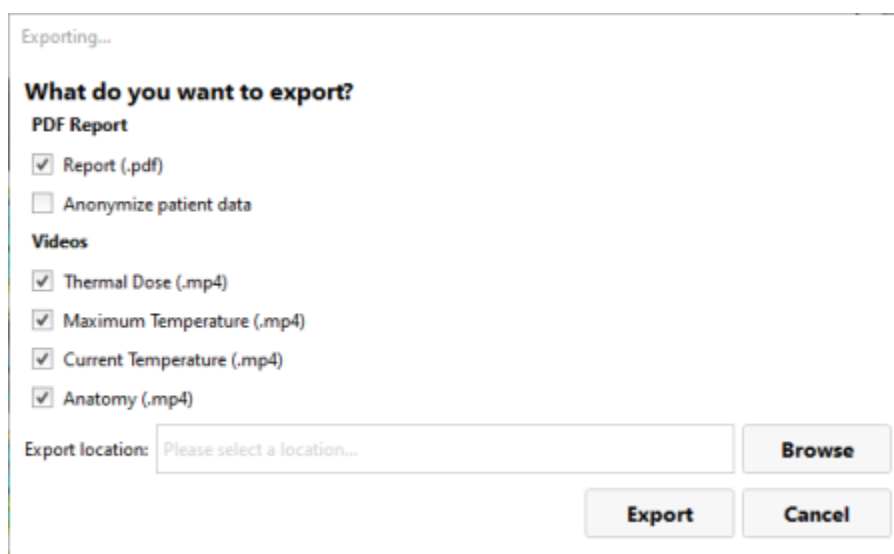
Figure 61: Exporting treatment session reports and videos

You can also save the treatment report and videos to the computer hard drive or any storage medium. Attach the appropriate storage device and click **Export**. The system displays a window where you can choose a location to store the files and whether to export a PDF file of the report and videos with overlays (Thermal Dose, Maximum Temperature, Current Temperature, or Anatomy) (Figure 61).

As an option, you can exclude the patient's personal data from the PDF report to protect their privacy. To exclude patient data from the export, select **Anonymize patient data**.

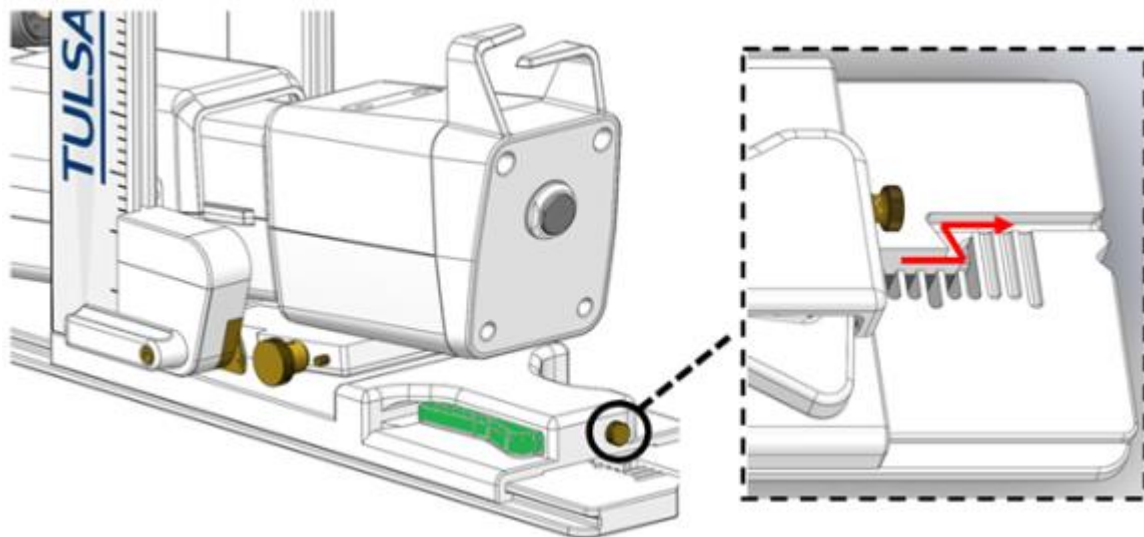
Figure 62: Removing PS from base plate

1. Remove the PS from its notched base plate by partially unscrewing the thumbscrew located on the rear of the PS base and depressing the horizontal adjustment lever through the Z channel at the rear of the PS base (*Figure 62*).

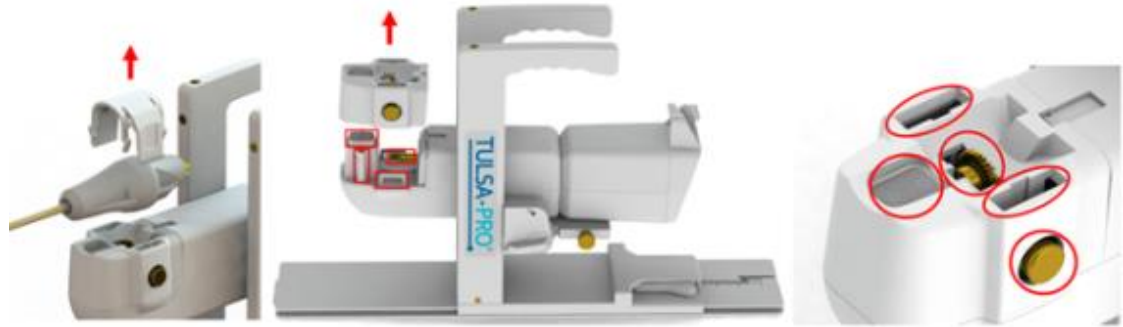
Figure 63: Inspecting the Positioning System

2. Detach the PS Nose by depressing the brass buttons.
3. If you see soiling in either the PS Base or PS Nose area, perform these steps:
 - a. Using a spray disinfectant, saturate the entire gripper area, focusing on the gear area or anywhere with visible soiling. Allow to remain wet for, at minimum, the manufacturer's specified contact time.
 - Ensure all edges, cracks, crevices, corners, and hard-to-reach areas are wetted with the spray disinfectant.
 - b. Use a wipe to loosen and brush away gross soil, then wipe all surfaces of gripper again using a fresh wipe.
 - c. Repeat steps 1 and 2 as necessary until no visible soiling remains, closely inspecting the areas around the gripper and gear (*Figure 63*).

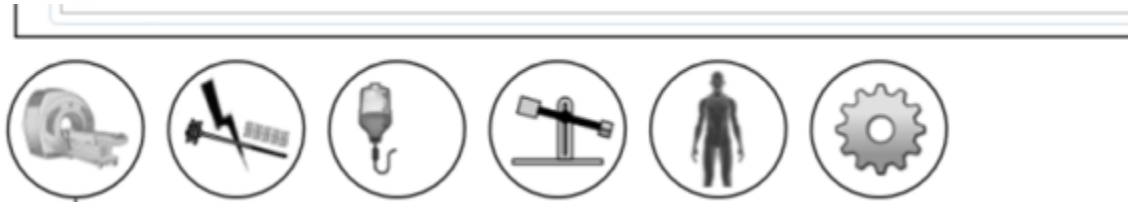
Figure 64: Alarm indicators (all indicators are clear)

An area at the bottom-left of the Treatment Delivery Console (TDC) screen shows alarm indicators when a session is in progress (Figure 64).

If there is no information or warning condition associated with a subsystem, the corresponding subsystem alarm indicator stays clear (*Figure 64*).

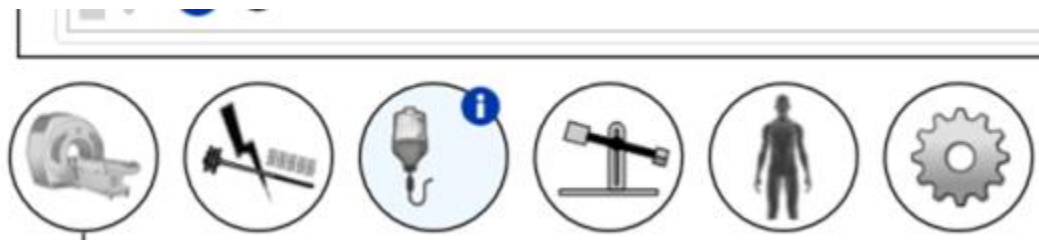
Figure 65: Example of Information condition

If a subsystem detects an **information** condition, the background color of the corresponding indicator changes to **light blue** and an additional icon (i) is shown at the top-right of the indicator (*Figure 65*).

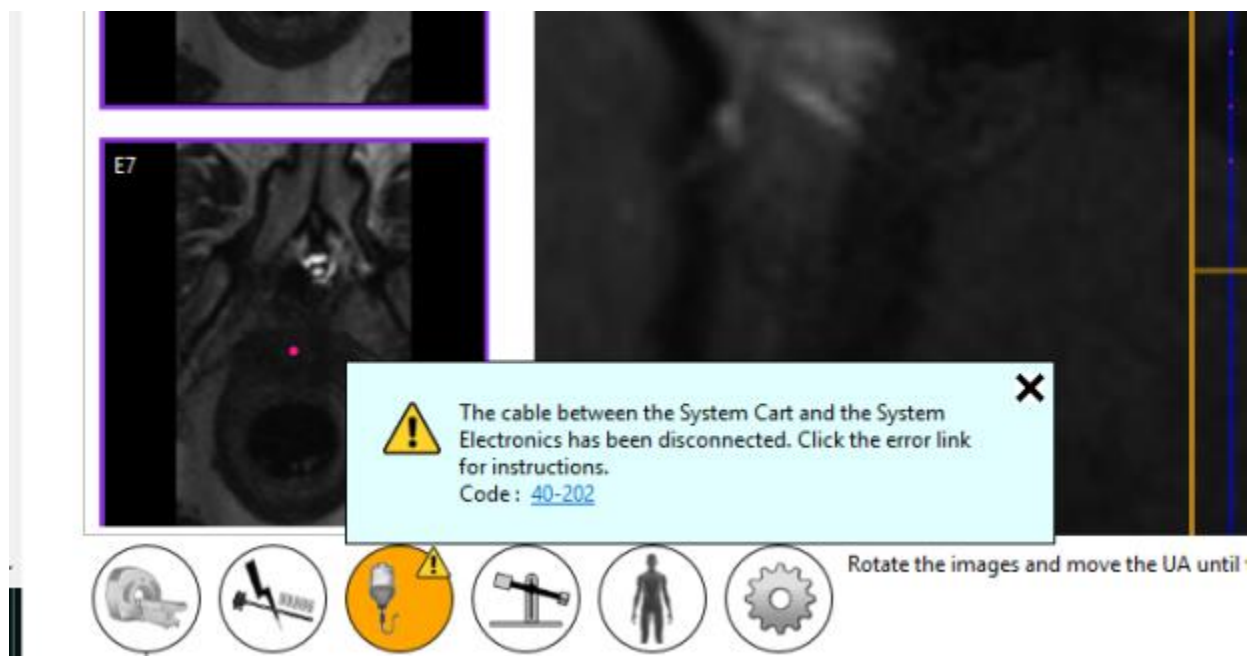
Figure 67: Example of message with Alarm condition details

In addition to a change in the background color of an alarm indicator, a pop-up message containing details shows beside the indicator (*Example of message with Alarm condition details*). The message stays on the screen for 10 seconds. To see the pop-up message again, hover the cursor over the alarm indicator.

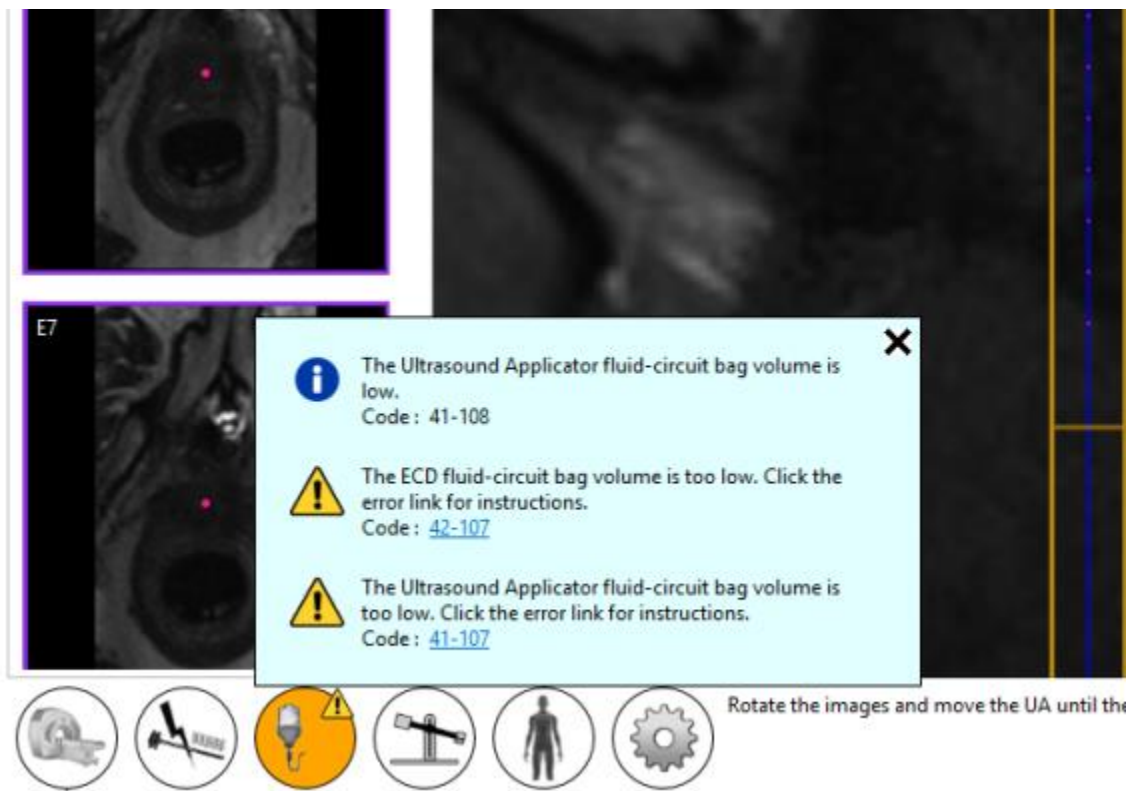
Figure 68: Multiple condition messages in the pop-up message

The corresponding subsystem pop-up message will contain all condition messages (*Multiple condition messages in the pop-up message*).
