TULSA-PRO<sup>®</sup> Transurethral Ultra-  
sound Ablation System  
Operator's Manual

Philips Ingenia 3T and Ingenia Elition 3T

**TULSA-PRO® SYSTEM Model Number:** PAD-105

**Document Number:** 105774 REV J

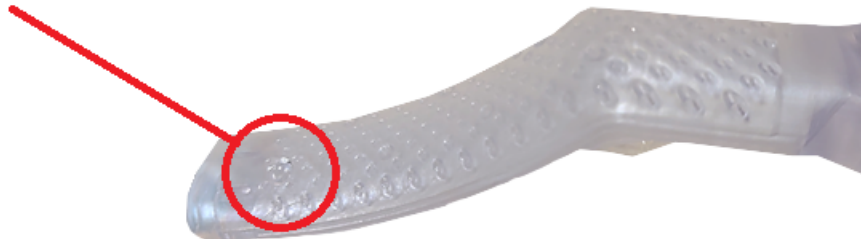
Lubricant emerging from pores

Figure 12: Lubricant emerging from ECD pores

- ii. Slowly inject approximately 8-10 ml of low-viscosity lubricant into the black channel, which will add lubricant to the ECD surface. Gently press on the pores closest to the handle to allow lubricant to fill the large pores at the tip of the ECD. Ensure that lubricant emerges from all the large pores from the handle to the tip of the ECD (*Figure 12*).

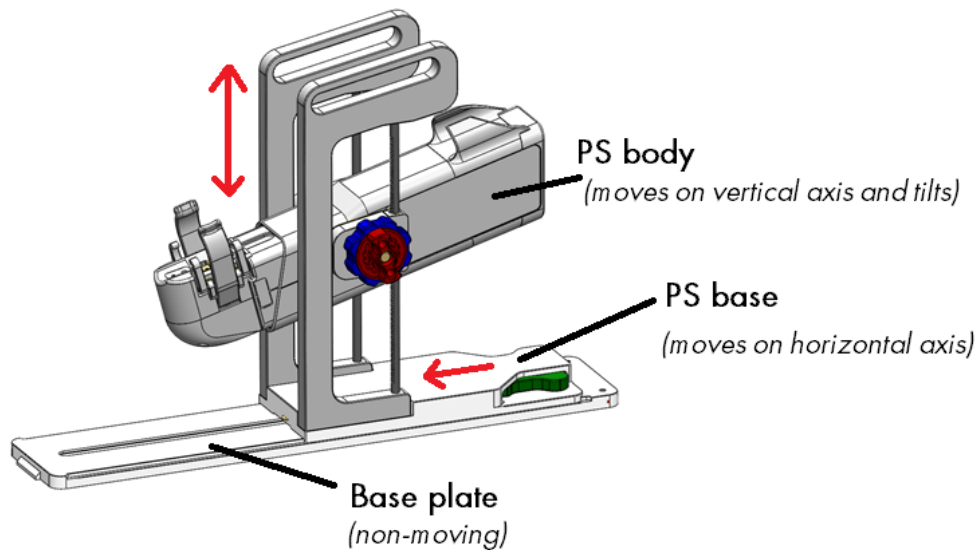
Figure 22: Adjusting the Positioning System

**NOTE:** The PS adjustment knobs and levers are not coloured as in Figure 22, but are coloured here to help with these instructions.

3. **MRI Technologist:** Manually move the PS into position so that the UA gripper aligns with the natural angle of the UA in the patient. Manually adjust the base of the PS forward and backward and up and down, and tilt the linear axis of the PS up and down (Figure 22).

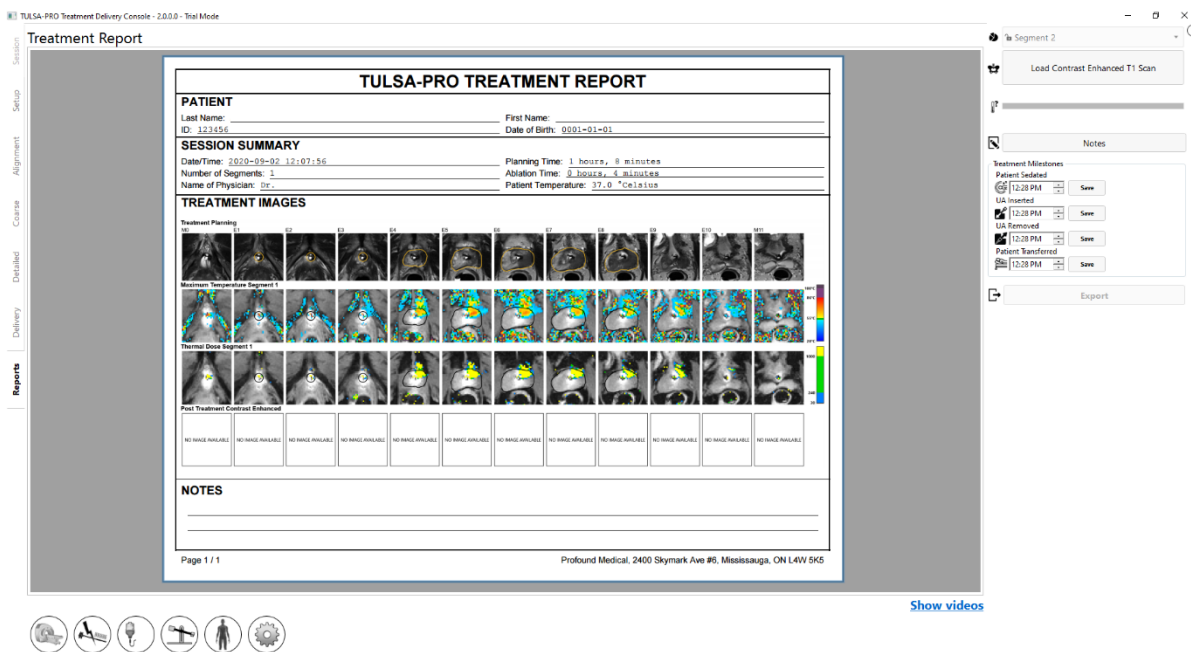
Figure 57: TDC Reports tab

When the Treatment Delivery Console (TDC) enters the *Reports* workspace, users see a brief summary of the treatment session (Figure 57). At the same time, the TDC starts to generate videos of the treatment, which might take several minutes.

The **TREATMENT IMAGES** section shows the AX T2 scan for each slice, as used for planning, followed by the maximum temperature observed in each treatment segment and the estimated thermal dose. If there was more than one treatment segment, there will be one series of maximum temperature images and thermal dose images for each segment.

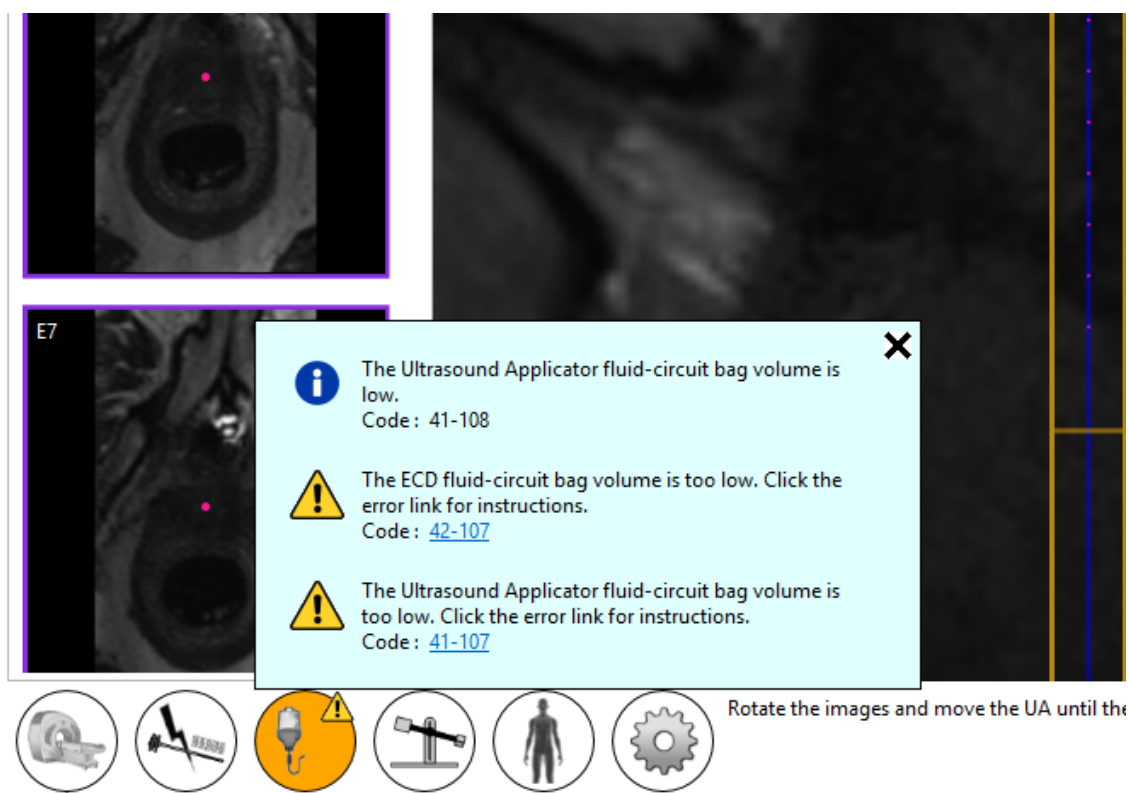
Figure 65: Multiple condition messages in the pop-up message

The corresponding subsystem pop-up message will contain all condition messages (*Multiple condition messages in the pop-up message*).
