TULSA-PRO<sup>®</sup> Transurethral  
Ultrasound Ablation System

Operator's Manual

Siemens XA platform

**Document Number:** 109303 REV E

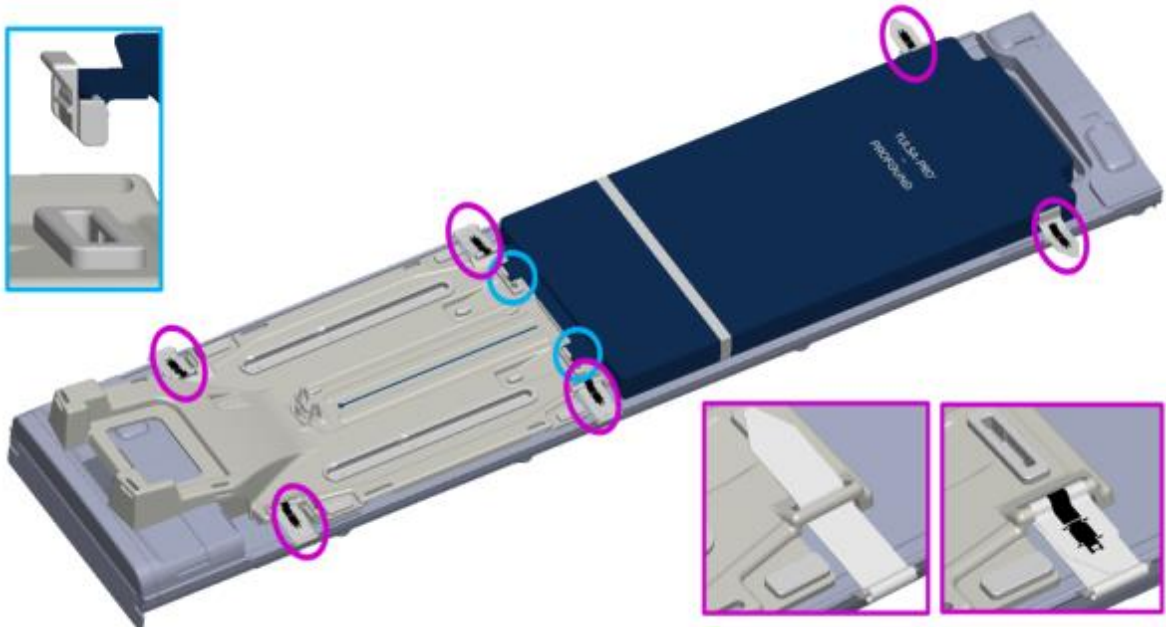
Figure 2: Securing the base plate and patient pad to the MRI bed

1. MRI Technologist Attach the base plate onto the foot end of the MRI table and secure using the four base plate straps (*Figure 2*, your configuration might not match exactly as shown). The feet of the base plate should fit in the rails of the MRI table and not move around when in position.

2. Place the patient pad on the MRI table and secure it using the provided straps shown in (Figure 2, your configuration might not match exactly as shown).
3. Drape the upper part of the patient pad with a sheet and place an absorbent pad at the end closest to the base plate.

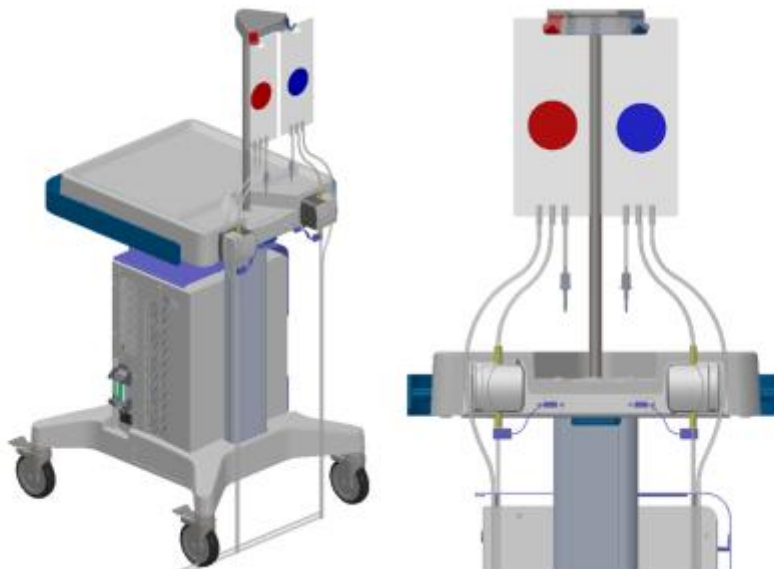
Figure 3: Preparing the system cart and fluid tube sets

- c. Connect the ECD pressure sensor to the corresponding connection on the System Cart.
  - d. Insert the spike from the empty bag into the treated ECD IV bag and then open the line clamp by the spike port to allow the contents of the ECD IV bag to be transferred to the ECD tube set.
  - e. When all the contents from the ECD IV bag have been transferred to ECD reservoir bag, close the line clamp in between.
  - f. Hang the ECD reservoir bag on the blue weight sensor hook on the System Cart (*Figure 3*).
2. Repeat [Step 1](#). for the UA circuit using a UA tube set (identified with a red dot).
  3. With assistance from someone inside the MRI magnet room, pass the UA and ECD tube sets (capped ends) through the appropriate waveguide, into the MRI magnet room. Secure the tube sets near the MRI work surface.

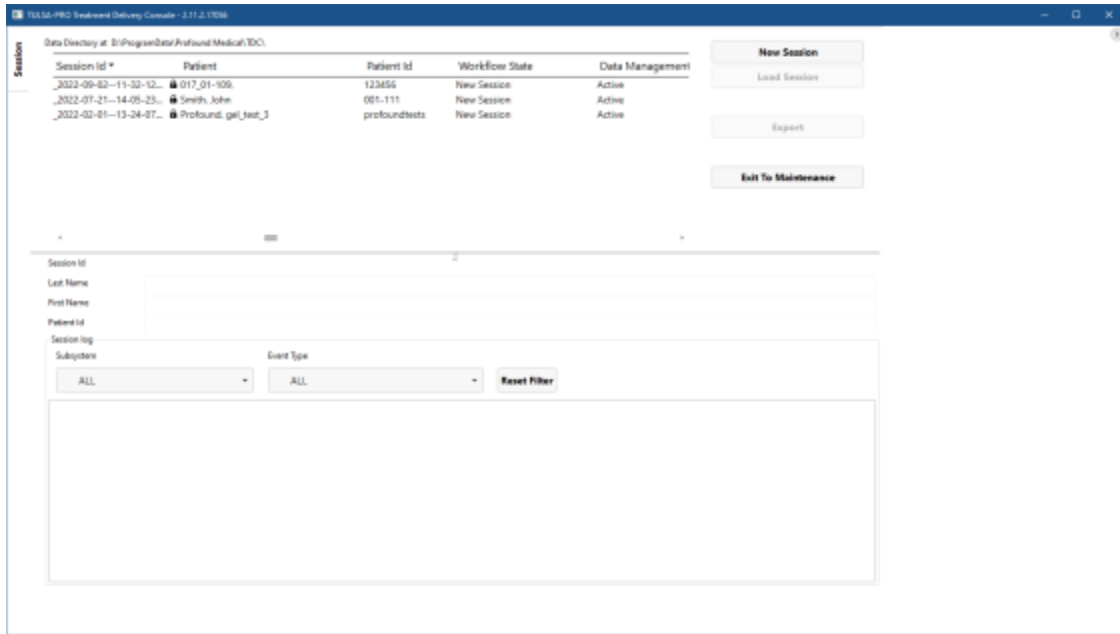
Figure 5: Session Data Management workspace of the TDC Main Menu

1. Launch the TDC software from the desktop. The *Session Data Management* workspace will appear. Click **New Session** (*Figure 5*).

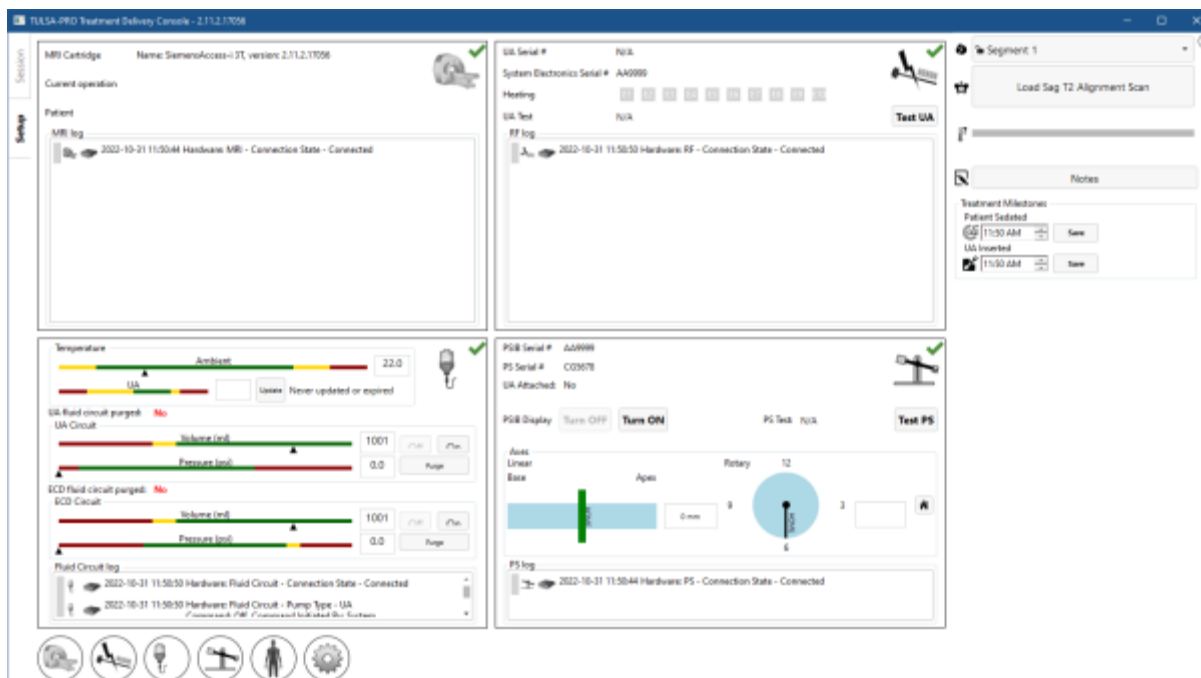
Figure 6: Setup workspace of the TDC software

2. After selecting **New Session**, you will enter the **Setup** Workspace (*Figure 6*) where you can ensure all equipment is functioning properly before proceeding. A green checkmark will appear in the MRI quadrant of the Setup Workspace if the TDC computer and MRI host can communicate with each other, and a patient is currently open with the TULSA-PRO® MRI sequence protocol on the MRI console.

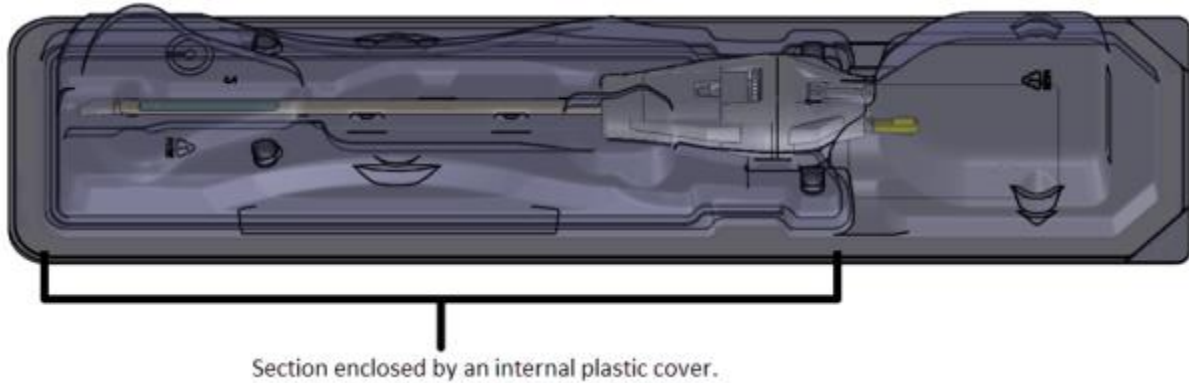
Figure 7: UA sealed inside a sterile package

**NOTE:** MRI Technologist: The ECD is *not* sterile and can be handled accordingly. The UA and contents inside the UA packaging **are** sterile. *Figure 7* shows the UA inside its sealed and sterile package. There is another plastic cover that encloses the UA from its tip to the top of the handle that exposes the UA cable and guidewire inputs and fluid tubes. When you connect the fluid tubes and UA cable, the UA's sterile barrier will have to be broken. Keep the internal plastic cover over the UA during preparation to limit contamination to only the top of the UA handle.

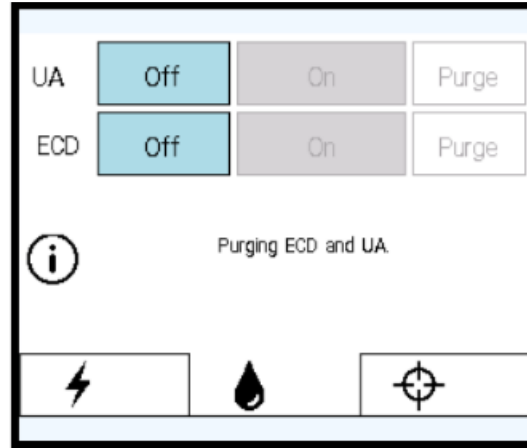
Figure 8: PSIB Display - Fluid Circuit tab

5. On the PSIB display, choose the **Fluid Circuit** tab (*Figure 8*) and **Purge** the UA and ECD fluid circuits. You can also do this from the TDC by pressing **PURGE** beside the fluid circuit (FC) quadrant (*Figure 9*).

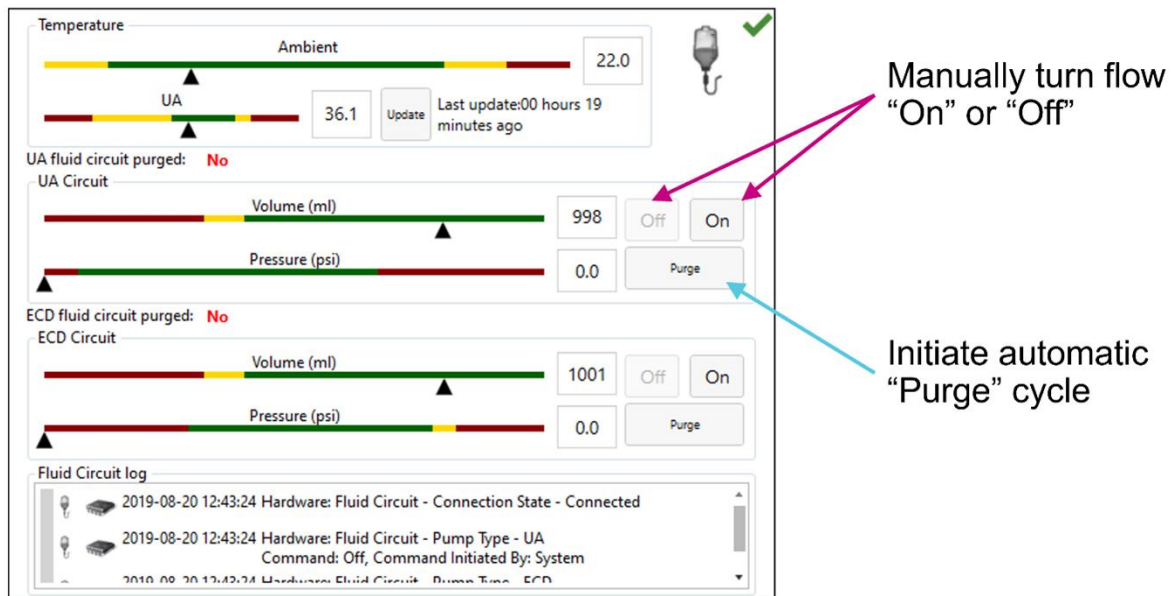
Figure 9: Fluid Circuit information box in TDC Setup workspace

7. Purge the UA of all air bubbles.
  - a. If the purging cycle ends before completing the steps in this process, return to the PSIB display (or TDC window) and manually turn the flow on by clicking **On**. The fluid pumps will remain on until you click **Off** (Figure 9).
  - b. While the purging operation is on, hold the UA in its package—be careful not to touch the UA handle to keep the UA sterile. Tip the package upwards in the 0° position, then tilt to approximately 45°, then 90°, and 135°. At each angle, slowly rotate the package approximately 360° (Figure 10).

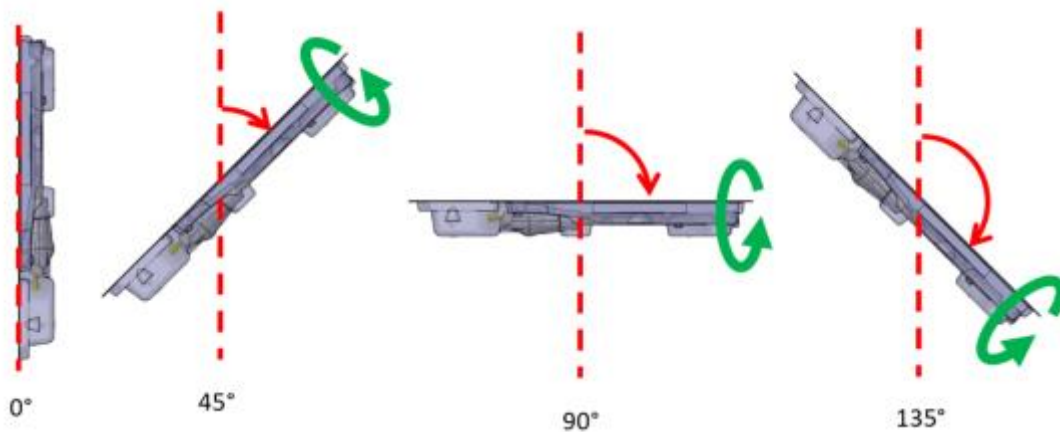
Figure 10: Recommended procedure for purging air from ultrasound applicator

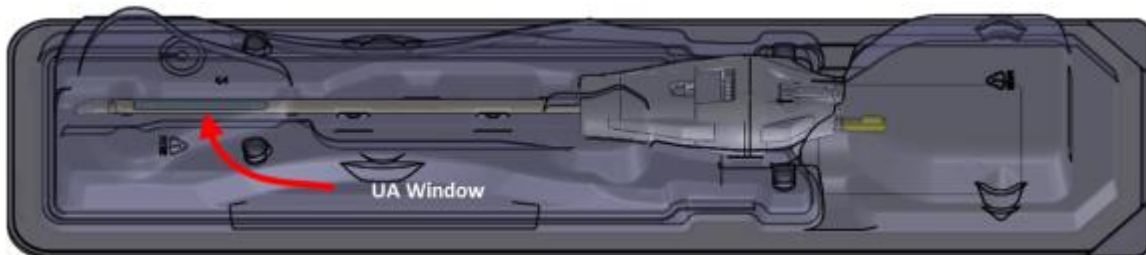
Figure 11: Examine the UA window for air bubbles

- c. Rotate the UA package so that the flat side is facing down. Inspect the UA closely through the plastic package and ensure there are no signs of water in the package, which would indicate a leak. If you see any signs of water, the UA is defective and should not be used. Use a new UA package and repeat the UA preparation procedure.
- d. Look through the package and carefully inspect the UA window for bubbles (Figure 11). There should be **no** bubbles of **any** size. If you see bubbles, gently tap the package-end close to the UA window against the work surface to dislodge them. If you still see bubbles, repeat the procedure, starting from [step “a”](#).

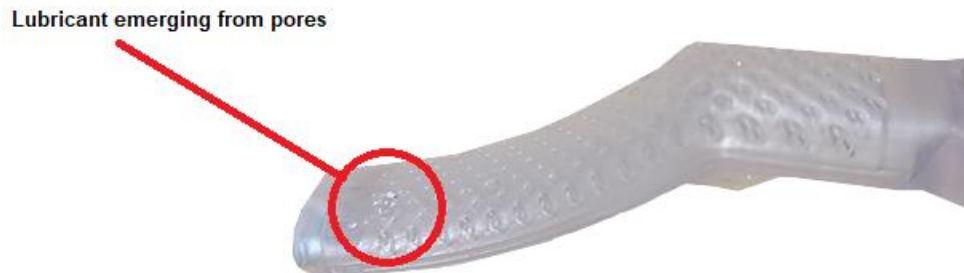
Figure 13: Lubricant emerging from ECD pores

- ii. Slowly inject approximately 8-10 ml of low-viscosity lubricant into the black channel, which will add lubricant to the ECD surface. Gently press on the pores closest to the handle to allow lubricant to fill the large pores at the tip of the ECD. Ensure that some lubricant emerges from all the large pores from the handle to the tip of the ECD (*Figure 13*).

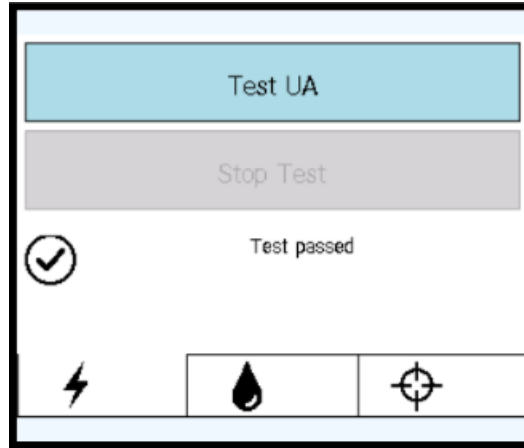
Figure 14: RF tab on PSIB display after successful RF connectivity test

When the RF connectivity test is complete, the PSIB will display a short message (*Figure 14*). You can see detailed RF connectivity test results in the RF information box of the TDC software (*Figure 15*).

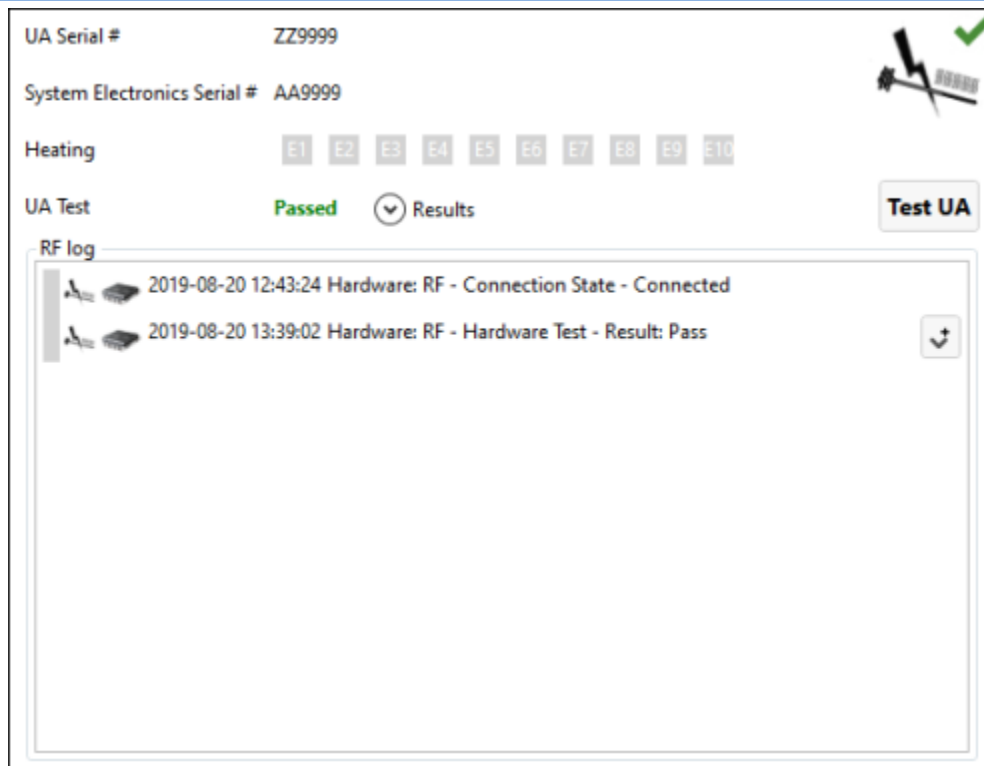
Figure 15: RF information box in Setup workspace after successful RF connectivity test

- a. Ensure the UA is connected to the UA tube set and purged of air (see *Purge the UA of all air bubbles.*).
- b. Without removing the UA from its package, ensure the UA cable is connected from the PSIB to the back of the UA. Care should be taken to avoid contaminating the UA handle.
- c. In the **RF** tab of the PSIB display (*Figure 14*), click **Test UA**.  
The system will send a short burst of power to each of the ten UA elements to ensure continuity and functionality of all ten channels. This can also be done from the TDC Setup workspace from the RF information box in the top-right quadrant (*Figure 15*).

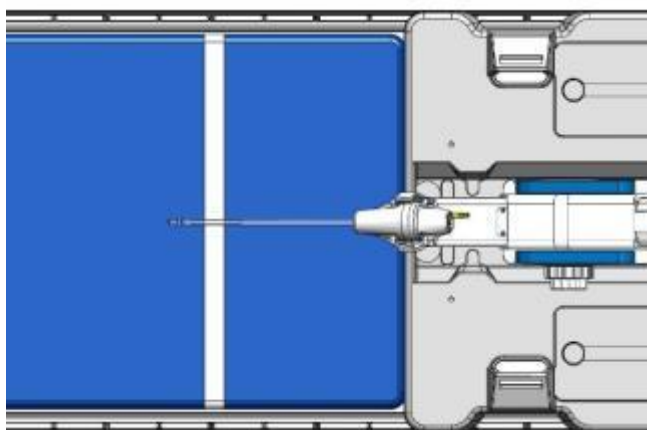
Figure 18: Centering and aligning the coils with the prostate

2. Position the patient on the MRI bed in a head-first supine position so that their sagittal midline is centered from left to right on the MRI table, and their prostate is at the white line of the patient pad (*Figure 18 [Your configuration might not match exactly as shown]*).

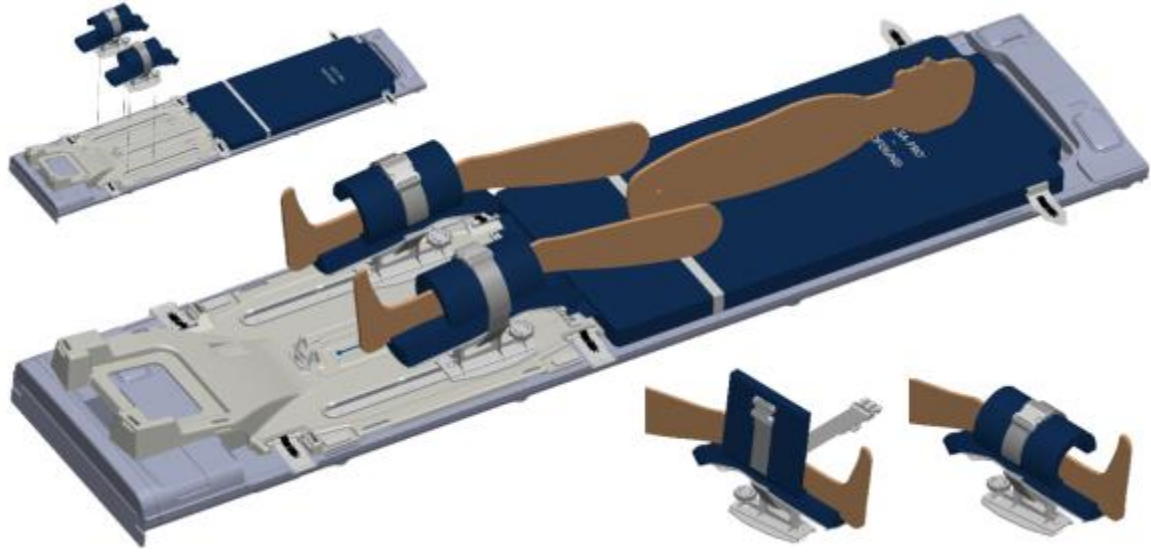
Figure 19: Initial patient positioning and attachment of leg supports

4. Have an assistant lift the patient's legs one at a time while you set up the leg supports (*Figure 19*):
  - a. Place the leg supports into the designated slots of the base plate.
  - b. Support the patient's legs and adjust the positions of the leg supports along the slots in the base plate.
  - c. Wrap the leg pad around the patient's leg, connect the buckle of the leg support strap, and pull the strap to tighten.
5. Provide the patient with ear protection to protect against MRI-related hearing injury, even though the patient might be under general anesthetic.

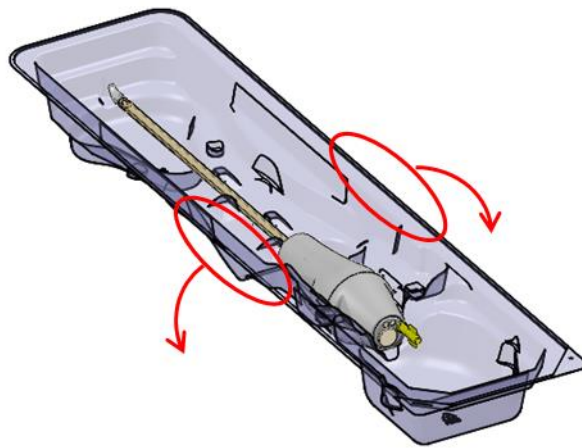
Figure 20: Releasing the UA from the packaging tray

1. **MRI Technologist:** Using the fluid circuit (**FC**) tab of the PSIB display (or the FC information box of the Setup workspace in TDC), flow water into the UA by clicking **ON**.
2. **MRI Technologist:** Ensure the UA cable is connected to the UA and disconnected from the PSIB.
3. **MRI Technologist:** Without touching the UA to maintain sterility, remove the plastic cover enclosing the UA in the package.
4. **MRI Technologist:** While holding the UA packaging tray by the long edges of its perimeter, flex the tray to release the UA from its snap features (*Figure 20*).
5. **Urologist:** Using one sterile, gloved hand, remove the UA from the package by gripping the end with the white plastic handle.

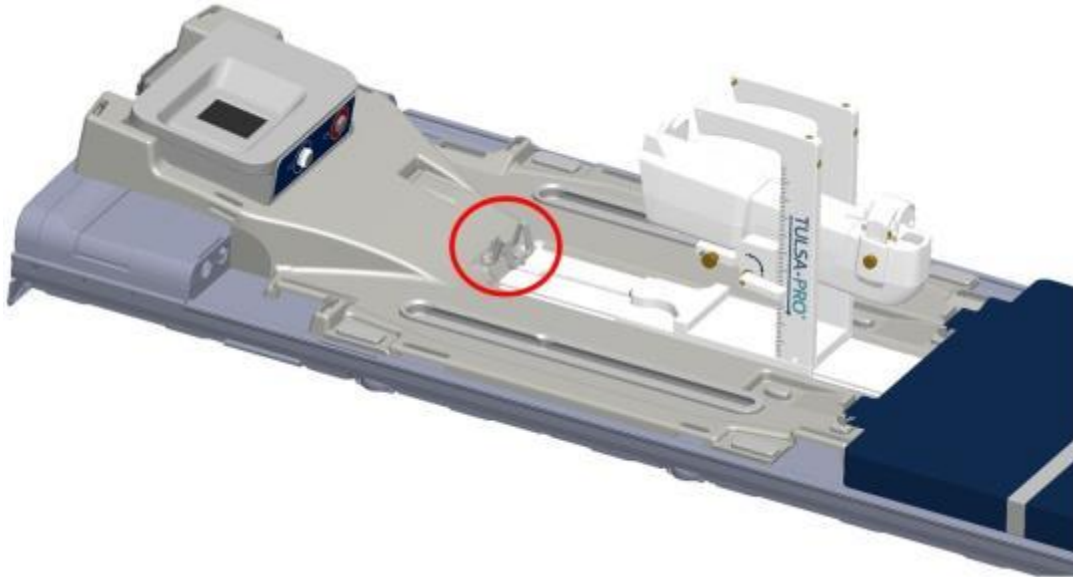
Figure 22: Secure the Positioning System using the latch on the base plate

1. **Urologist:** Hold the UA handle with the UA positioned at a natural angle in the patient, while the **MRI Technologist** installs and adjusts the PS to capture the UA in the PS gripper.
2. **MRI Technologist:** Ensure that the slot for the PSIB is clear. Place the PS and PSIB in their respective slots on the base plate. Secure the Positioning System (PS) to its slot on the base plate between the patient's legs by closing the latch (*Figure 22*).

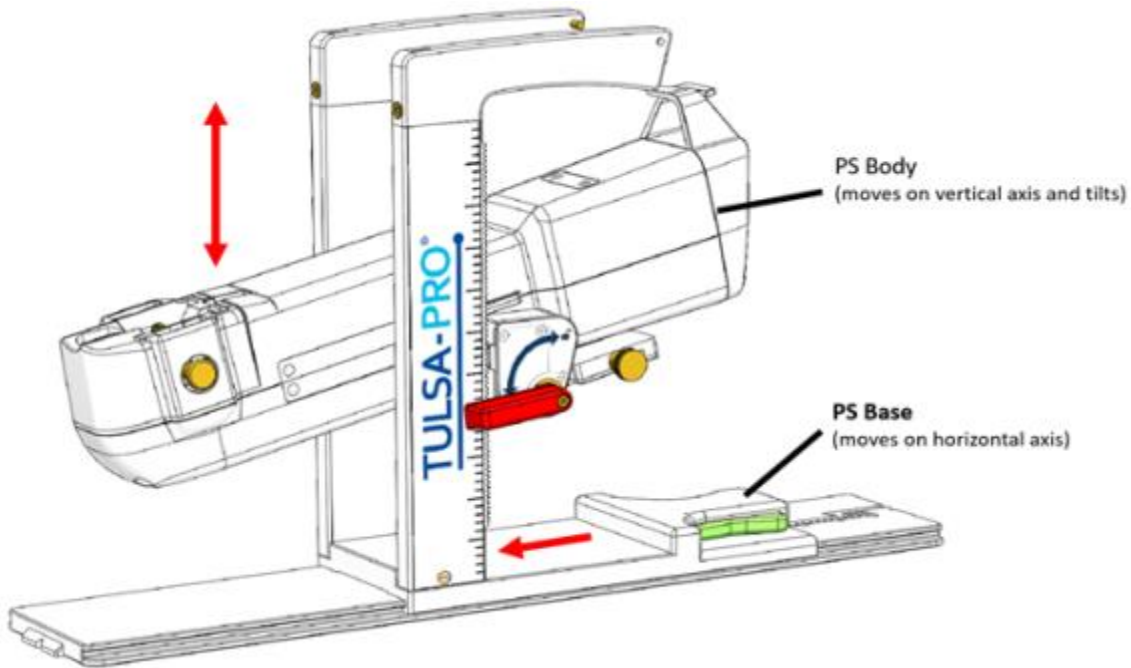
Figure 23: Adjusting the Positioning System

**NOTE:** The PS adjustment knobs and levers are not colored as in *Figure 23*, but are colored here to help with these instructions.

3. MRI Technologist: Manually move the PS into position so that the UA gripper aligns with the natural angle of the UA in the patient. Manually adjust the base of the PS forward and backward and up and down, and tilt the linear axis of the PS up and down (*Figure 23*).

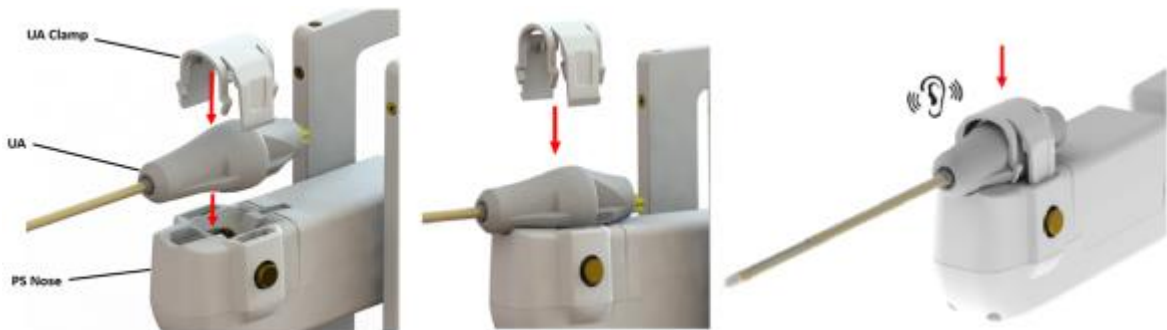
Figure 24: UA attachment to Positioning System

4. **MRI Technologist:** After locking the PS tilt and height, seat the UA in the PS nose and then secure it by pressing the UA clamp down over top of the UA until it is fully engaged with the PS nose. (Figure 24).

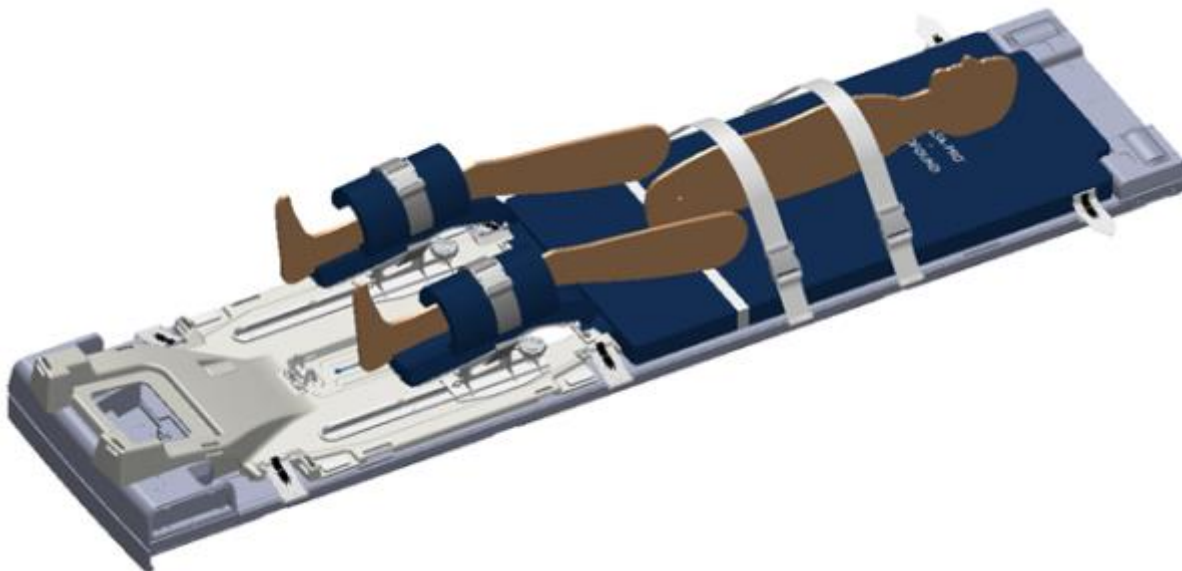
Figure 25: Securing the abdomen and arm straps

1. **MRI Technologist:** Place restraint straps around the patient to prevent motion of the pelvis during MR imaging and position the anterior coil.
2. **MRI Technologist:** Fasten one abdomen-arm strap tightly over the lower abdomen to minimize anterior-posterior breathing motion. Wrap the sheet over the abdomen and place the patient's hands on top. Fasten a second abdomen-arm strap over the arms to help fit the patient into the MRI bore (*Figure 25*, your configuration might not match exactly as shown).

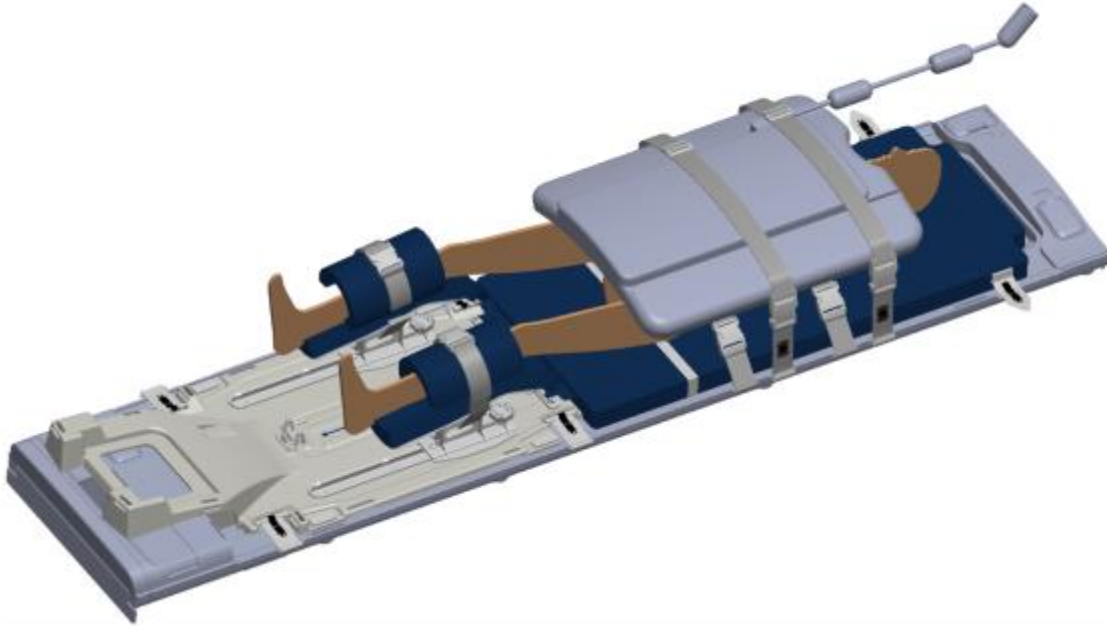
Figure 26: Placement of the anterior imaging coil

2. MRI Technologist: Strap the anterior imaging coil over the patient's pelvis and arms. The coil should cover the prostate, without interfering with the travel of the Positioning System (*Figure 26*).

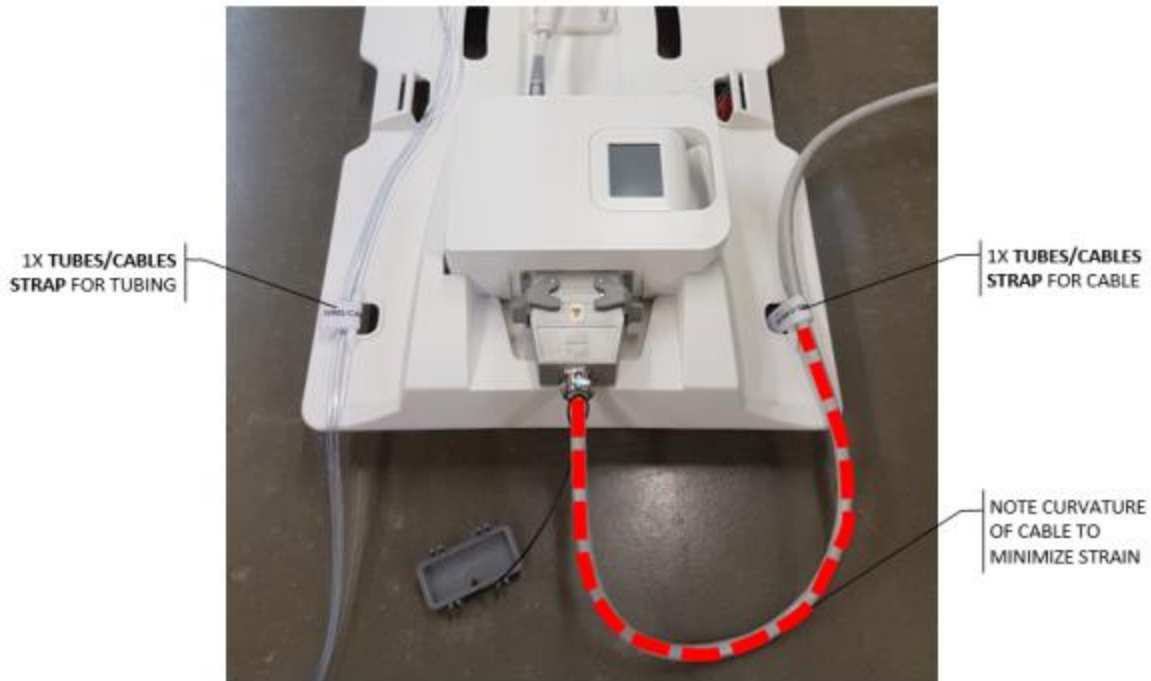
Figure 27: Tube-and-cable straps of base plate: one for tube sets and one for RF cable

3. MRI Technologist: For the patient's comfort, use sheets to keep him warm and pads to avoid pressure points. Also, to avoid electrical burns, ensure that the patient's skin is not directly touching the coils or MRI bore.
4. MRI Technologist: Use tube-and-cable straps to manage fluid tubes and the white RF cable as shown in *Figure 27*. Leave some slack to allow the cables to slide freely and to reduce tripping hazards. Ensure no cables, tubing, or other materials can be caught while the MRI table is moving.

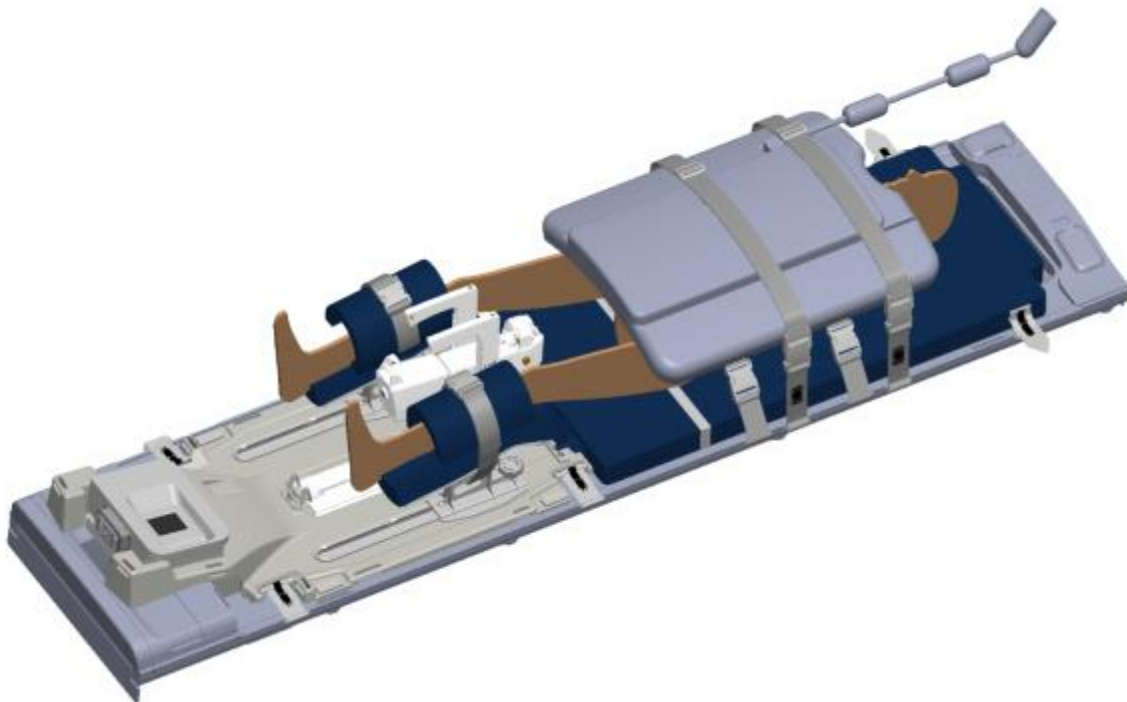
Figure 28: Patient positioning is complete

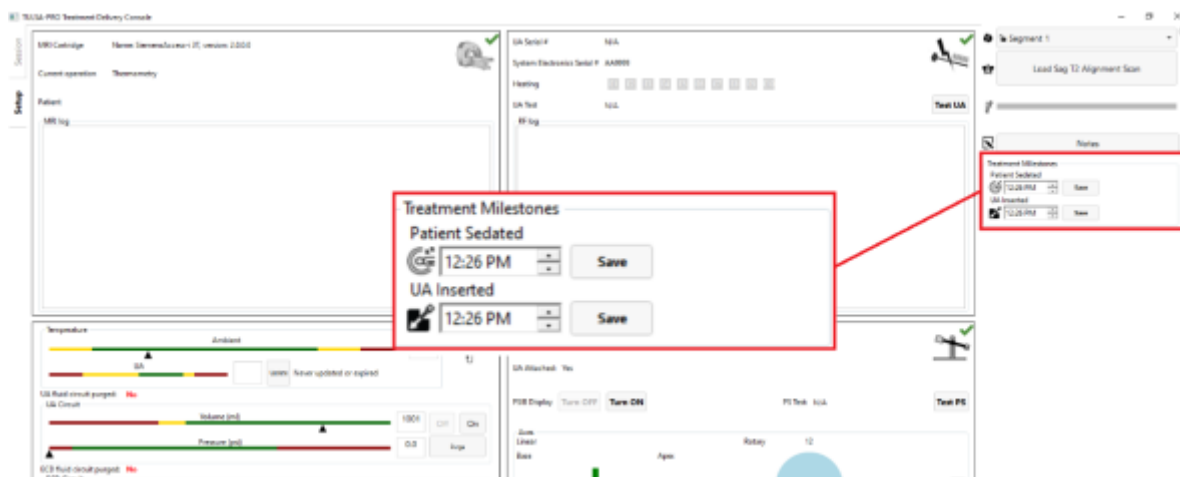
Figure 29: Entering Treatment Milestones in the TDC Setup Workspace

1. In the TDC *Setup* Workspace, enter the sedation and UA insertion times under **Treatment Milestones** (*Figure 29*).
2. Click **Save**. The Treatment Milestones area will turn gray and the Save button will be replaced by **Edit**.

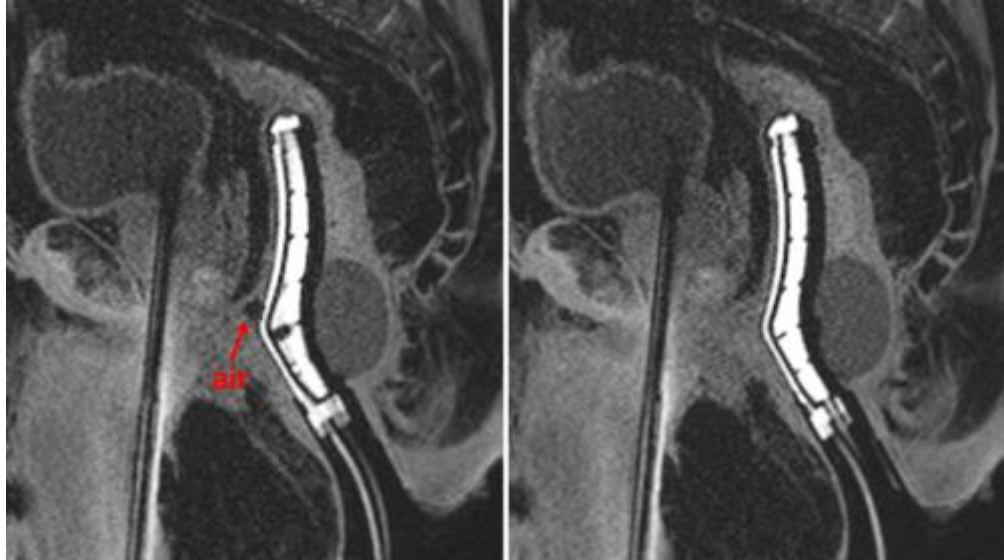
Figure 30: Sagittal images of ECD facing anteriorly towards the prostate, with air in the beam path (left) and correctly adjusted to eliminate air from the beam path (right)

- a. The cooling window should cover the prostate and expected range of ultrasound energy from the UA, as confirmed on the sagittal MRI (*Figure 30*).

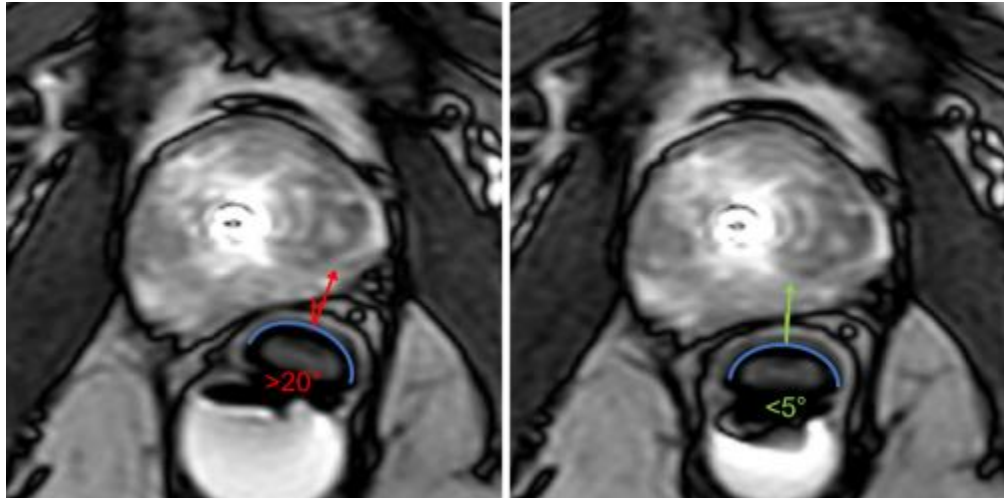
Figure 31: Axial images depicting ECD oriented incorrectly (left, rotated more than 20 degrees) and correctly (right, facing up towards the prostate)

- b. The orientation of the cooling window should face the prostate (anterior), as confirmed on the axial MRI (Figure 31).

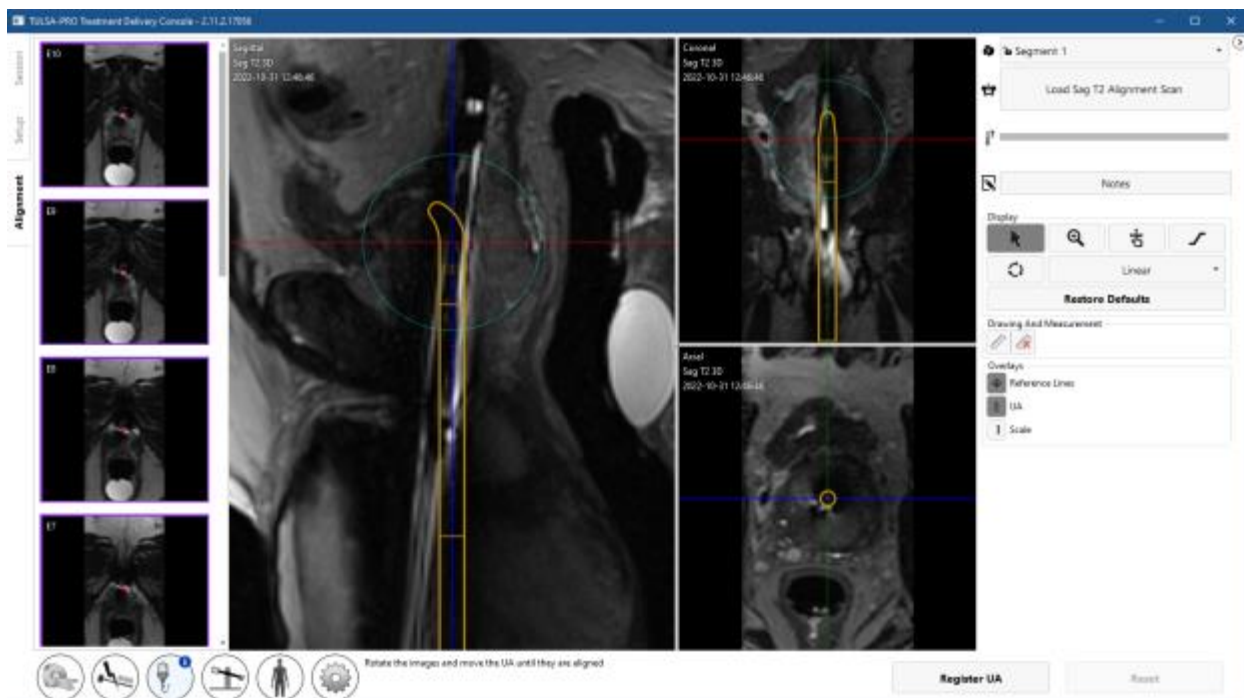
Figure 32: UA before alignment

**Radiologist:** Use the Alignment workspace to define the location and angulation of the UA in the TDC software by aligning a graphical representation of the UA with the actual UA on the MRI image in three dimensions. Accurate alignment will be critical to safe and effective heat delivery within the intended tissue volume. See example below of the UA in MR images before (*Figure 32*) and after (*Figure 33*) Alignment.

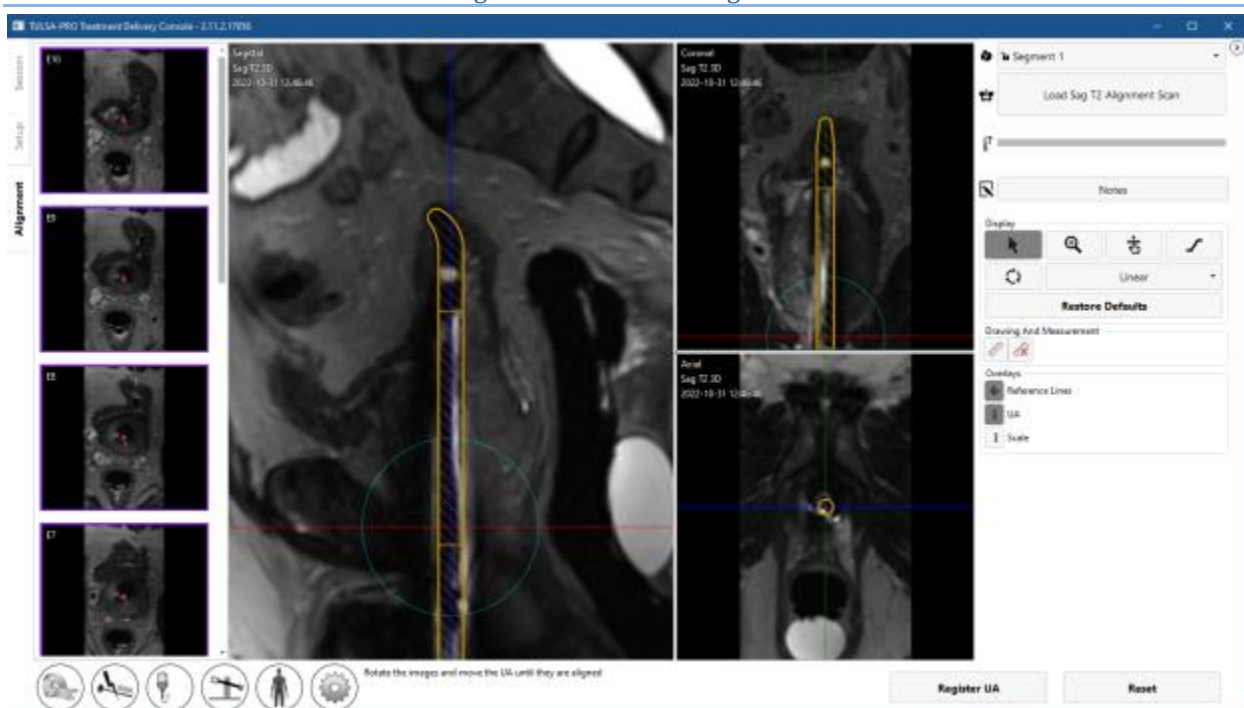
Figure 33: UA after alignment

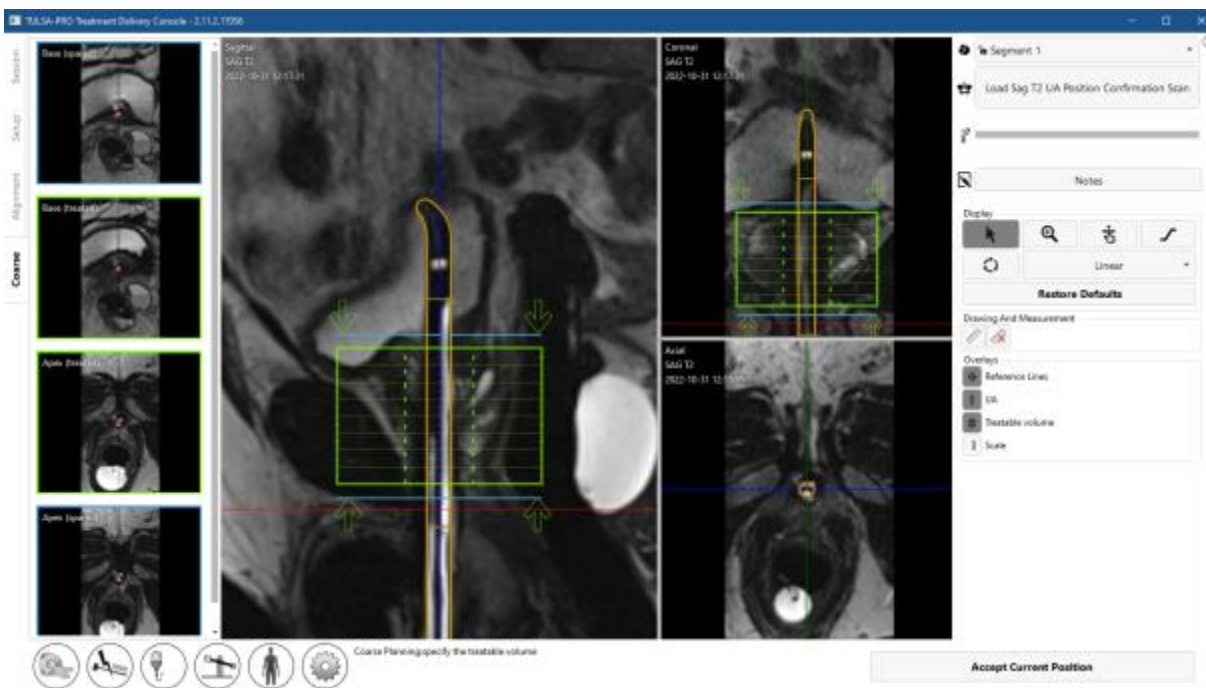
Figure 34: Coarse Planning workspace in TDC software

The treatment volume is displayed as a green rectangle on the sagittal and coronal views. Regions beyond a light blue line displayed 4 mm from the bottom and top edges of the green rectangle on the sagittal and coronal views are anatomical regions expected to be spared fully from thermal coagulation (*Figure 34*).

**NOTE:** When determining where to position the UA, identify the external urinary sphincter. If the external urinary sphincter cannot be identified, it should be considered immediately adjacent to the prostate apex. Place the light blue line below the first element on the external urinary sphincter (*Figure 34*).

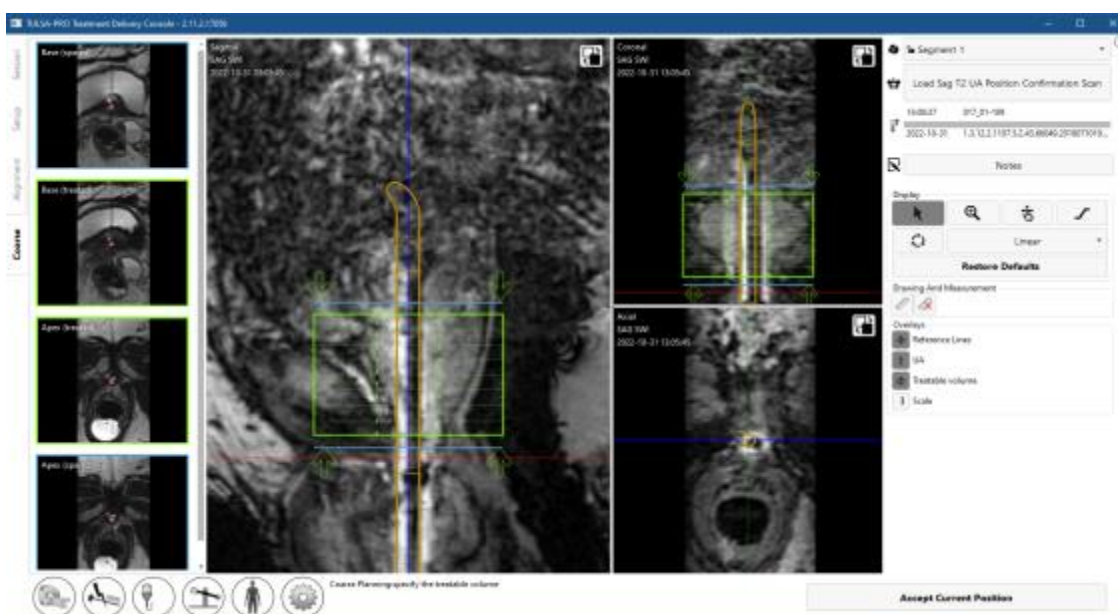
Figure 35: Using mpMRI Vision in Coarse Planning to visualize calcification on a SAG SWI scan and adjust the UA position to reduce the shadowing effect of the calcification on treatment

2. **Radiologist:** When adjusting the UA position, the presence of any small calcifications in the beam path should also be considered. Use the mpMRI Vision feature in Coarse Planning to load a set of sagittal susceptibility-weighted images (SWI), which highlight the magnetic field disturbances caused by intraprostatic calcifications. To reduce the shadowing effect of calcifications on ultrasound

propagation and tissue heating, place the midline of the calcification between two adjacent ultrasound elements (instead of directly in front of an element) (*Figure 35*).

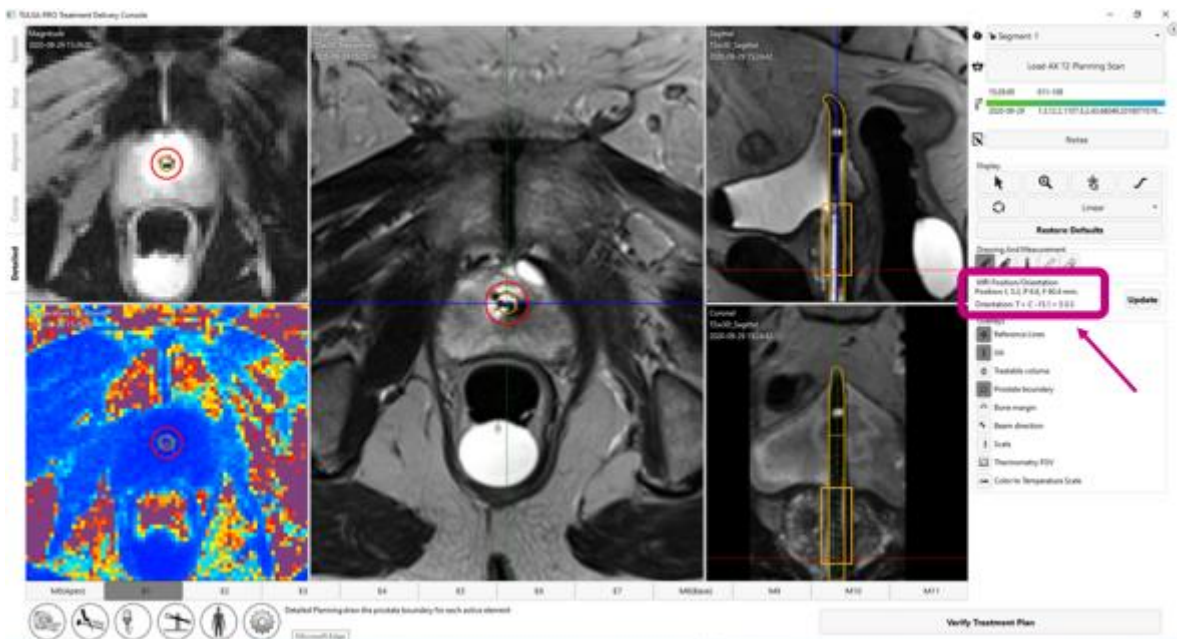
Figure 36: Detailed Planning workspace with Thermometry Magnitude and Temperature Uncertainty (MRI Position/Orientation coordinates used to prescribe treatment planning images are highlighted)

- d. On the new window, select **Center of Slice Groups and saturation regions** and also select the option to **Copy Phase-encoding direction**.
  - e. Click **OK**. The imaging volume should automatically move and be in the exact same position as the AX THERM SYNGO sequence.
  - f. Run the sequence by clicking **Go** (🟢). When complete, push the images to the TDC network node (see *Pushing planning images from the MRI to TDC*).
  - g. Repeat the steps above to prescribe and run the AX DWI sequence (" mpMRI Vision" on page 55).
6. Radiologist: As the thermometry scans are received, the **Magnitude** and **Temperature Uncertainty** views will be displayed automatically. Use **Load ... Scan** to load the AX T2 or AX DWI images (Figure 36).

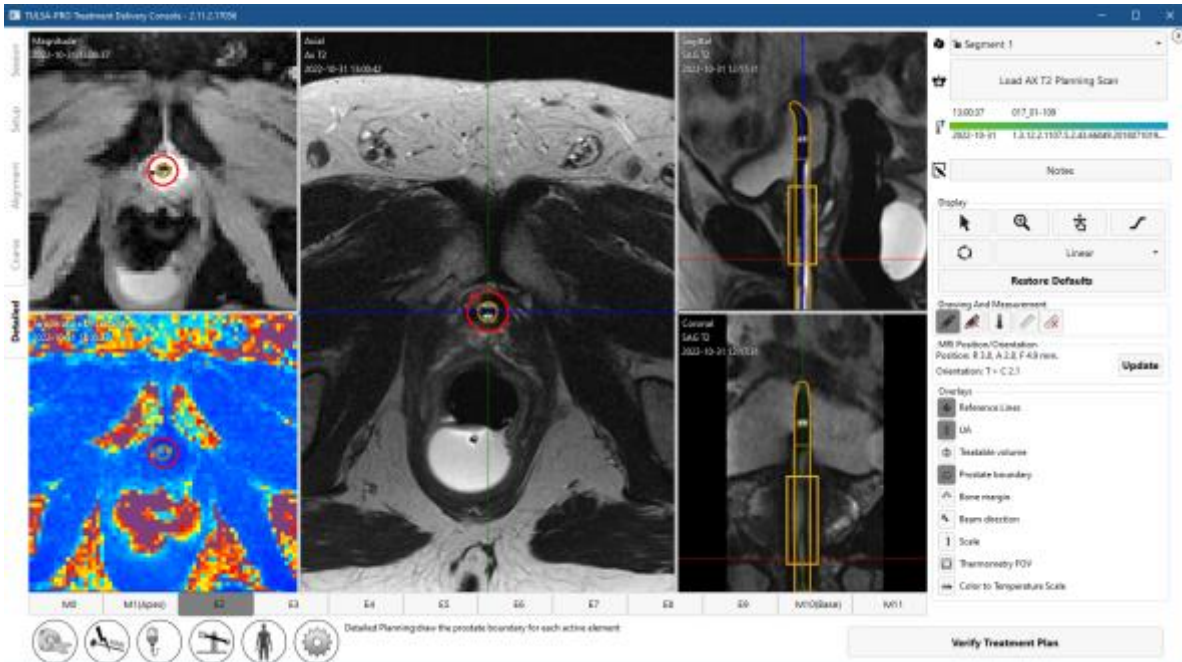
Figure 37: Detailed Planning workspace with Thermometry Magnitude and Temperature Uncertainty
