TULSA-PRO<sup>®</sup> Transurethral  
Ultrasound Ablation System

Operator's Manual

Siemens XA platform

**Document Number:** 109303 REV E

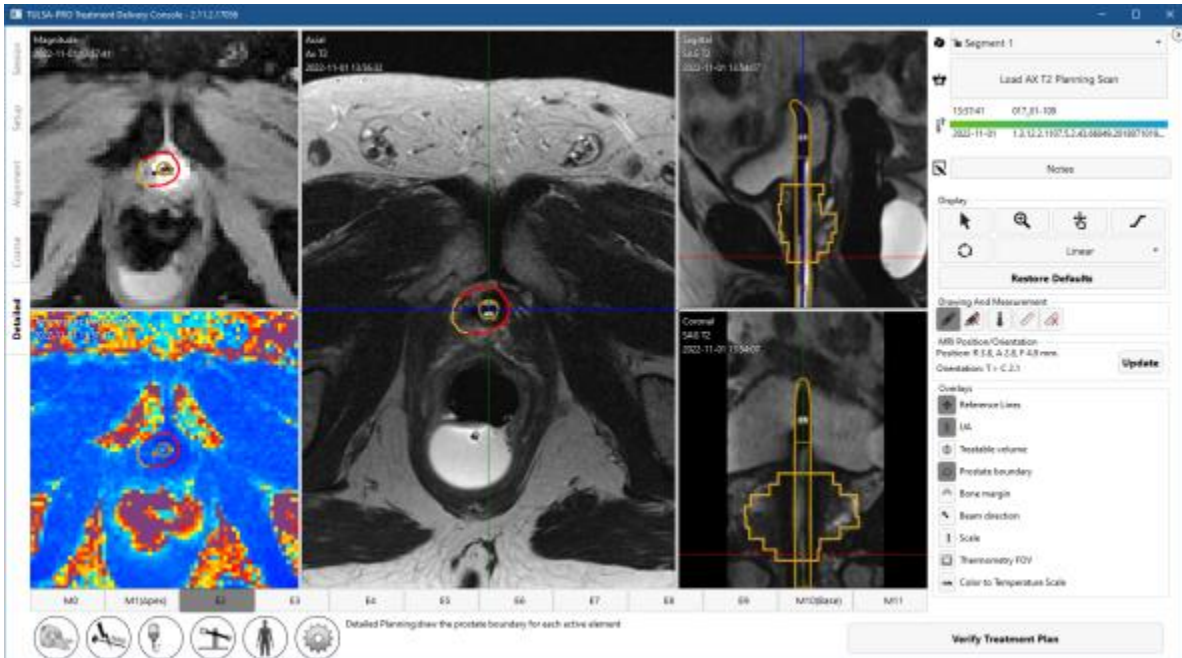
Figure 38: Detailed Planning after drawing boundaries

2. To draw the prostate boundary, select the drawing tool and outline the tissue to be ablated on each slice based on the corresponding AX T2 and THERM magnitude images (*Figure 38*). You can select individual slices by clicking on the numbered tab at the bottom of the screen or by pressing the left and right arrow keys on the keyboard. Use the sagittal and coronal views of the SAG T2 images to verify the intended ablation zone in three dimensions.

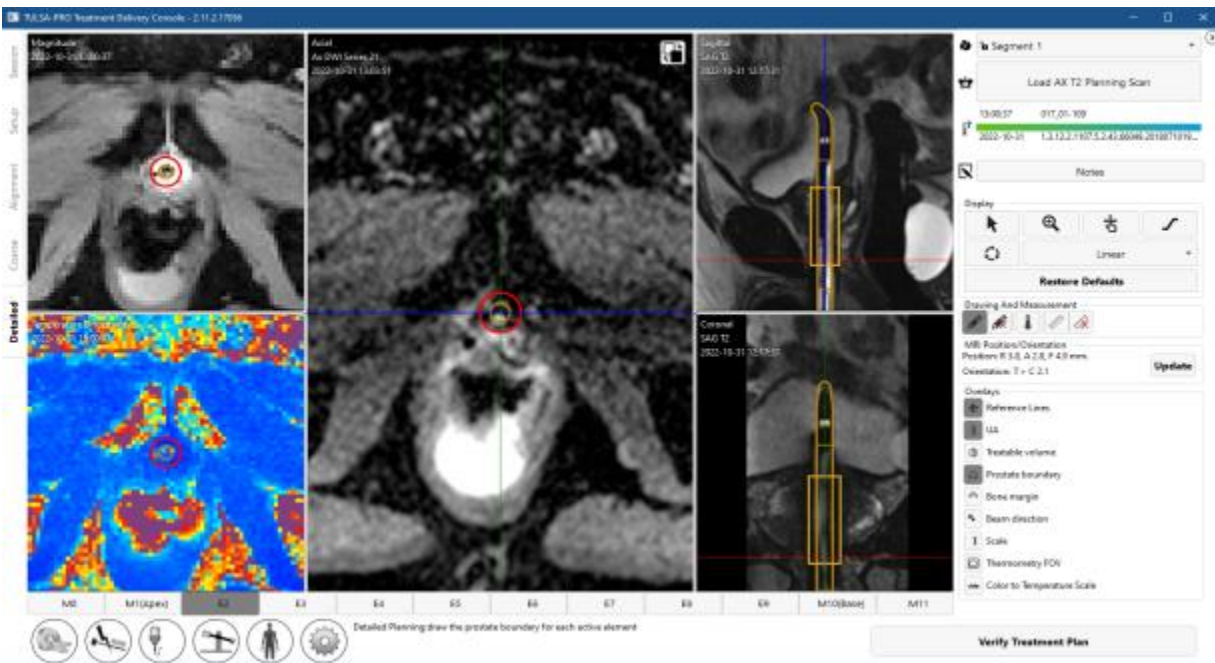
Figure 39: Using mpMRI vision in Detailed Planning to visualize intraprostatic differences in tissue properties on an AX DWI scan and select tissue intended for ablation

**Radiologist:** When prescribing the treatment volume, use the mpMRI Vision feature in *Detailed Planning* to load a set of axial diffusion weighted images (DWI), which can be used to visualize intraprostatic differences in prostate tissue to help select tissue intended for ablation (*Figure 39*).

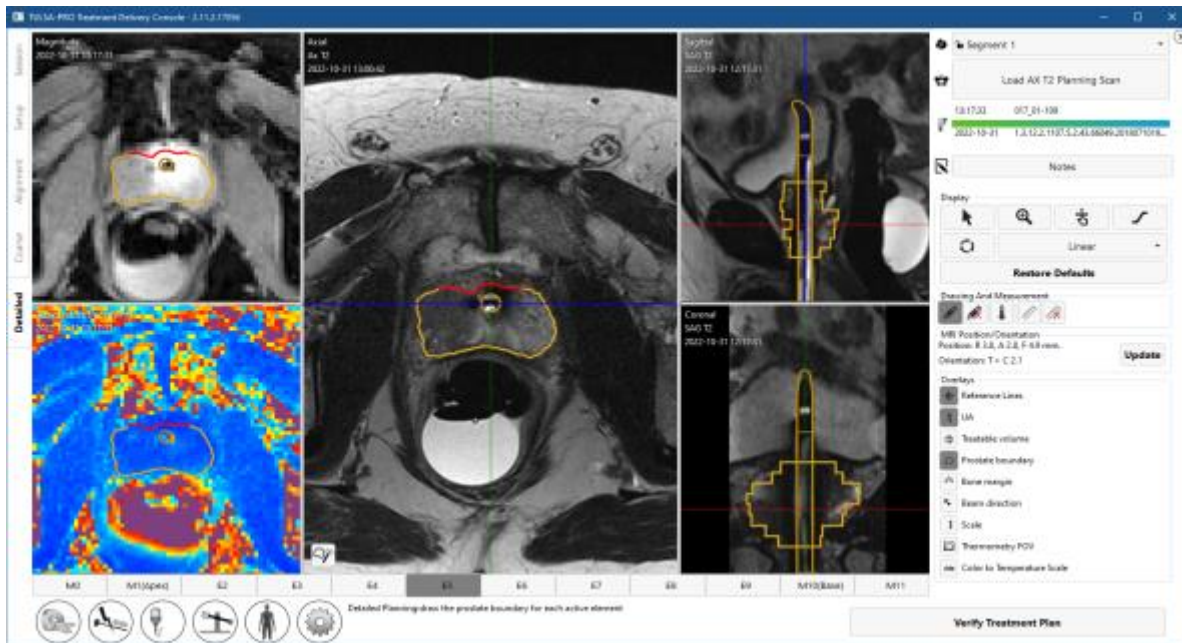
Figure 40: Using the Contouring Assistant feature in Detailed Planning to apply a software-assisted prostate boundary as a starting point for treatment planning on a selected slice

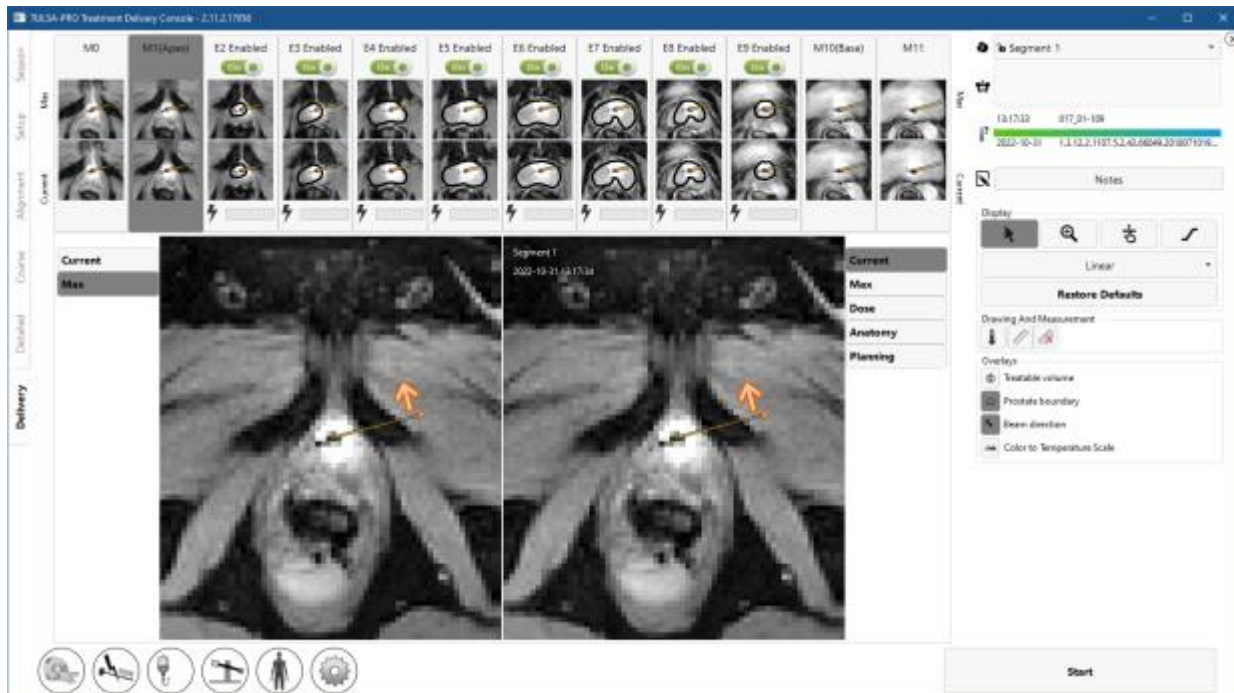
Figure 41: Delivery workspace of TDC software - Drag the orange dot to define the starting UA angle, and click the orange arrow to define the direction of rotation

The *Delivery* workspace displays information from 12 axial slices in real time: 10 slices corresponding to the elements (E1-E10) that can deliver heating, and two additional slices corresponding to the Monitoring Elements, M0 and M11 (*Figure 41*). Images are updated every 5 to 7 seconds during treatment as new images from the MR scanner are processed into temperature information.

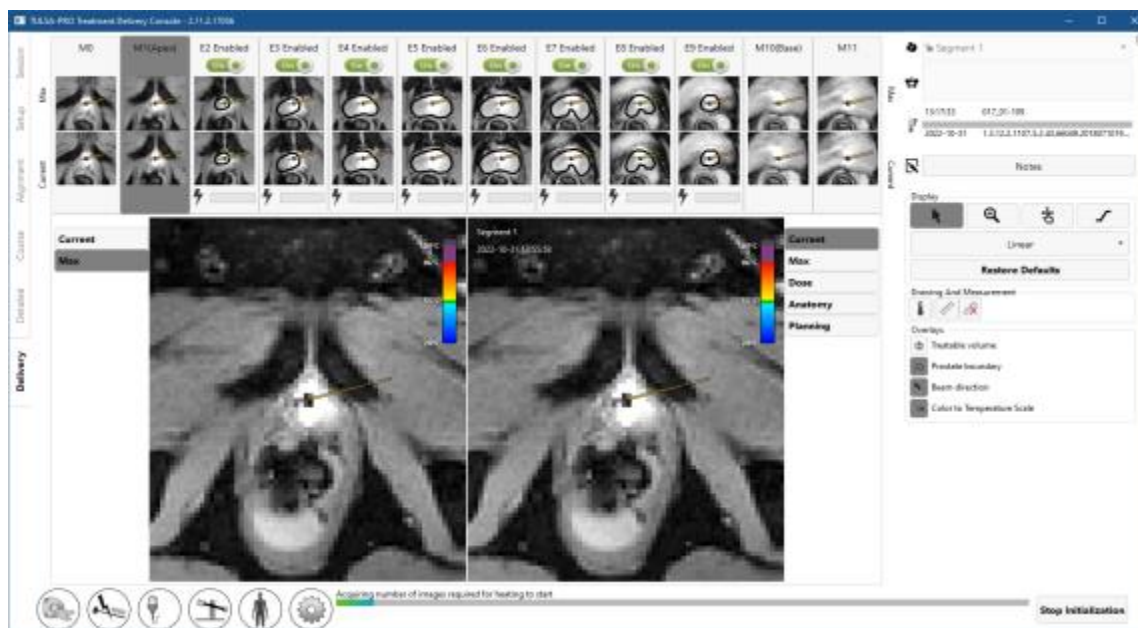
Figure 43: Treatment Initialization state

2. **MRI Technologist:** Prepare a long AX THERM SYNGO sequence for treatment.
  - a. Open the new AX THERM SYNGO template on the MRI console.
  - b. In the **Contrast > Dynamic** tab, change the number of measurements to the maximum allowed value or as instructed by the Radiologist. If the available scan time is less than 90 minutes, see "Delivery" on page 92
  - c. **Do not run the scan until instructed by the physician.**
3. **Radiologist:** Click **Start treatment** on TDC. It will prompt you to verify the core body temperature using an external temperature measurement device before proceeding. Enter the temperature in degrees Celsius and click **Confirm**. The TDC will go into **Treatment Initialization** state and is now ready to receive thermometry images (*Figure 43*).

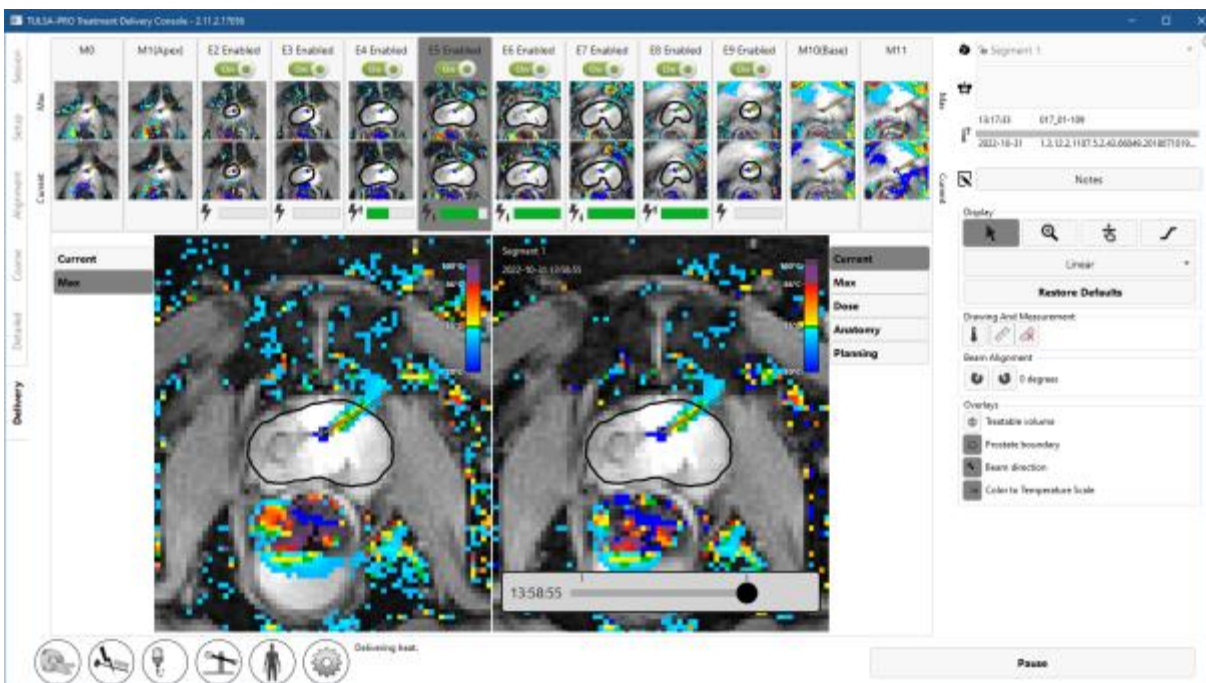
Figure 44: Ultrasound heating has begun

Radiologist: After receiving 25 thermometry dynamics, heating begins (*Figure 44*). Throughout the ablation, actively monitor real-time treatment images on all slices, ensuring that:

**Radiologist:** At any time during Delivery, click **Pause** in the bottom-right corner of the screen (see *Figure 44*). While in the paused state, all heating from the UA is suspended while thermometry acquisition continues (*Figure 49*).

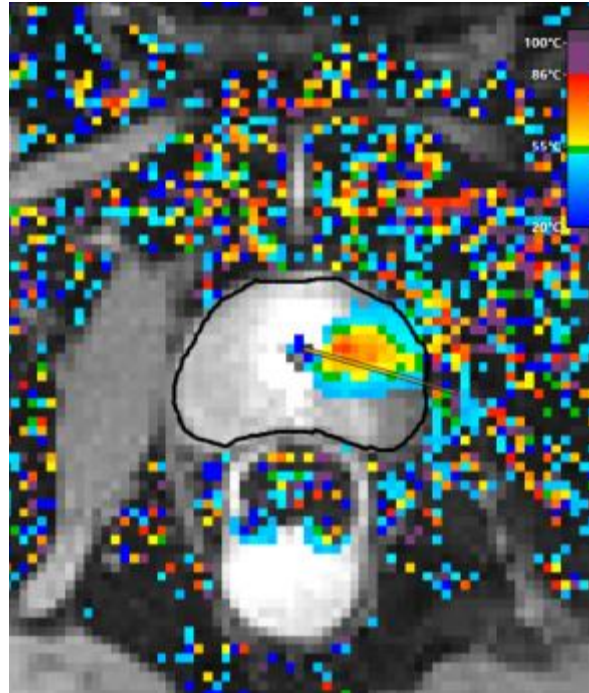
Figure 46: UA beam orientation overlay

The expected heating direction in the TDC software is represented by a feature called the **UA Beam Angle** (*Figure 46*), which is a visual overlay over the MRI Thermometry image and represented as a line extending radially outwards from the UA center.

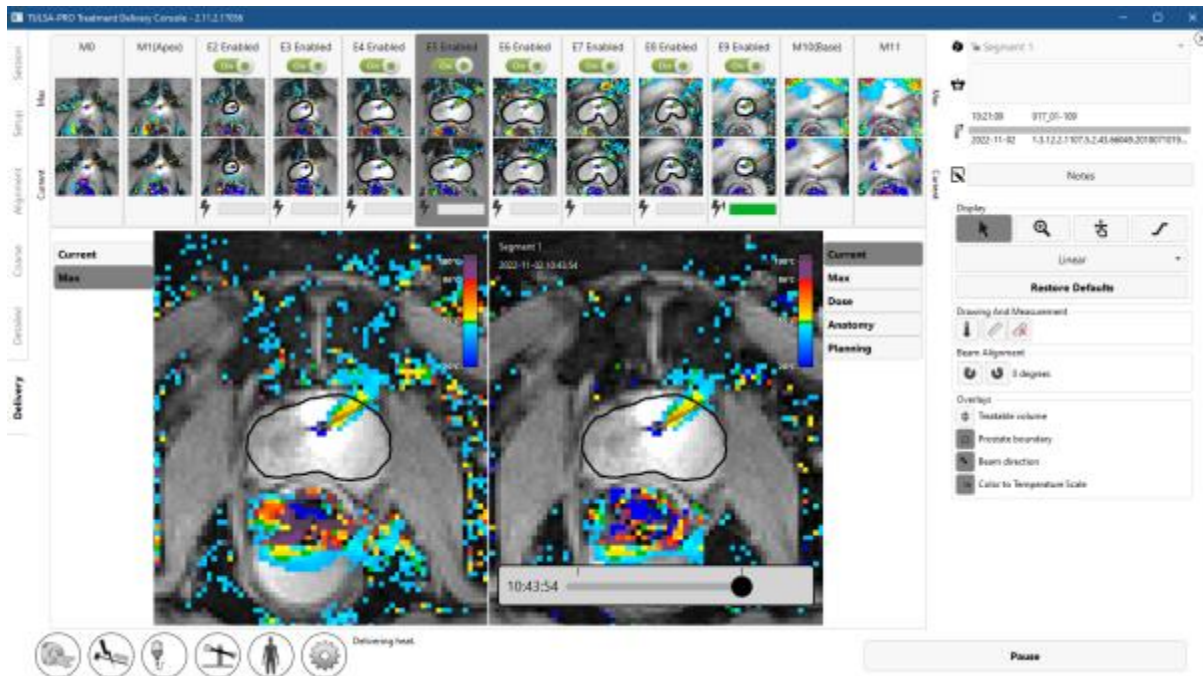
Figure 47: Misaligned ultrasound heating and UA beam angle

**During treatment delivery, if it is observed that the direction of ultrasound heating and the UA beam angle do not correspond or align with each other on the Current Temperature view (Figure 47), adjust the beam angle. If the adjustment does not resolve the problem, click Pause and create a new treatment segment (see *Creating a new Treatment Segment*) to suspend ultrasound delivery and thermometry acquisition. Enter the MRI magnet room to ensure the UA is properly mated to the PS. If the problem persists, contact a Profound Medical authorized service representative.**

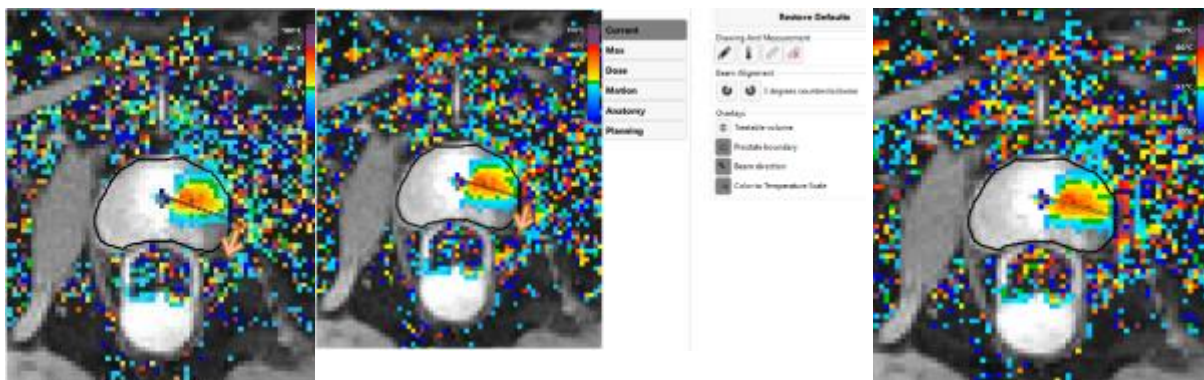
The UA is treating in the clockwise direction and the UA beam angle leads

The **Beam Alignment** buttons are used to adjust the beam angle in increments of 1 degree each time it is clicked. In this image

directions, up to a maximum of 5 degrees in either direction. It is recommended to perform beam alignment near the start of treatment when the heating pattern from the UA is a developing narrow beam. As treatment progresses, since the UA rotates while delivering heat, previously heated tissue can still appear hot and make it difficult to identify where the heat is currently being delivered. As an example, *Figure 48* shows a UA beam angle that is offset from the heating pattern of the temperature map. Next, the beam angle adjustment buttons are used to rotate the UA beam angle back toward the center of the heating pattern. After the adjustment is complete, the UA beam angle is positioned more centrally within the heating pattern.

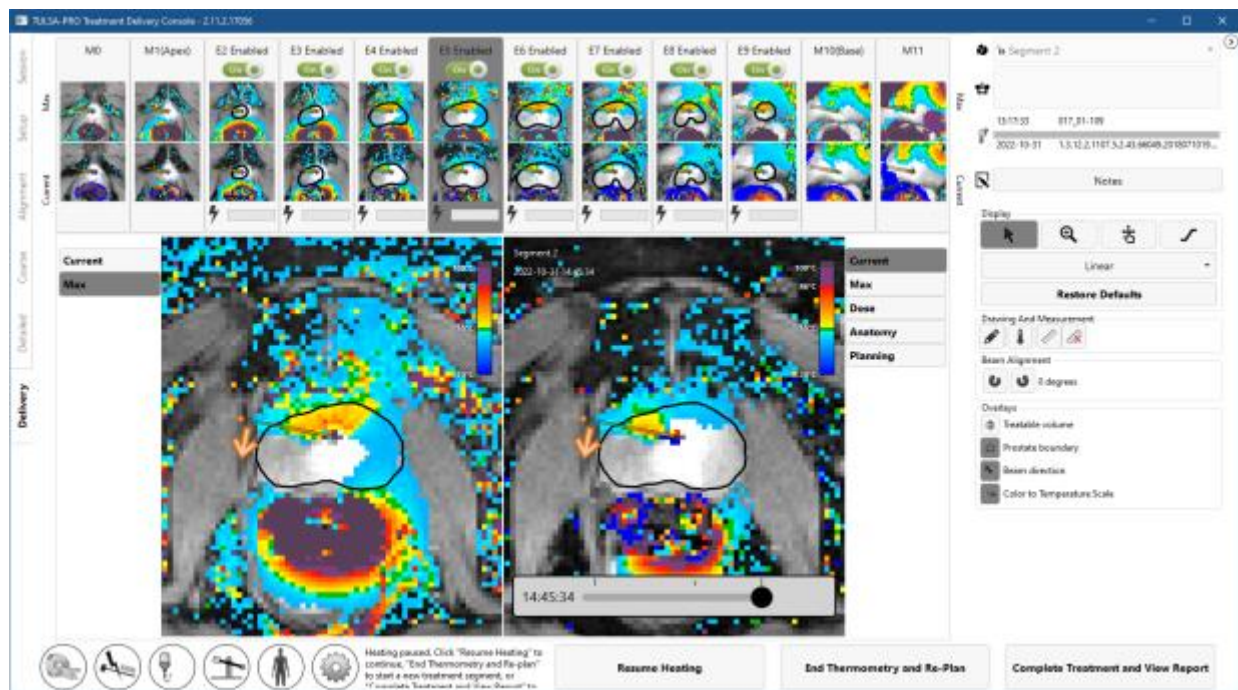
Figure 49: Delivery workspace with treatment and heating paused

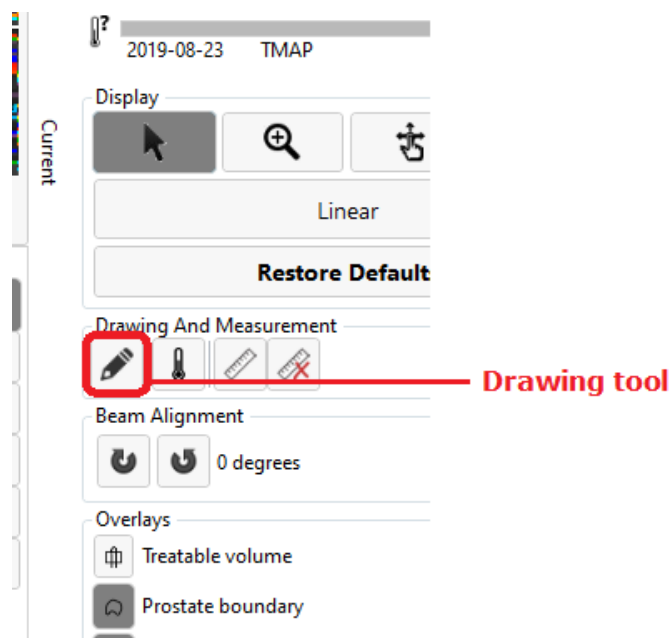
Figure 50: Prostate-boundary 'Drawing' tool on Delivery screen

1. Pause the treatment delivery.
2. Once delivery is paused, expand the right panel in the Delivery workspace to select the prostate boundary drawing tool (*Figure 50*).

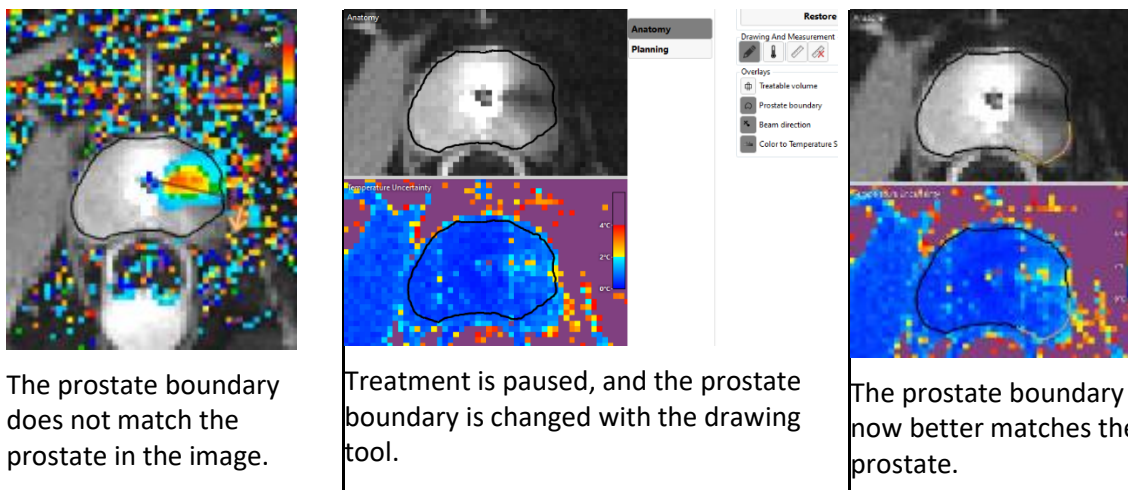
The prostate boundary does not match the prostate in the image.

Treatment is paused, and the prostate boundary is changed with the drawing tool.

The prostate boundary now better matches the prostate.

Figure 51: Editing the prostate boundary

3. Click the drawing tool. The TDC displays a new pane showing the prostate boundary contour and the temperature uncertainty for the selected slice (*Figure 51*).
4. Modify the boundary as needed on each slice. As with the thermometry uncertainty images in Detailed Planning, avoid drawing the boundary through high-temperature uncertainty regions.
5. If satisfied with the modified boundaries on all slices, click **Apply**. The TDC will validate the changes to the boundary and then you can click **Resume Heating** to resume treatment delivery. Otherwise, click **Discard Changes** to start editing from the current boundaries again. If none of the changes are acceptable, then create a new treatment segment by clicking **End Thermometry and Re-plan**.

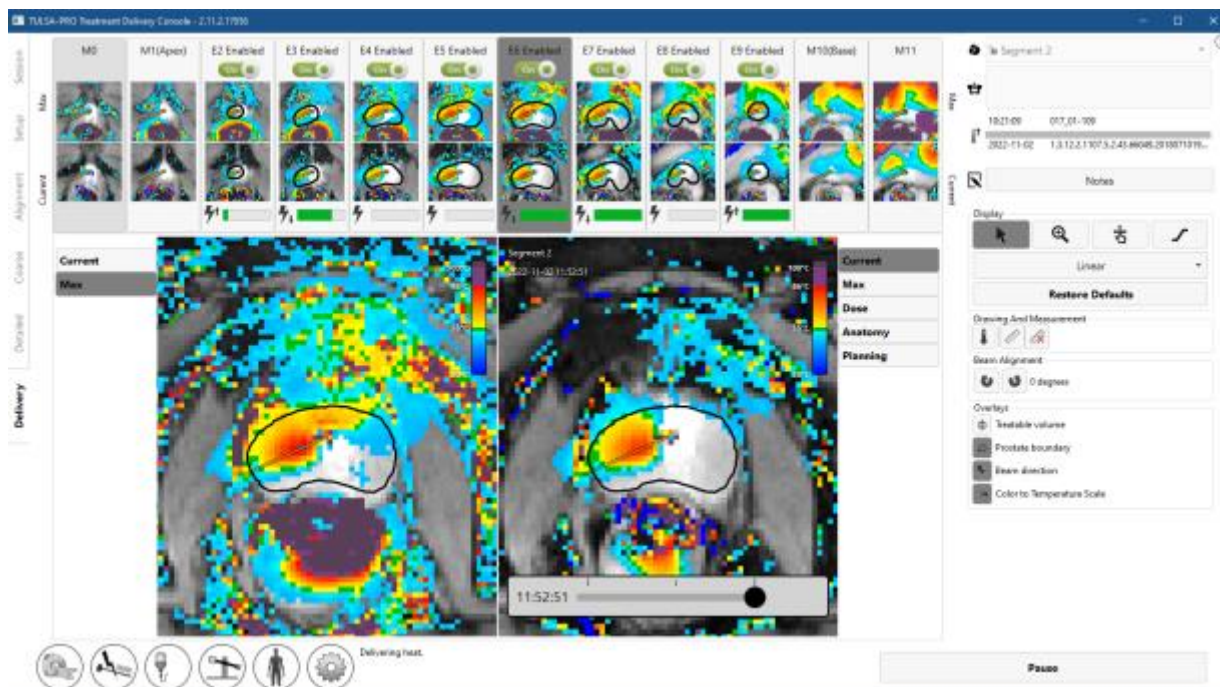
Figure 52: History slider in Delivery workspace

The History Slider appears at the bottom of the right viewport in the Delivery workspace (*Figure 52*), and is accessible during live treatment delivery, when treatment is paused, and after treatment is completed.

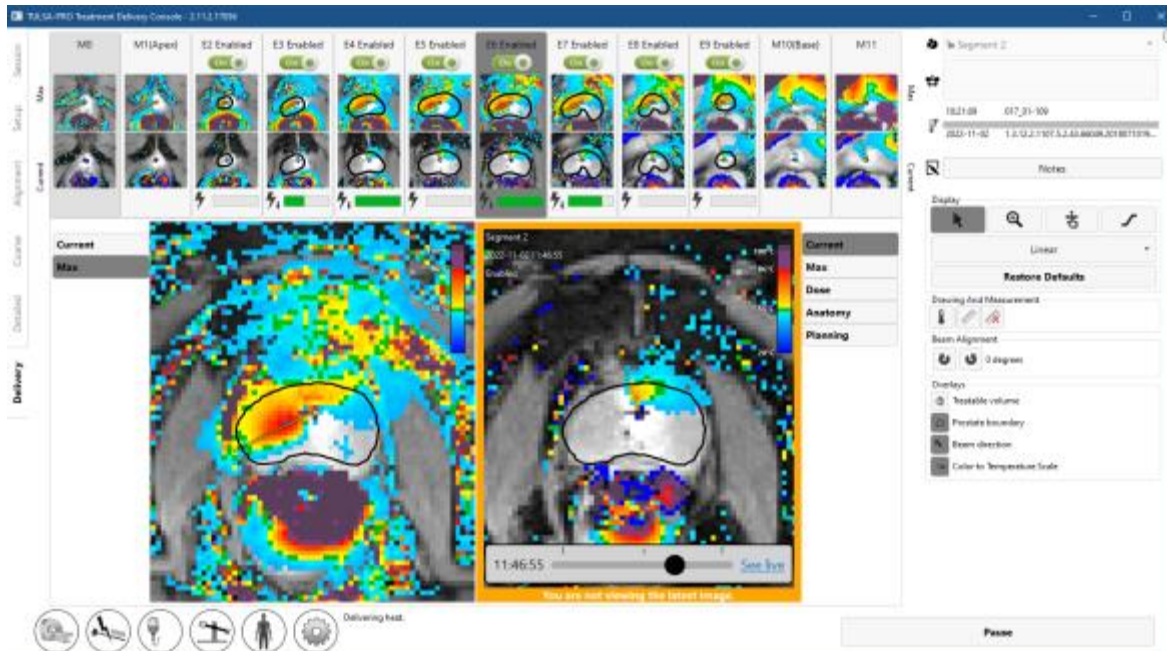
Figure 53: “You are not viewing the latest image” message below history slider

**NOTE:** When viewing images from previous timepoints, a frame around the right viewport shows that the latest images are not being viewed (*Figure 53*). A dashed line shows where the beam angle was at the previous timepoint. To return to the current timepoint, click **See live** or drag the History Slider until the framed message disappears.

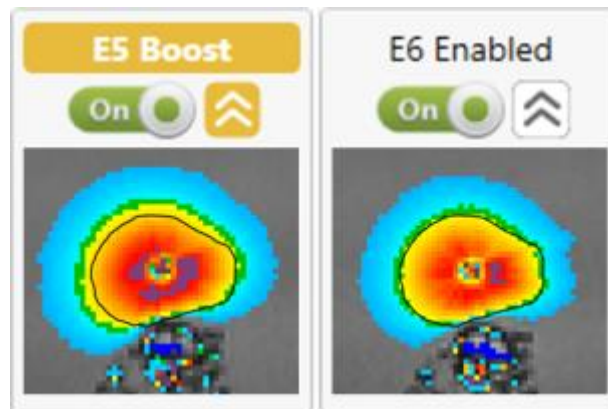
Figure 54: Max temperature maps of the same target boundary treated with boost (left) and without (right).

Figure 1 shows the maximum temperature view in a case where Thermal Boost was applied on one slice and not on the other.

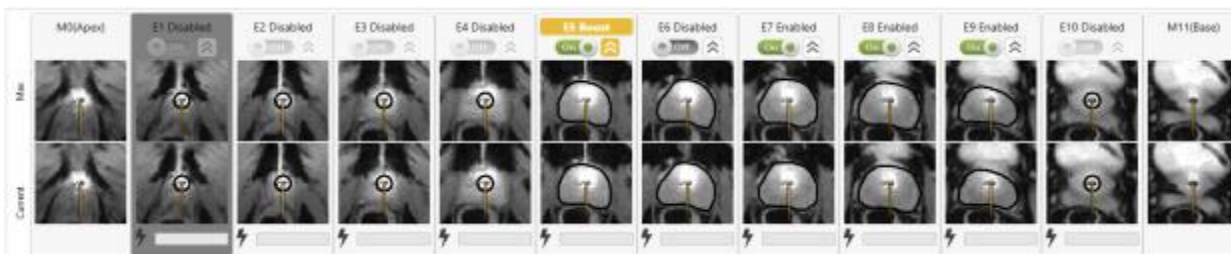
Figure 56: Thermal Boost enabled

2. Click on the double-chevron to activate the **boost**. When Boost is activated, the element's label will change from **Enabled** to **Boost**, its Boost icon will turn yellow, and the Thermal Boost control parameters will remain in effect for that element until deactivated. For example, in Figure 3, heating is Enabled on elements 5, 7, 8, 9, and Boost is activated on Element 5.

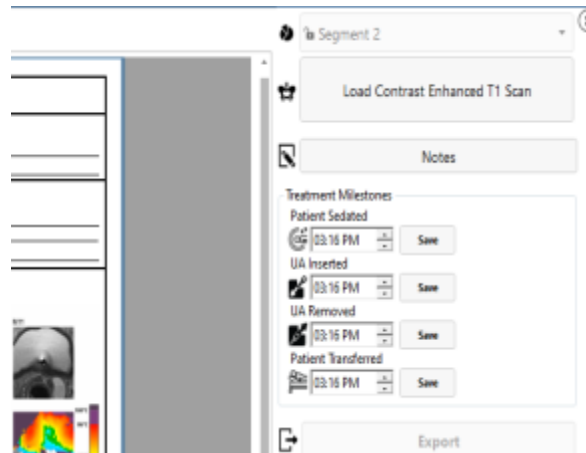
Figure 57: Treatment Milestones panel in Reports workspace

**MRI Technologist:** Use the Treatment Milestones panel in the *Reports* workspace (*Figure 57*) to record:

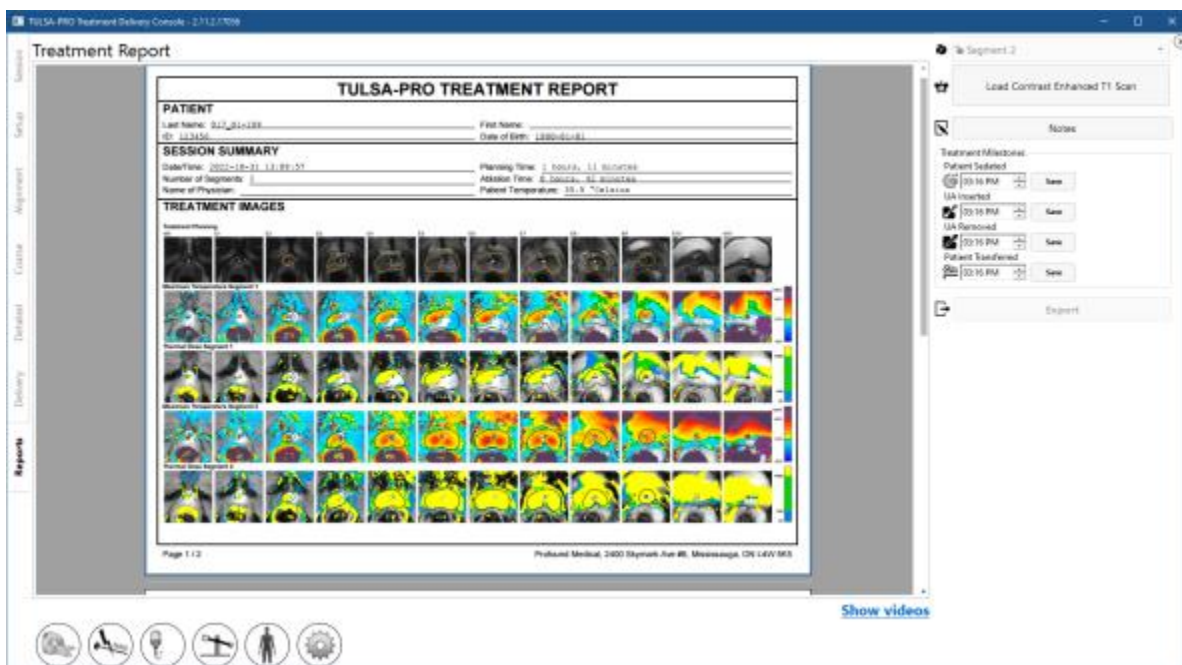
Figure 58: TDC Reports tab

When the Treatment Delivery Console (TDC) enters the *Reports* workspace, users see a brief summary of the treatment session (Figure 58). At the same time, the TDC starts to generate videos of the treatment, which might take several minutes.

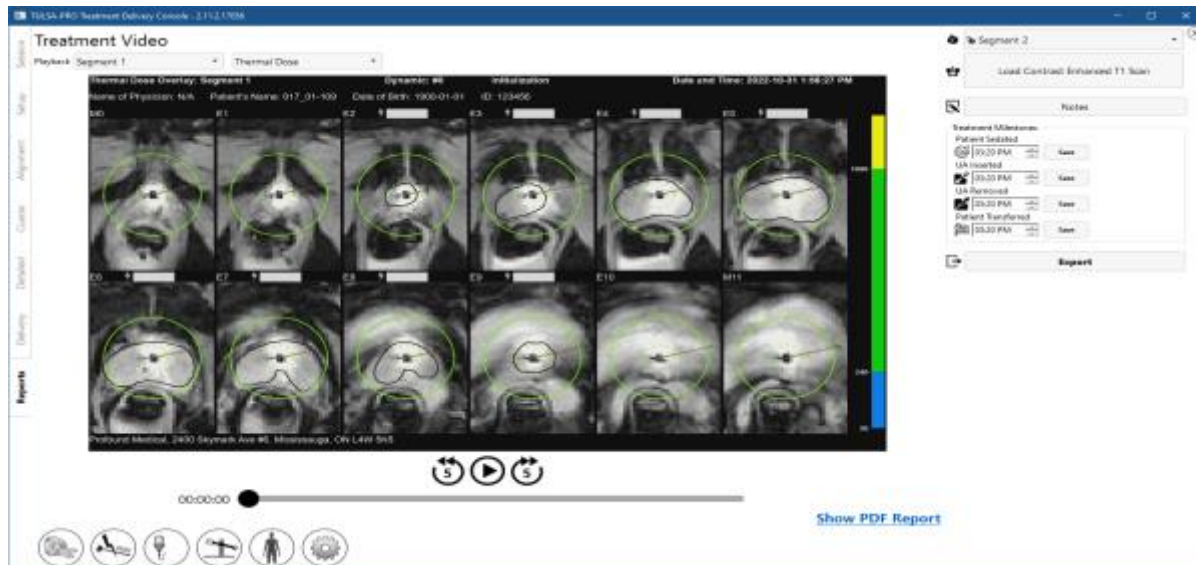
Figure 59: Treatment video displayed in Reports workspace

You can play (▶) the video for the treatment segment (or if the session had multiple segments, use the segment selector (*Figure 59*) to choose an individual segment) and choose to see the anatomy with an overlay of the current temperature, maximum temperature, or thermal dose. Each video also shows the prostate boundary, the direction of the beam at each moment, and the intensity of heating.

When TDC has finished generating the treatment videos, the [Show videos](#) link will be available at the bottom of the *Reports* workspace. Click [Show videos](#) and the report region of the display will show the treatment videos (*Figure 59*).

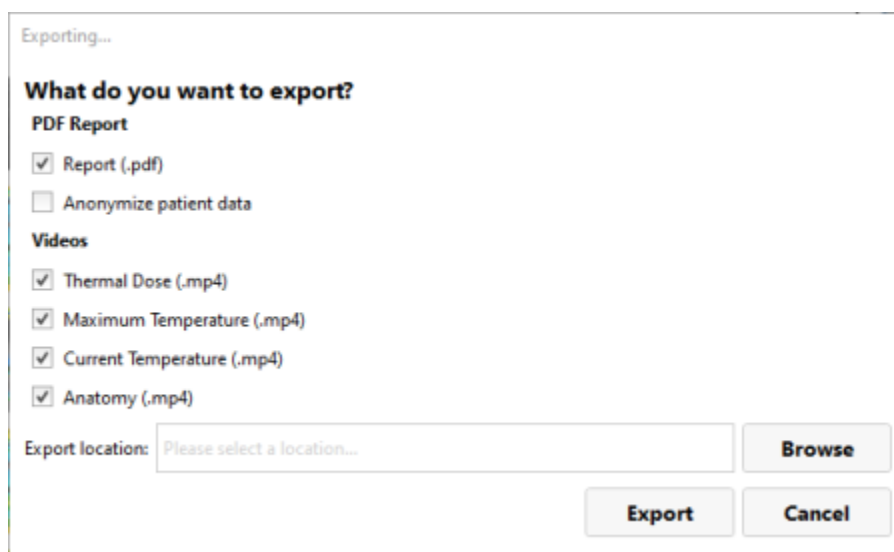
You can also save the treatment report and videos to the computer hard drive or any storage medium. Attach the appropriate storage device and click **Export**. The system displays a window where you can choose a location to store the files and whether to export a PDF file of the report and videos with overlays (Thermal Dose, Maximum Temperature, Current Temperature, or Anatomy) (*Figure 60*).

Figure 60: Exporting treatment session reports and videos

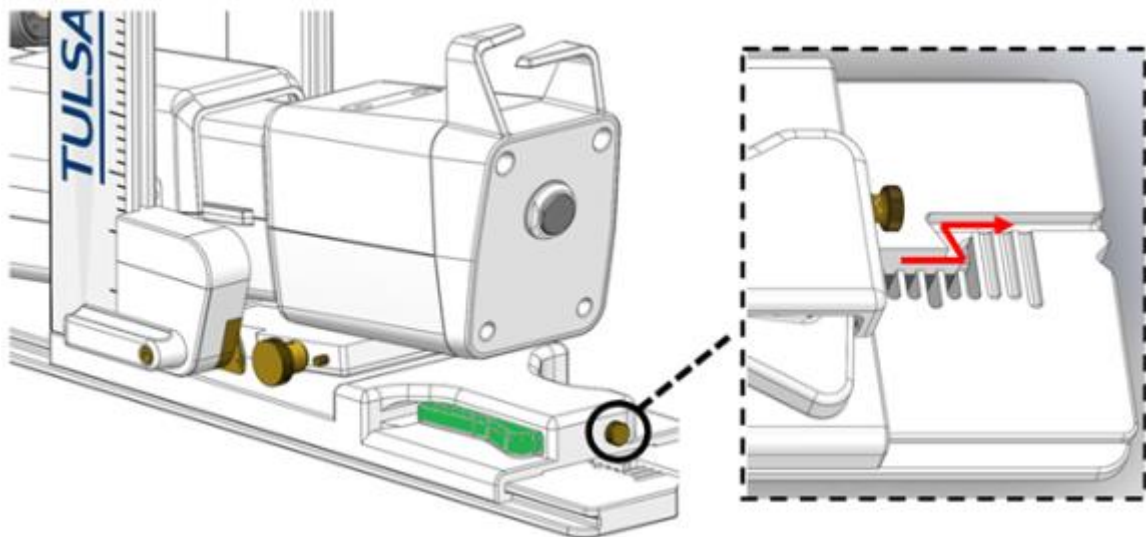
1. Remove the PS from its notched base plate by partially unscrewing the thumbscrew located on the rear of the PS base and depressing the horizontal adjustment lever through the Z channel at the rear of the PS base (*Figure 61*).

Figure 61: Removing PS from base plate

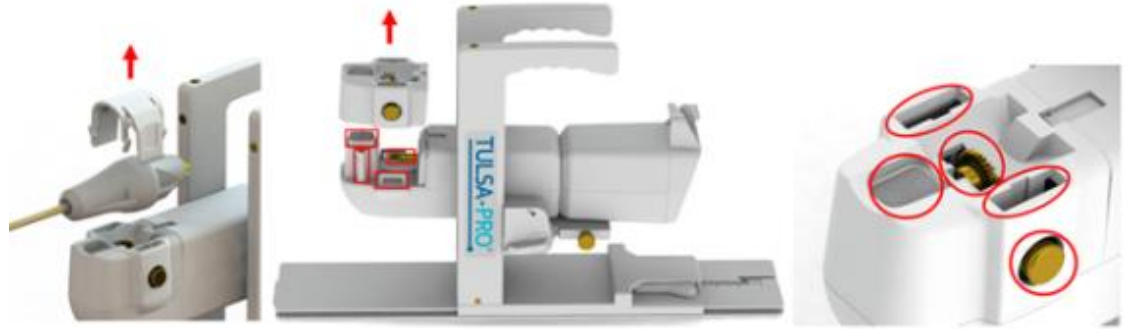
2. Detach the PS Nose by depressing the brass buttons.
3. If you see soiling in either the PS Base or PS Nose area, perform these steps:
  - a. Using a spray disinfectant, saturate the entire gripper area, focusing on the gear area or anywhere with visible soiling. Allow to remain wet for, at minimum, the manufacturer's specified contact time.
    - Ensure all edges, cracks, crevices, corners, and hard-to-reach areas are wetted with the spray disinfectant.
  - b. Use a wipe to loosen and brush away gross soil, then wipe all surfaces of gripper again using a fresh wipe.
  - c. Repeat steps 1 and 2 as necessary until no visible soiling remains, closely inspecting the areas around the gripper and gear (*Figure 62*).

Figure 62: Inspecting the Positioning System

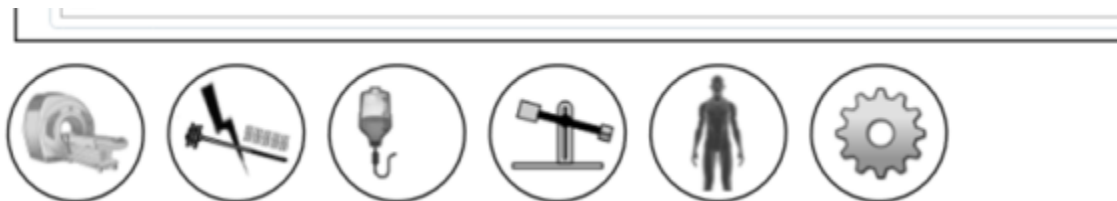
An area at the bottom-left of the Treatment Delivery Console (TDC) screen shows alarm indicators when a session is in progress (*Figure 63*).

Figure 63: Alarm indicators (all indicators are clear)

If there is no information or warning condition associated with a subsystem, the corresponding subsystem alarm indicator stays clear (*Figure 63*).

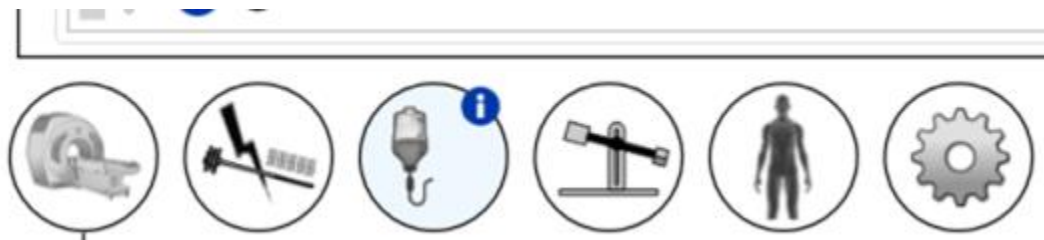
If a subsystem detects an **information** condition, the background color of the corresponding indicator changes to **light blue** and an additional icon (i) is shown at the top-right of the indicator (*Figure 64*).

Figure 64: Example of Information condition

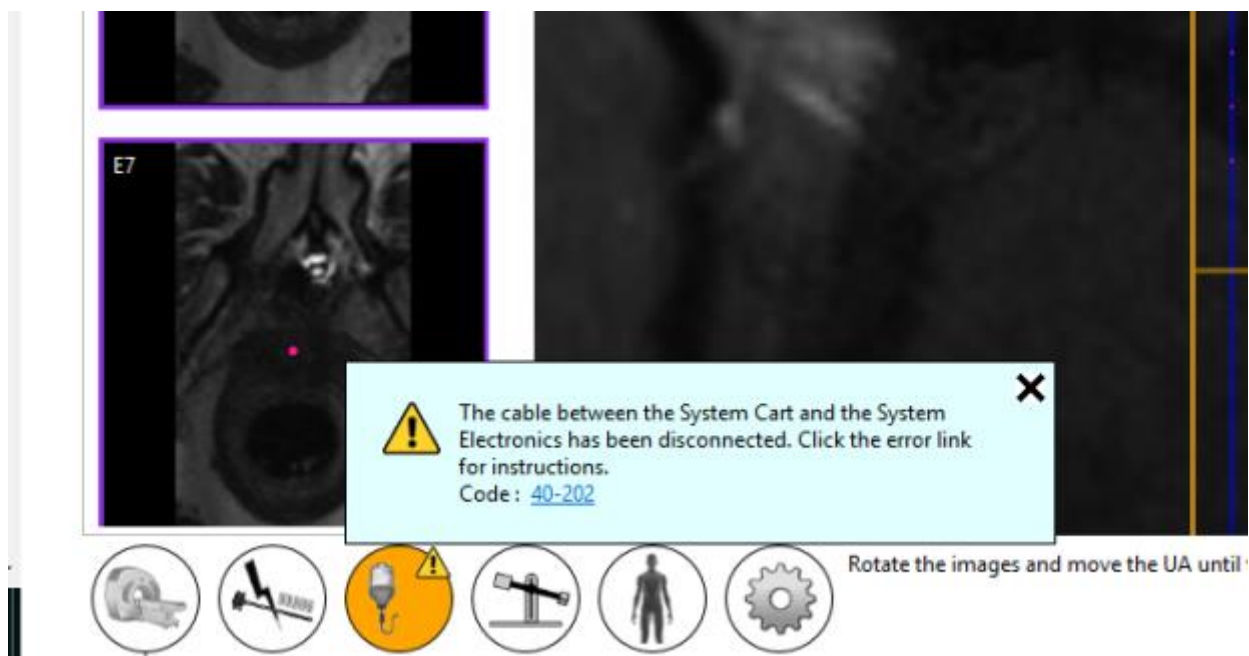
In addition to a change in the background color of an alarm indicator, a pop-up message containing details shows beside the indicator ( *Example of message with Alarm condition details*). The message stays on the screen for 10 seconds. To see the pop-up message again, hover the cursor over the alarm indicator.

Figure 66: Example of message with Alarm condition details

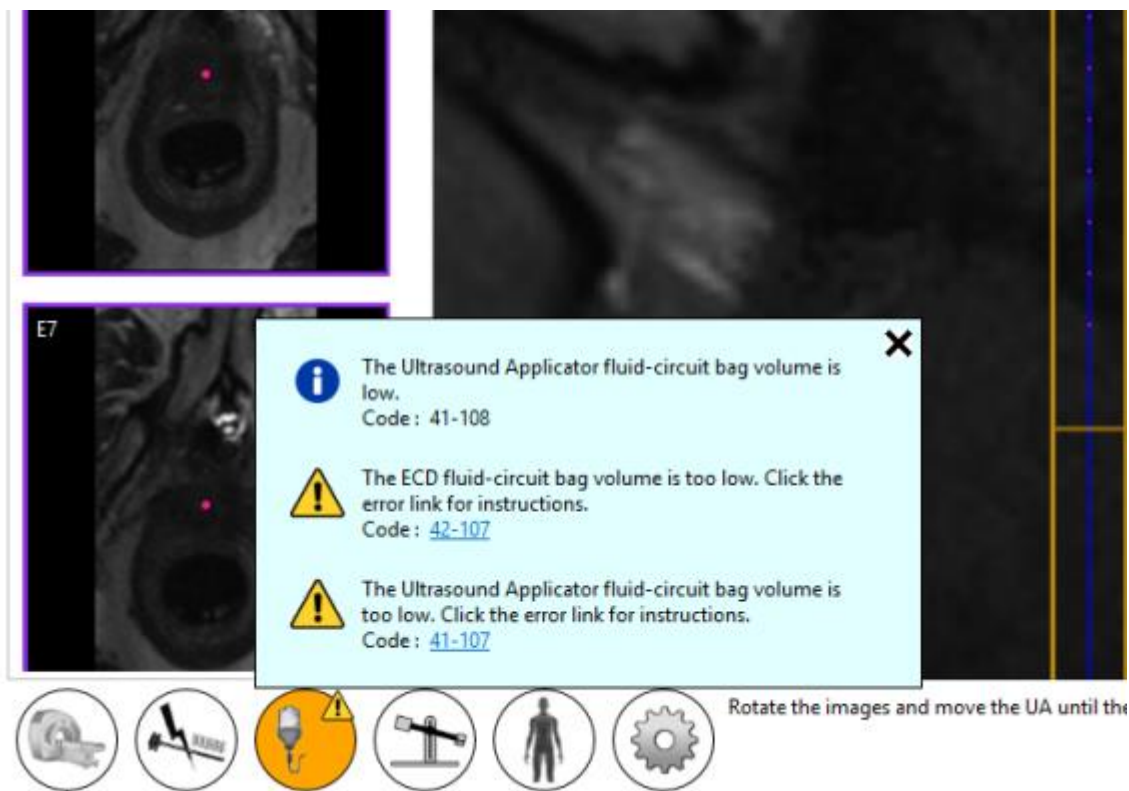
The corresponding subsystem pop-up message will contain all condition messages ( *Multiple condition messages in the pop-up message*).

Figure 67: Multiple condition messages in the pop-up message
