**TULSA-PRO® Transurethral Ultrasound
Ablation System**

Operator's Manual

TULSA-PRO® SYSTEM Model Number: PAD-105

Document Number: 109303 REV F

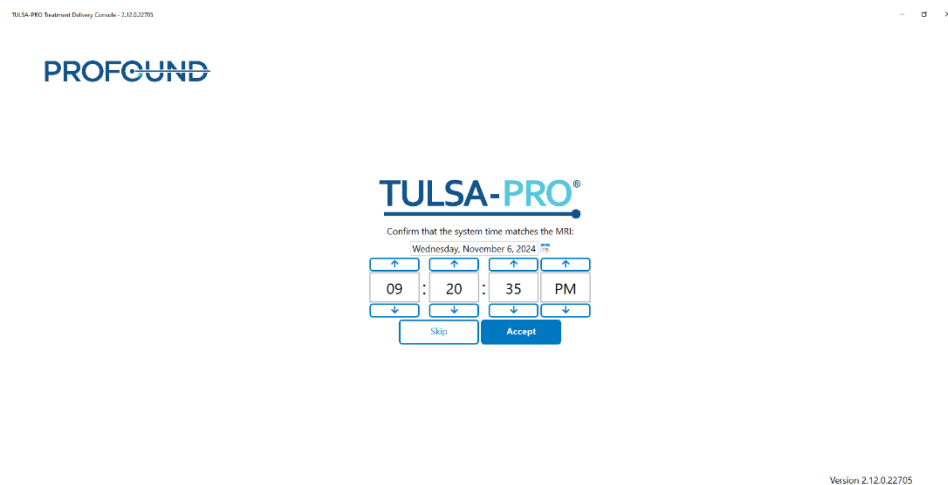
1. Launch the TDC software from the desktop. The **Clock Sync** workspace will appear (5). To correctly recognize and accept the most recent planning images, the TULSA computer will try to connect to the MRI and automatically synchronize its clock with the MRI host computer. If automatic clock sync fails, check the date and time displayed on the MRI computer monitor, and if the times are more than 1 minute apart, manually adjust the date and time displayed in the TDC Clock Sync workspace.

Figure 5: Clock Sync workspace

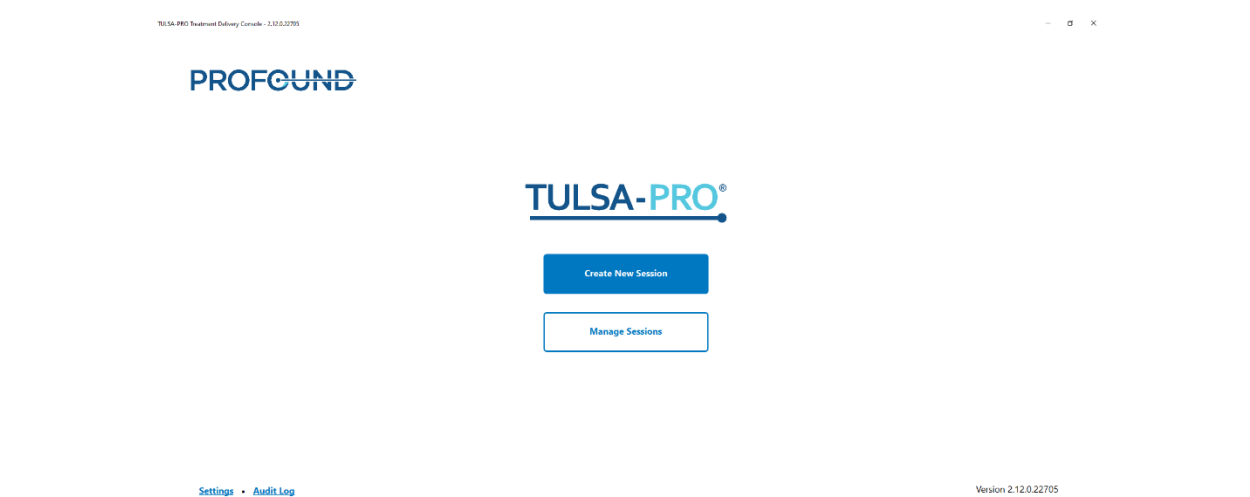
2. After synchronizing the system clocks, the **Start Screen** will appear (Figure 6). Click **Create New Session**.

Figure 6: TULSA-PRO Start Screen

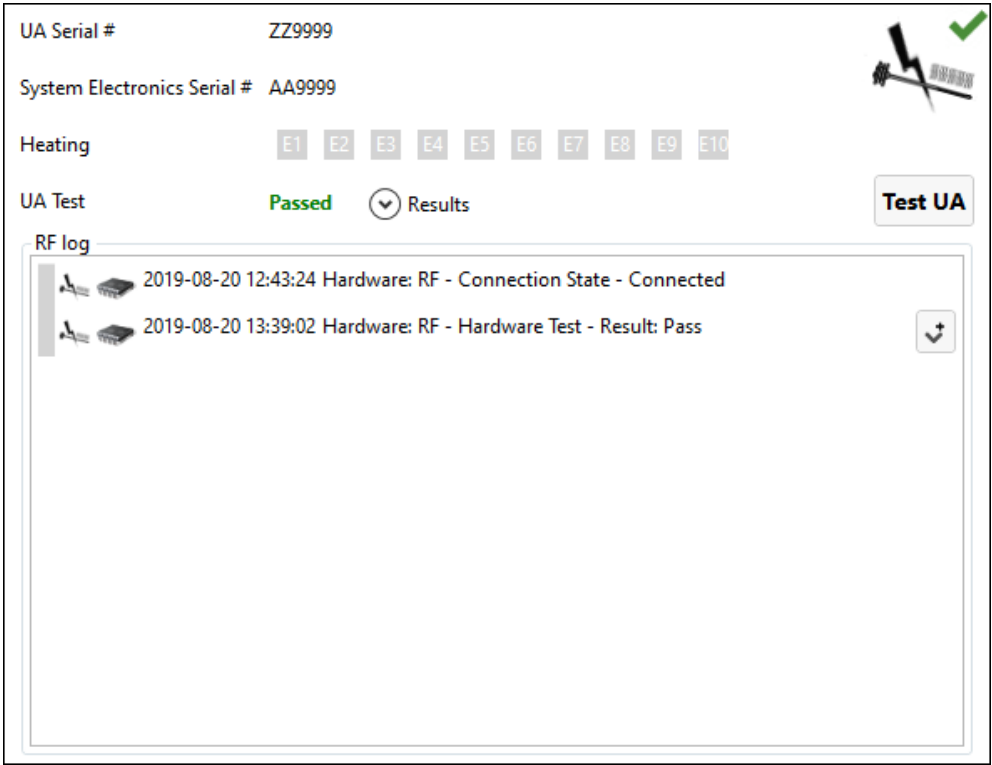
The system will send a short burst of power to each of the ten UA elements to ensure continuity and functionality of all ten channels. This can also be done from the TDC Setup workspace from the RF information box in the top-right quadrant (Figure 16).

When the RF connectivity test is complete, the PSIB will display a short message (Figure 15). You can see detailed RF connectivity test results in the RF information box of the TDC software (Figure 16).

Figure 16: RF information box in Setup workspace after successful RF connectivity test

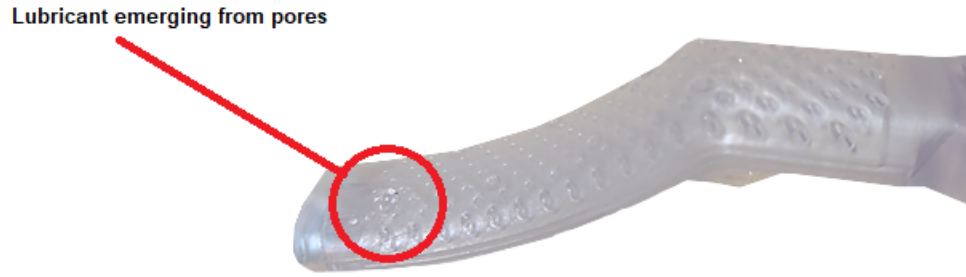
Ensure that lubricant emerges from all the small pores from the handle to the tip of the ECD.
 - b. Slowly inject approximately 10 ml of low-viscosity lubricant into the black channel, which will add lubricant to the ECD surface. Gently press on the pores closest to the handle to allow lubricant to fill the large pores at the tip of the ECD. Ensure that some lubricant emerges from all the large pores from the handle to the tip of the ECD (*Figure 18*).

Figure 18: Lubricant emerging from ECD pores

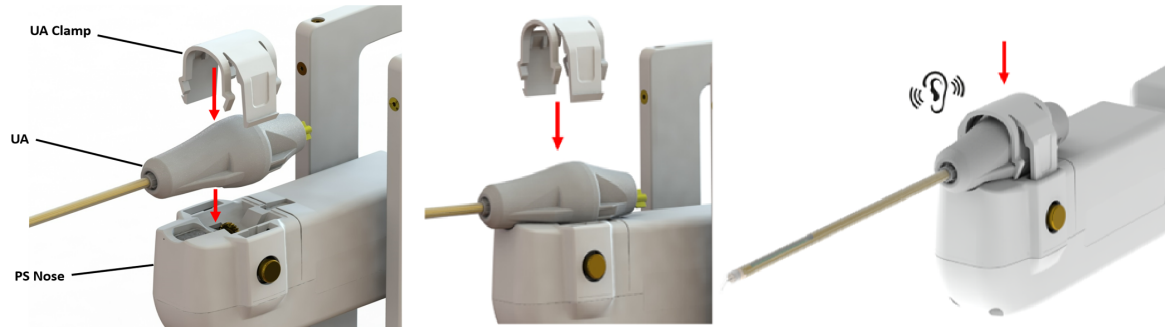
- MRI Technologist:** After locking the PS tilt and height, seat the UA in the PS nose and then secure it by pressing the UA clamp down over top of the UA until it is fully engaged with the PS nose. (*Figure 25*).

Figure 25: UA attachment to Positioning System

NOTE: You will hear an audible click when the clamp is fully inserted into the PS nose.

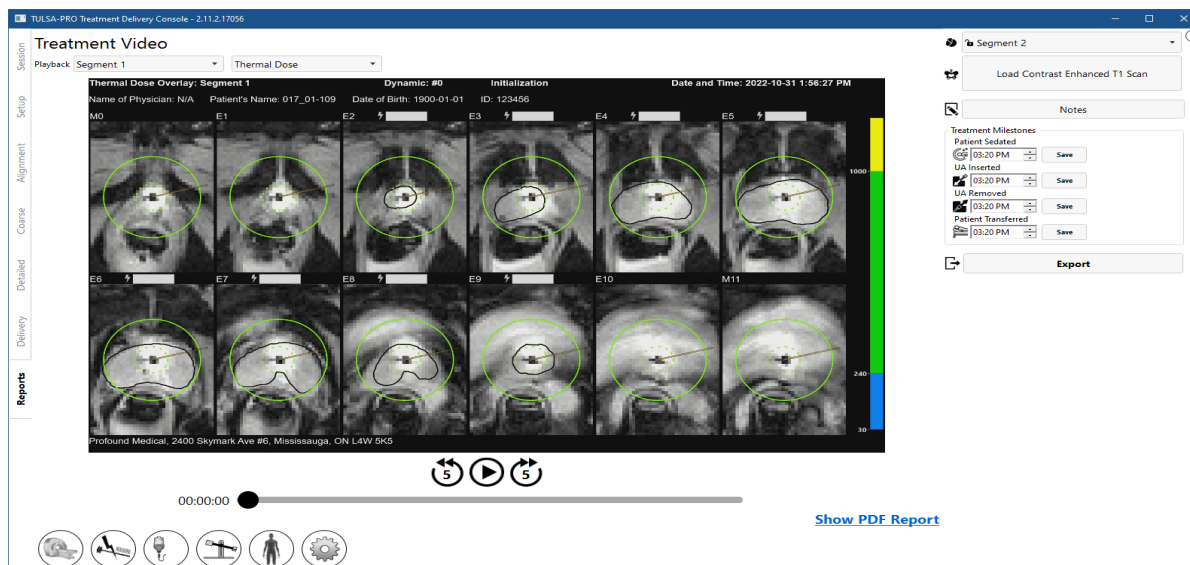
Figure 59: Treatment video displayed in Reports workspace

When TDC has finished generating the treatment videos, the [Show videos](#) link will be available at the bottom of the *Reports* workspace. Click [Show videos](#) and the report region of the display will show the treatment videos (*Figure 59*).

You can play (⏮) the video for the treatment segment (or if the session had multiple segments, use the segment selector (Figure 59) to choose an individual segment) and choose to see the anatomy with an overlay of the current temperature, maximum temperature, or thermal dose. Each video also shows the prostate boundary, the direction of the beam at each moment, and the intensity of heating.

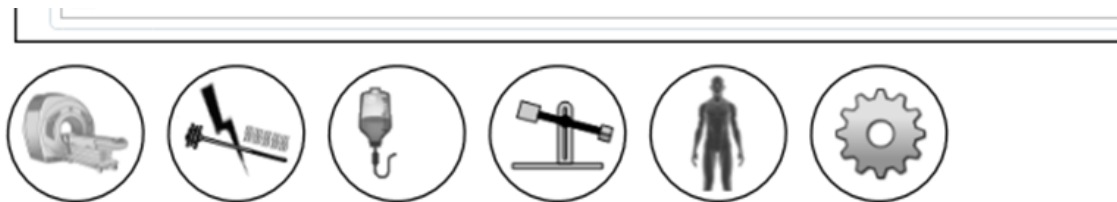
Figure 65: Alarm indicators (all indicators are clear)

An area at the bottom-left of the Treatment Delivery Console (TDC) screen shows alarm indicators when a session is in progress (*Figure 65*).

If there is no information or warning condition associated with a subsystem, the corresponding subsystem alarm indicator stays clear (*Figure 65*).

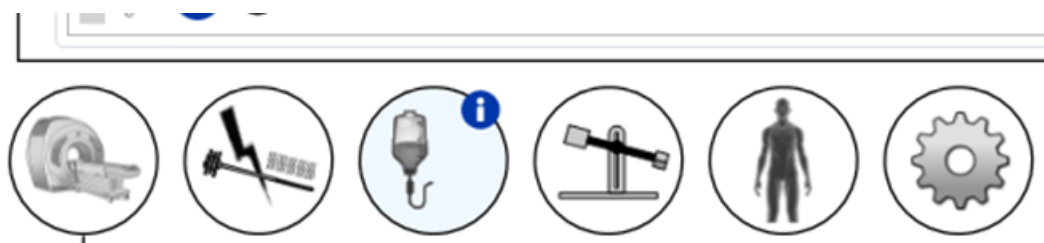
Figure 66: Example of Information condition

If a subsystem detects an **information** condition, the background color of the corresponding indicator changes to **light blue** and an additional icon (i) is shown at the top-right of the indicator (*Figure 66*).
